## Survey Report

### Crystaliner 29

### Sea Watch III

<b>FILE NUMBER.....</b>	24-1023
<b>DATE AND TIME OF SURVEY.....</b>	23 Oct 2024
<b>PLACE OF SURVEY.....</b>	Newport Beach, CA
<b>SURVEY PREPARED FOR.....</b>	Southcoast Shipyard
<b>TYPE OF SURVEY.....</b>	Condition and Value
<b>NAME OF VESSEL.....</b>	Sea Watch III
<b>OVERALL VESSEL RATING.....</b>	Above Average
<b>ESTIMATED MARKET VALUE.....</b>	\$40,000
<b>ESTIMATED REPLACEMENT COST.....</b>	200,000
<b>HULL IDENTIFICATION NUMBER (HIN)...</b>	Not Readable
<b>CALIFORNIA REGISTRATION NO.....</b>	CF 2303 XC
<b>MAKE OF VESSEL.....</b>	Crystaliner
<b>MODEL OF VESSEL.....</b>	29
<b>BUILDER.....</b>	Crystaliner Corp, Costa Mesa, CA
<b>YEAR BUILT.....</b>	Information not Available
<b>HULL MATERIAL.....</b>	Fiber Reinforced Plastic
<b>HULL TYPE.....</b>	Modified V
<b>LENGTH OVER ALL (LOA).....</b>	29' 5" (per BUC Guide)
<b>BEAM.....</b>	11' 0" (per BUC Guide)
<b>DRAFT.....</b>	2' 6" (per BUC Guide)
<b>DISPLACEMENT.....</b>	11,000 Lbs (per BUC Guide)

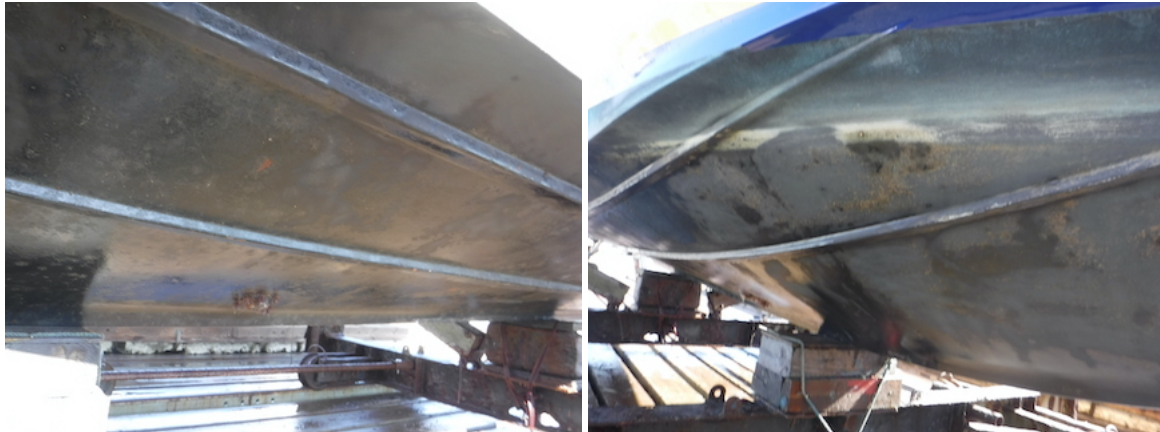
The hull is constructed of fiber-reinforced plastic in a V configuration with hard chines and strakes. The hull is stiffened by stringers and partial and full bulkheads. The hull is in good condition above the waterline. The interior of the hull is in good condition where accessible. The hull below the waterline is in good condition. Percussion soundings to the hull found no delamination. The bottom paint is in fair condition. There are no blisters or cracks sighted.

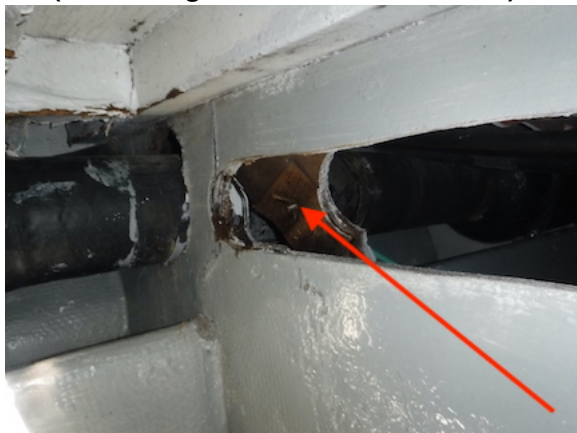
#### **B.1 (see findings and recommendations)**

The bulkheads are constructed of plywood covered with fiber-reinforced plastic and tabbed to the hull. The bulkheads and tabbing are in good condition. Percussion soundings to the bulkheads found no core damage or delamination. There is some damaged plywood in the bulkhead aft of the engine compartment at the starboard exhaust hose.

FINDINGS	RECOMMENDATIONS
<b>B.1</b> There is some damaged plywood in the bulkhead aft of the engine compartment at the starboard exhaust hose.	<b>Repair the plywood at the bulkhead.</b>
<b>B.2</b> There is only on bilge blower.	<b>There shall be at least one powered blower for each gasoline engine used for propulsion. ABYC H-2.5.4.1</b>
<b>B.3</b> The bilge blower does not extend to below the engines.	<b>Extend the bilge blower inlet hose to the lower part of the bilge but above the bilge water level and secure in place. ABYC H-2.6.3</b>
<b>B.4</b> There is corrosion and evidence of a leak at the starboard engine outboard exhaust.	<b>Repair the leak at the exhaust.</b>
<b>B.5</b> There is evidence of a leak at the port shaft seal.	<b>Inspect the shaft seal for leaks.</b>

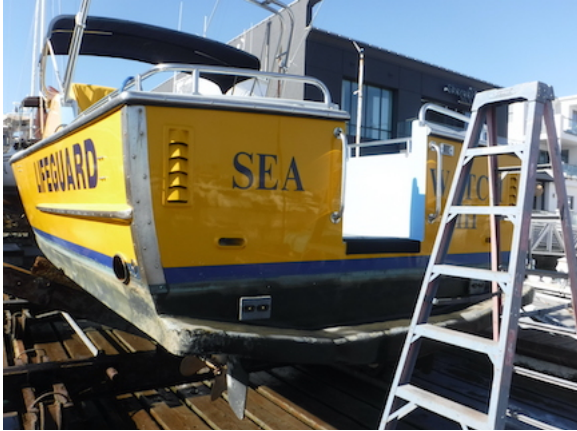
The stringers and transverse members are constructed of fiber-reinforced plastic and tabbed into the hull and are in good condition. The wood strings supporting the engines are in good condition and secure.

The transom is in good condition.

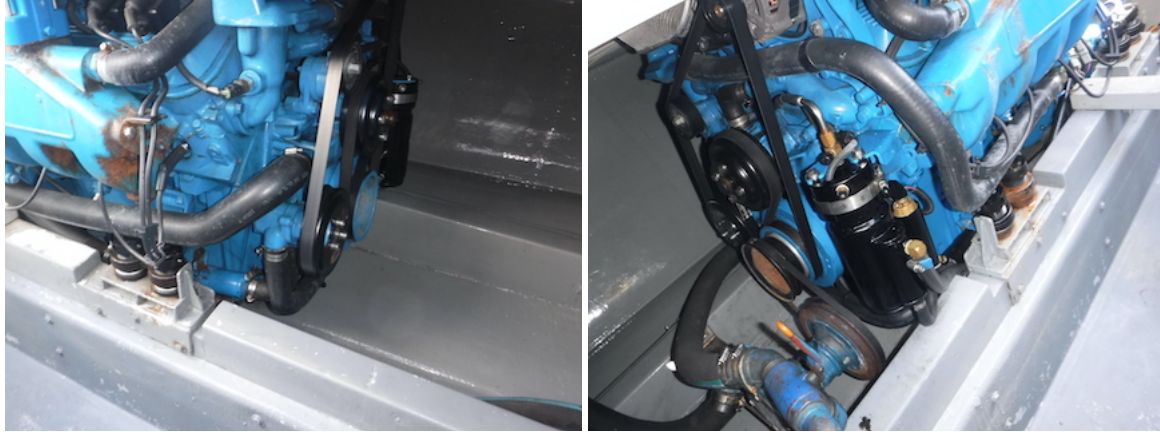
The engines are in good operational condition with signs of regular maintenance. The engine compartment is clean and orderly.
