SUBJECT: 2016 Newport Bay Harbor Structure Condition Inspection

Newport Bay
2016 Structure Condition Inspection
Field Notes**East Jetty**

Newport Bay
2016 Structure Condition Inspection
Field Photographs

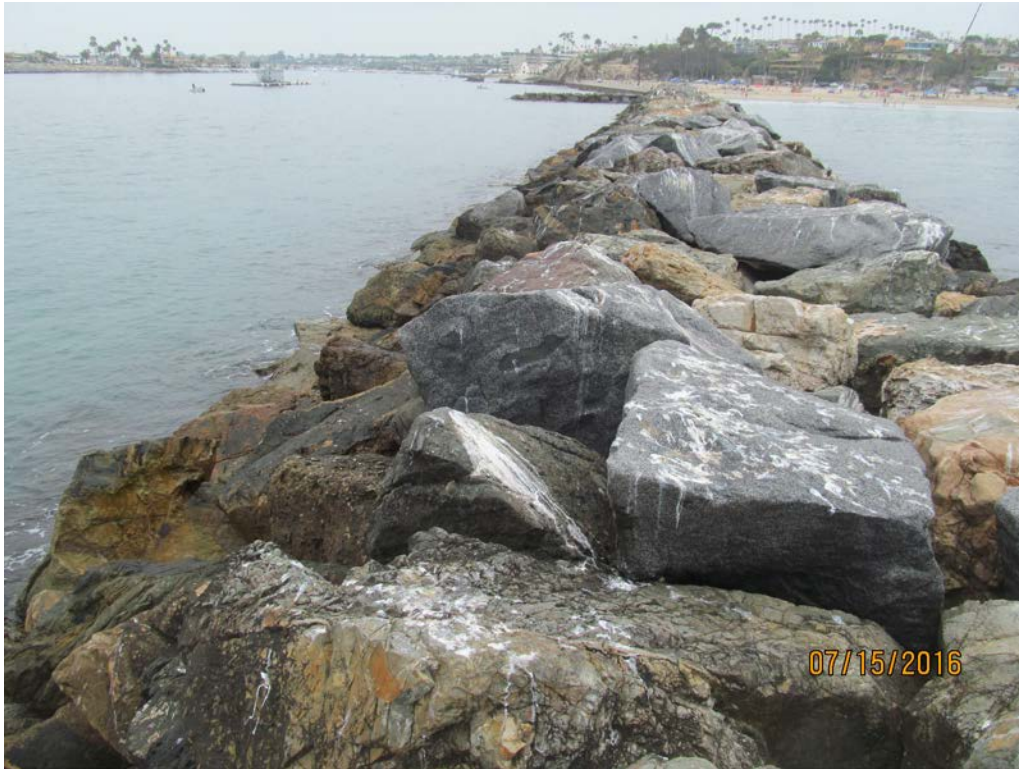
Fig 7. East Jetty: Sta. 30+00 viewing landward

Sta. 30+50 - Sta. 31+00: Few missing stones on the channel side along the waterline; the seaward slope and the crest are beginning to slump down.

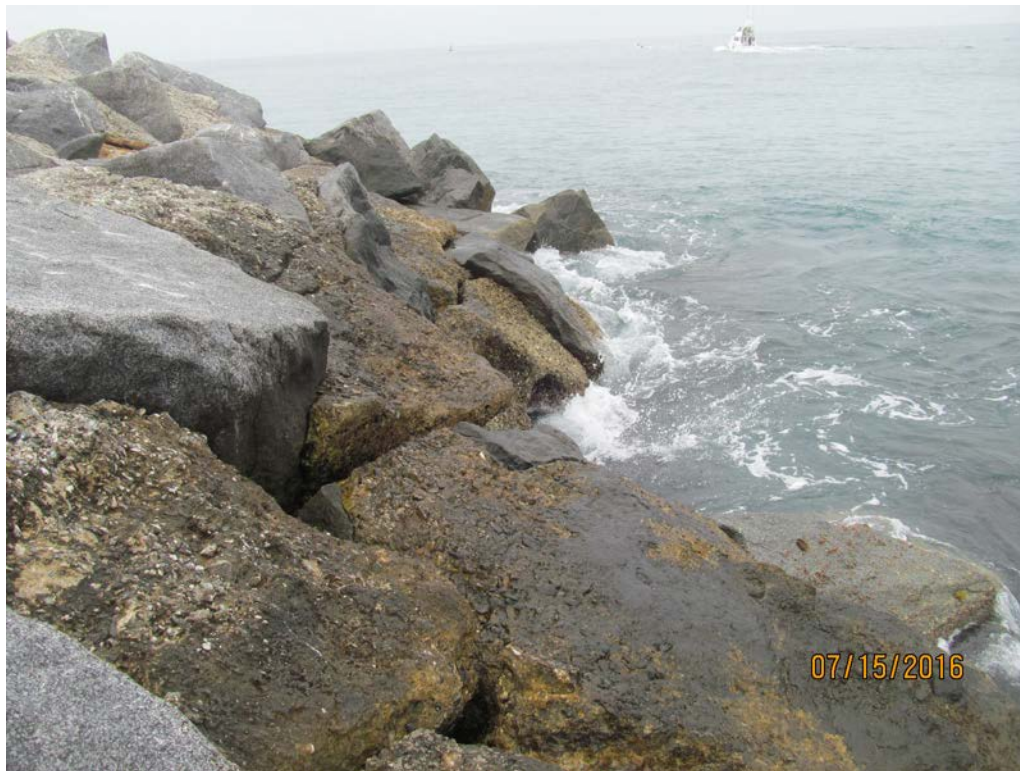
Head Section: On the seaward radial, one armor stone that has slipped down towards the waterline resulting in a minor loss of interlocking; on the harbor side radial, a group of stones have slipped down slope causing instabilities in the adjacent stones and resulting in separation from the overlaying grout; the grout is cracking and beginning to slump down slope but the upper adjacent stones are held in place by the grout.

Fig 12. East Jetty: Damage at the head

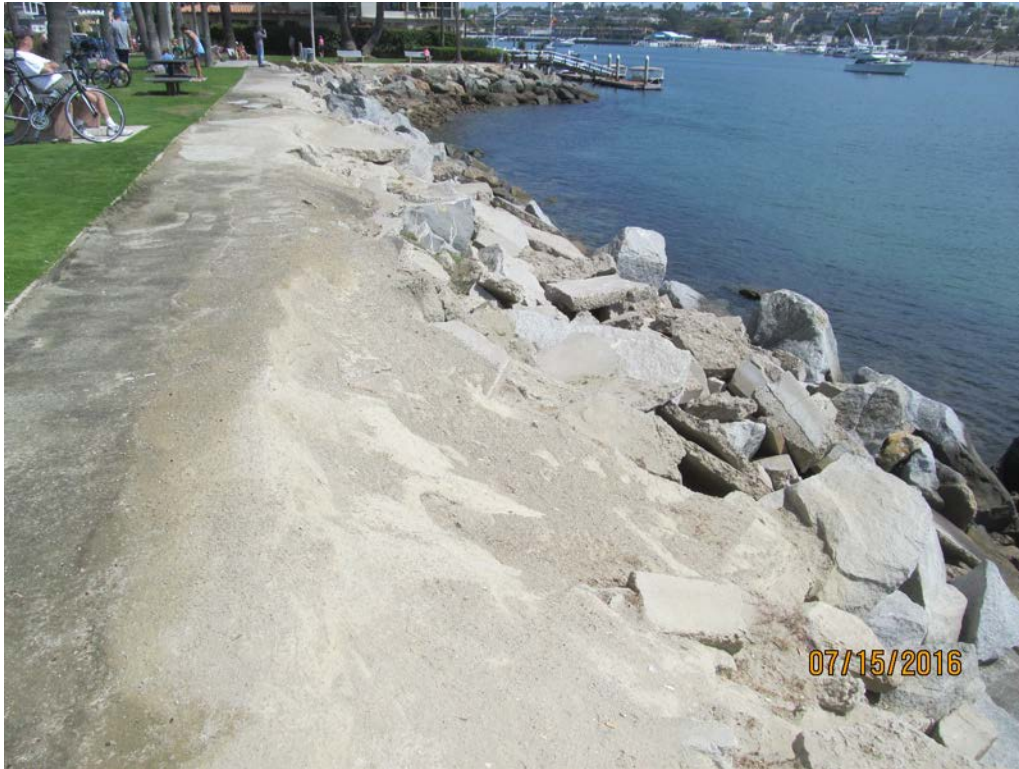
Fig 13. West Jetty: Sta. 10+00 viewing landward

Sta. 8+00 - Sta. 10+00: The rubble concrete is in poor condition but no change from previous inspections.

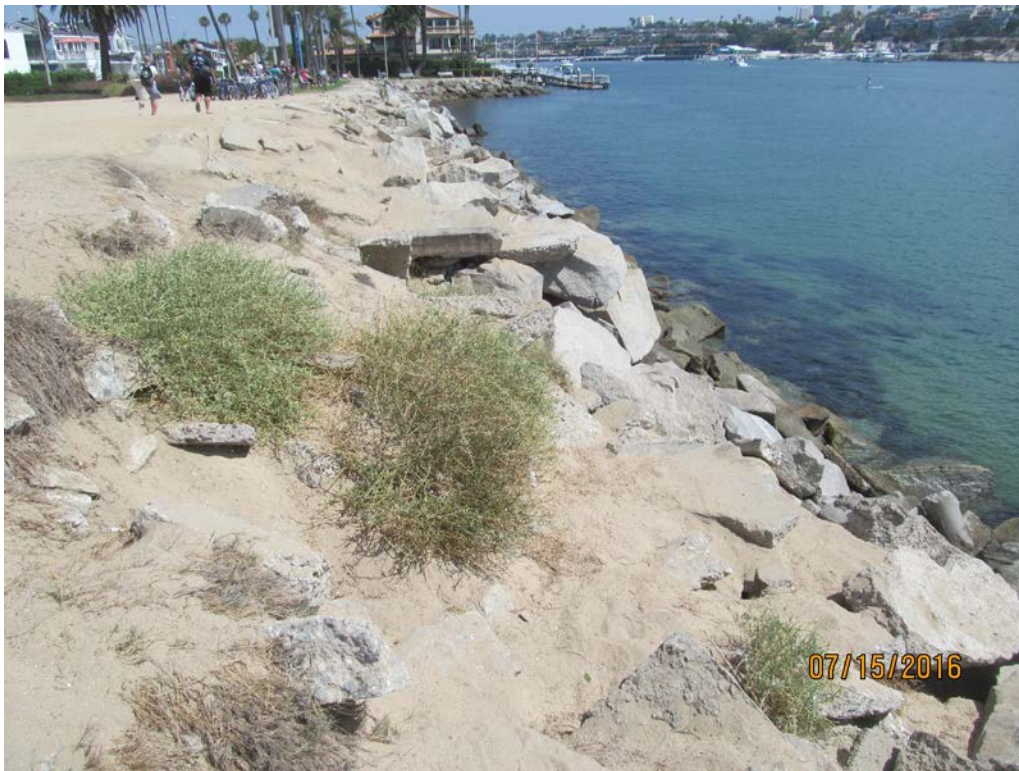
Fig 14. West Jetty: Sta. 12+00 viewing landward

Sta. 10+00 - Sta. 12+00: The existing stone is in poor to fair condition with a loss of interlocking but little to no change from previous inspections.

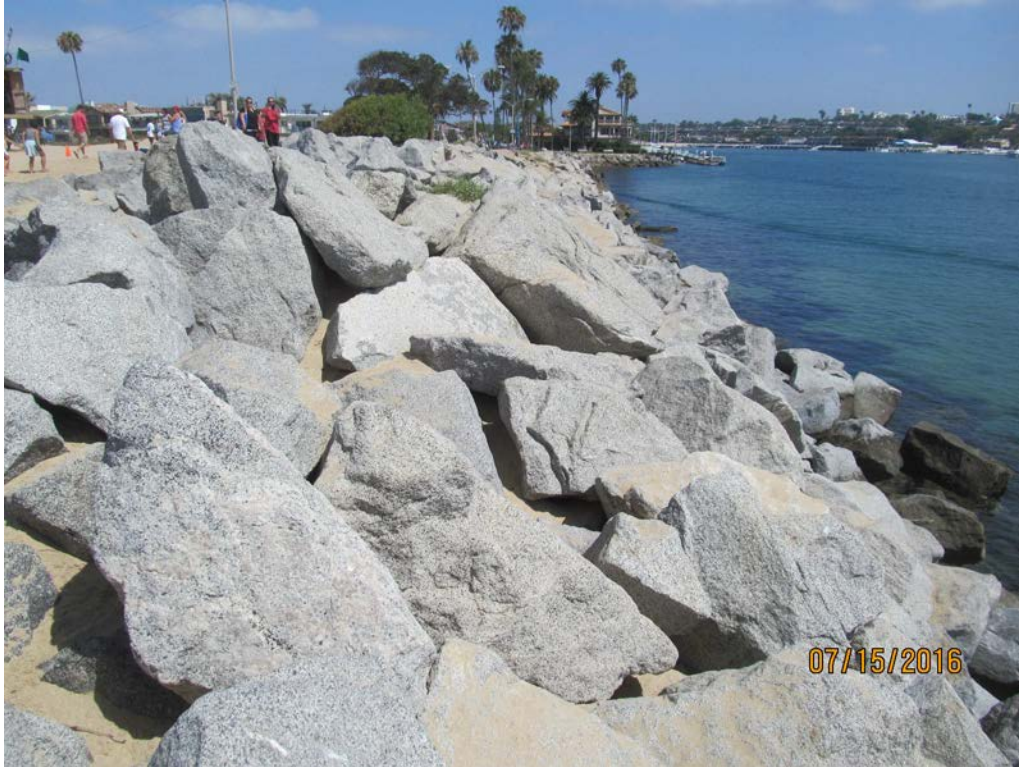
Fig 15. West Jetty: Sta. 14+00 viewing landward

Sta. 12+00 - Sta. 14+00: The crest of the jetty remains in poor condition; the harbor side slope is in poor condition but remains unchanged.

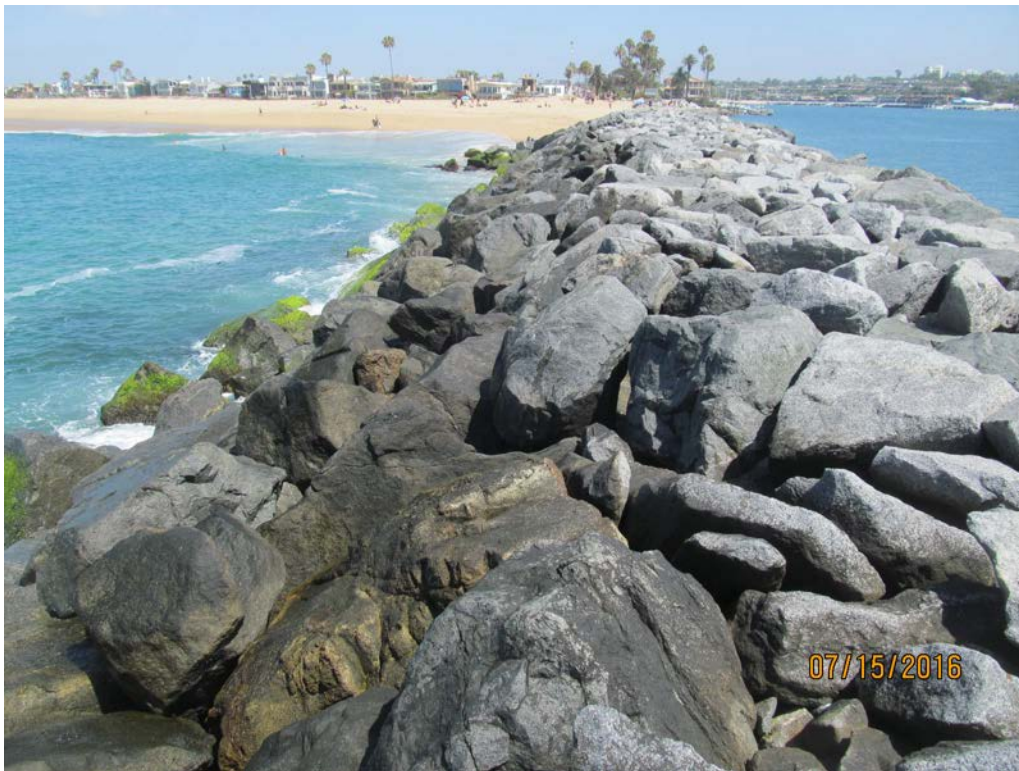
Fig 16. West Jetty: Sta. 18+00 viewing landward

Sta. 17+00 - Sta. 18+00: Minor loss of interlocking at the water line on the seaward side.

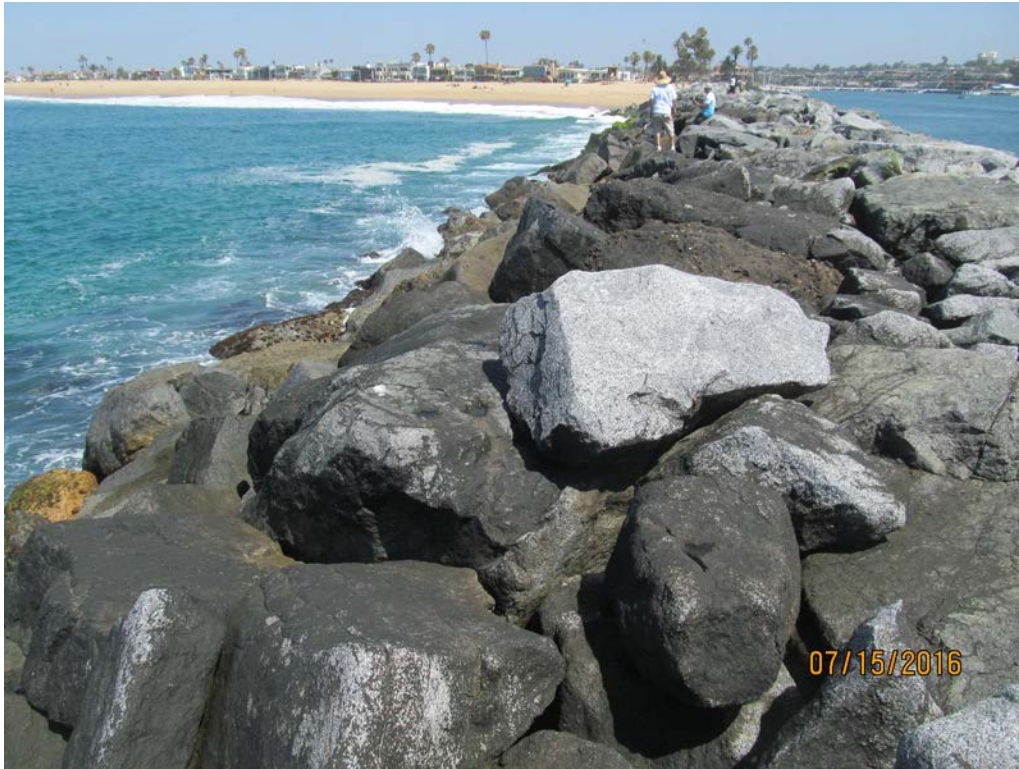
Fig 17. West Jetty: Sta. 20+00 viewing landward

Sta. 18+00 - Sta. 20+00: The seaward slope has minor loss of interlocking along the waterline and some stones are starting to roll out; there is also loss of interlocking on the upper slope causing upturned stones.

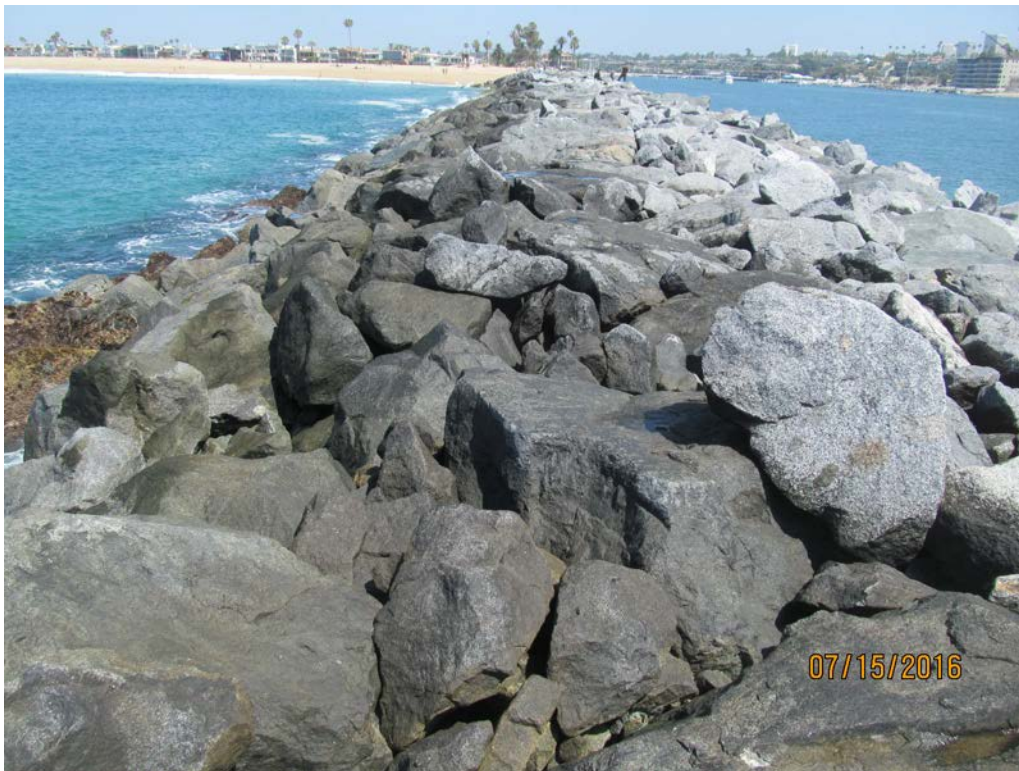
Fig 19. West Jetty: Sta. 22+00 viewing landward

Sta. 21+50 - Sta. 22+00: Armor stones at the water line have been ejected and the upper adjacent stones on the slope are becoming unstable.

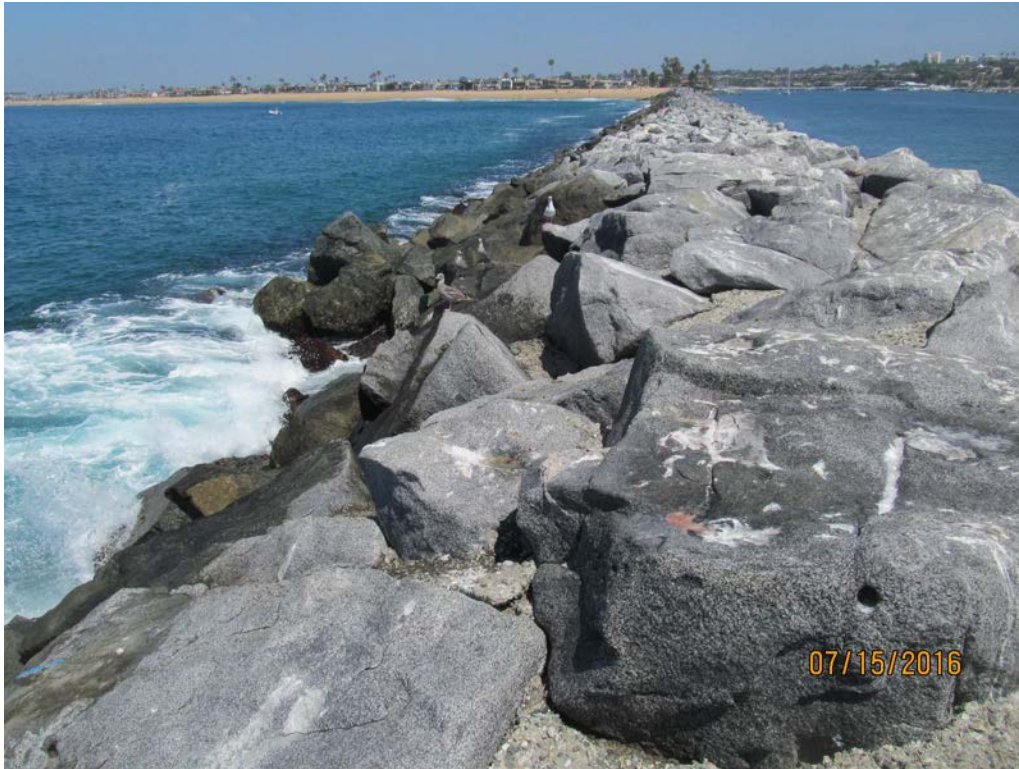
Fig 22. West Jetty: Sta. 28+00 viewing landward

Sta. 27+75: Slumping of stones at the water line to the lower parts of the slope which is opening a small void in the structure.

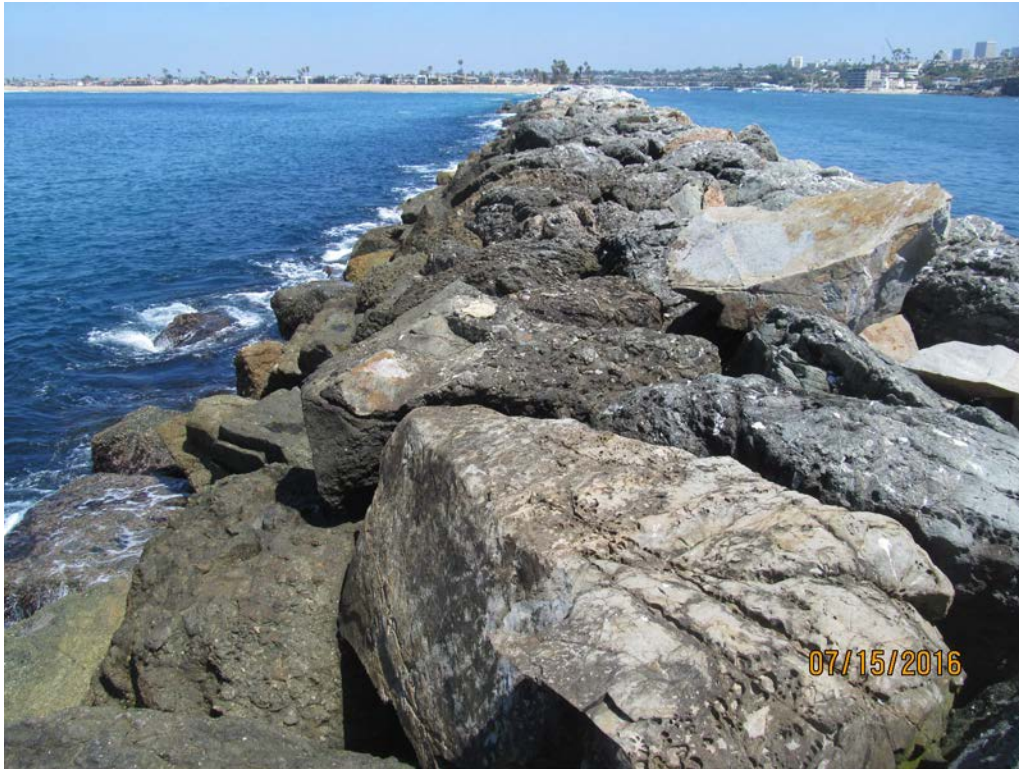
Fig 24. West Jetty: Sta. 32+00 viewing landward

Sta. 31+50: Missing stones at the water line on the seaward side is creating a small void but not yet causing upper slope instability.

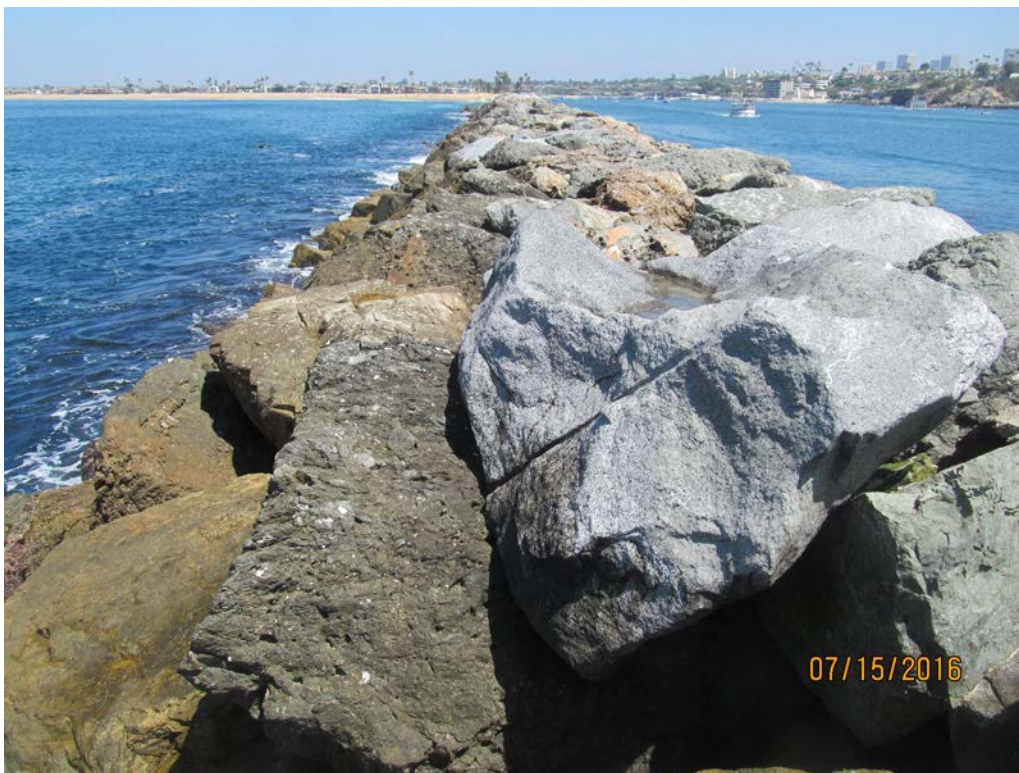
Fig 25. : West Jetty: Sta. 34+00 viewing landward

Sta. 34+00: An upturned armor stone on the central crest area is present.

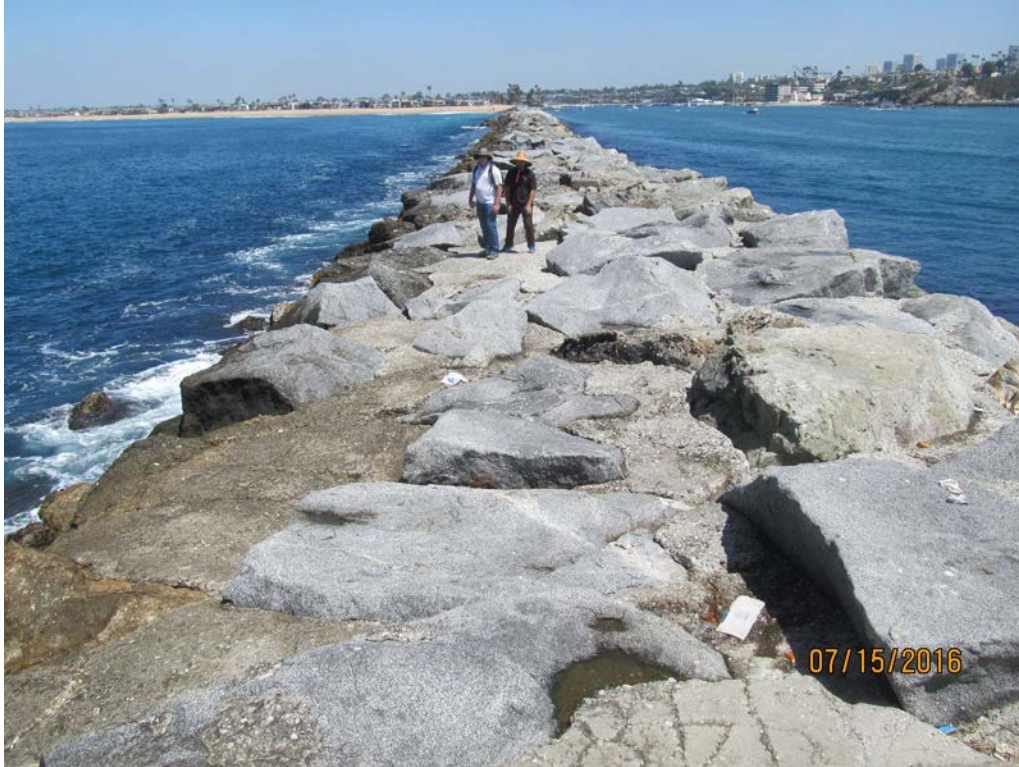
Fig 26. West Jetty: From Navigation Aid viewing landward

Head Section: The head section looks in poor condition; there is increasing damages around the entire perimeter; the seaward slope just forward of the navigation-aid has been over steepened for some time now and just further seaward long the slope there is a large void that is opening up; the stones that were being held by the grout have slipped down slope leaving a very steep void; the slope is very vertical as you progress to the centerline section; many stones along the water line have lost interlocking, the crest

centerline area is in very poor condition; many upturned armor stones which are starting to separate from the grout; a very large stone is upturned and sitting at the center of the slope on the harbor side radial also separated from the grout.
