# Parks, Beaches, and Recreation Commission

September 3, 2019

## Marine Avenue Special Tree Removal Request

Public Works Department  
Municipal Operation Division

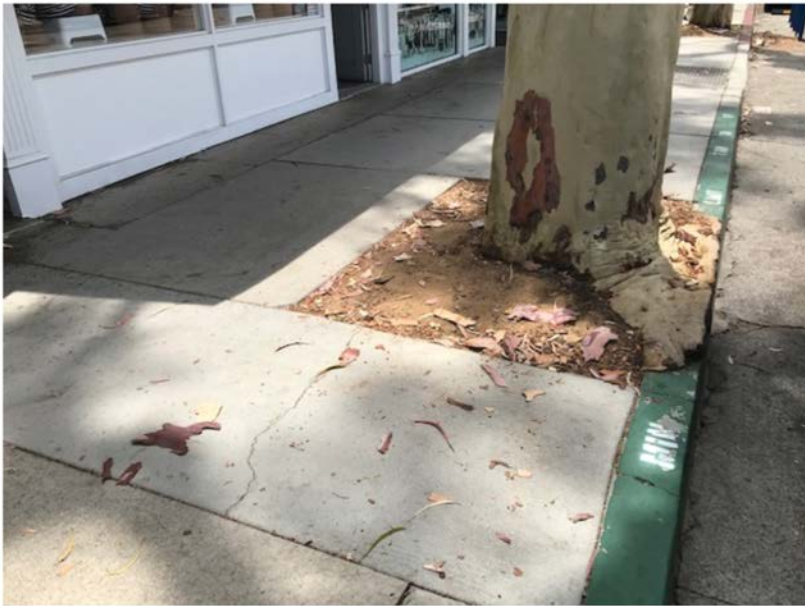
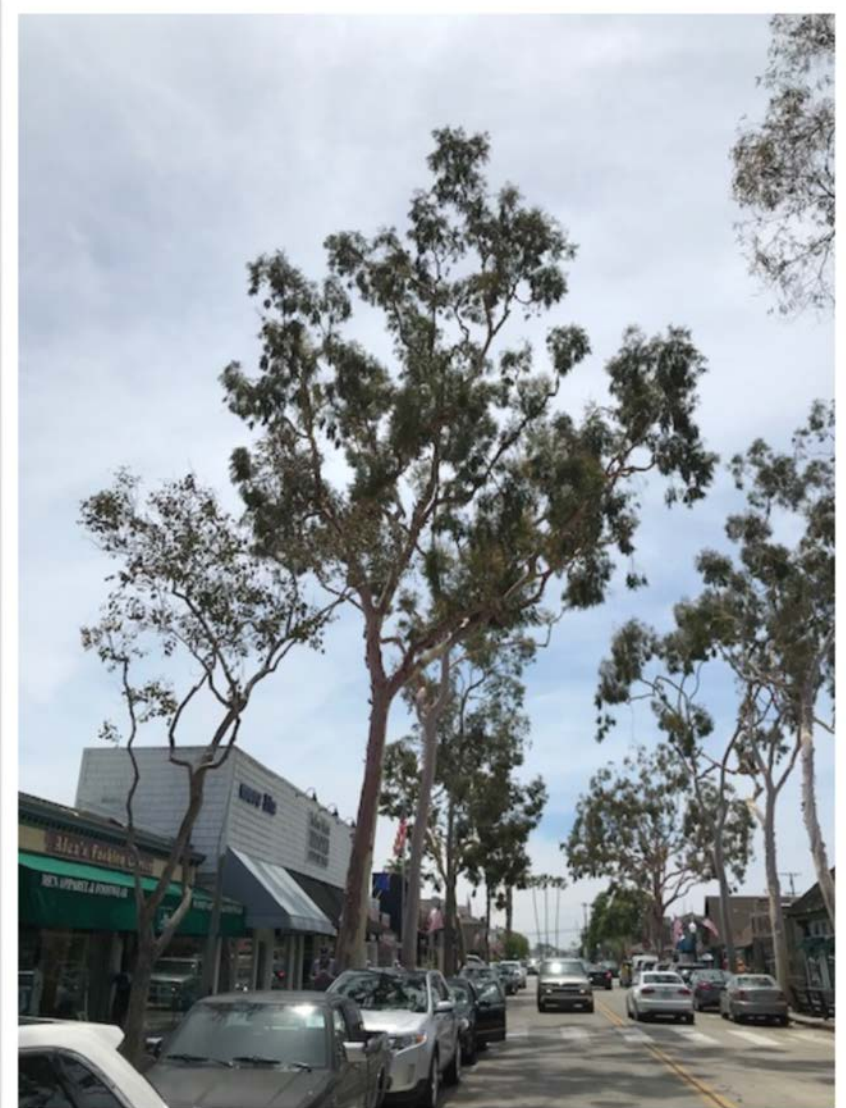
# 210 Marine Ave.

- Asymmetrical
- Co-Dominant Limbs
- Dieback
- Contact Growth
- Suspected Heartwood Decay

- Schedule Removal of the three Highest Risk trees, soon after Labor Day
  - 210 Marine Ave
  - 217 Marine Ave
  - 224 Marine Ave
- Remove Dead Tree at 315 Marine Ave (soon after Labor Day)
- Make any Necessary Hardscape Repairs Around existing Tree Wells where trees were removed such as uplifted and/or broken sidewalk or curb
- Replant all 9 Tree Wells with 24"-36" Box Eucalyptus  
*(5 currently vacant and 4 from removals)*
- Arrange for on-going Watering on new Trees by Water Truck or Merchant Volunteer

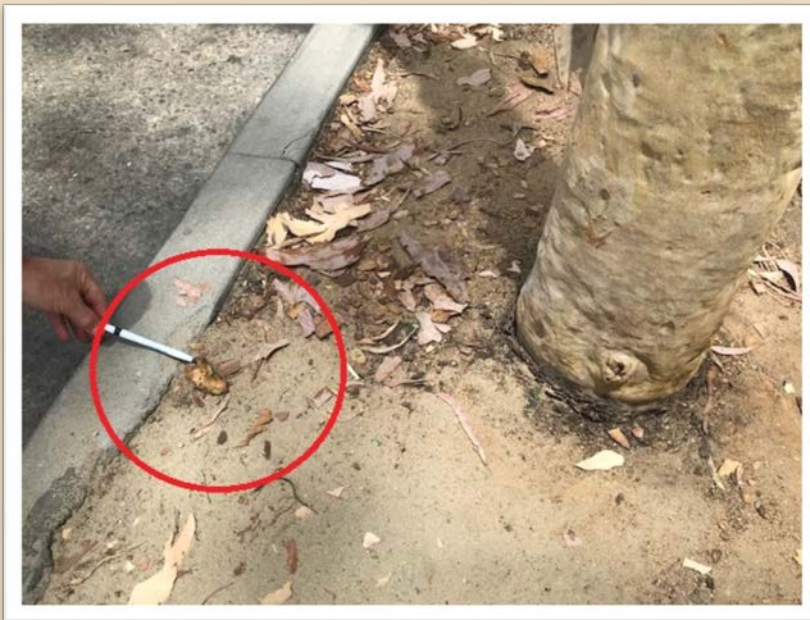
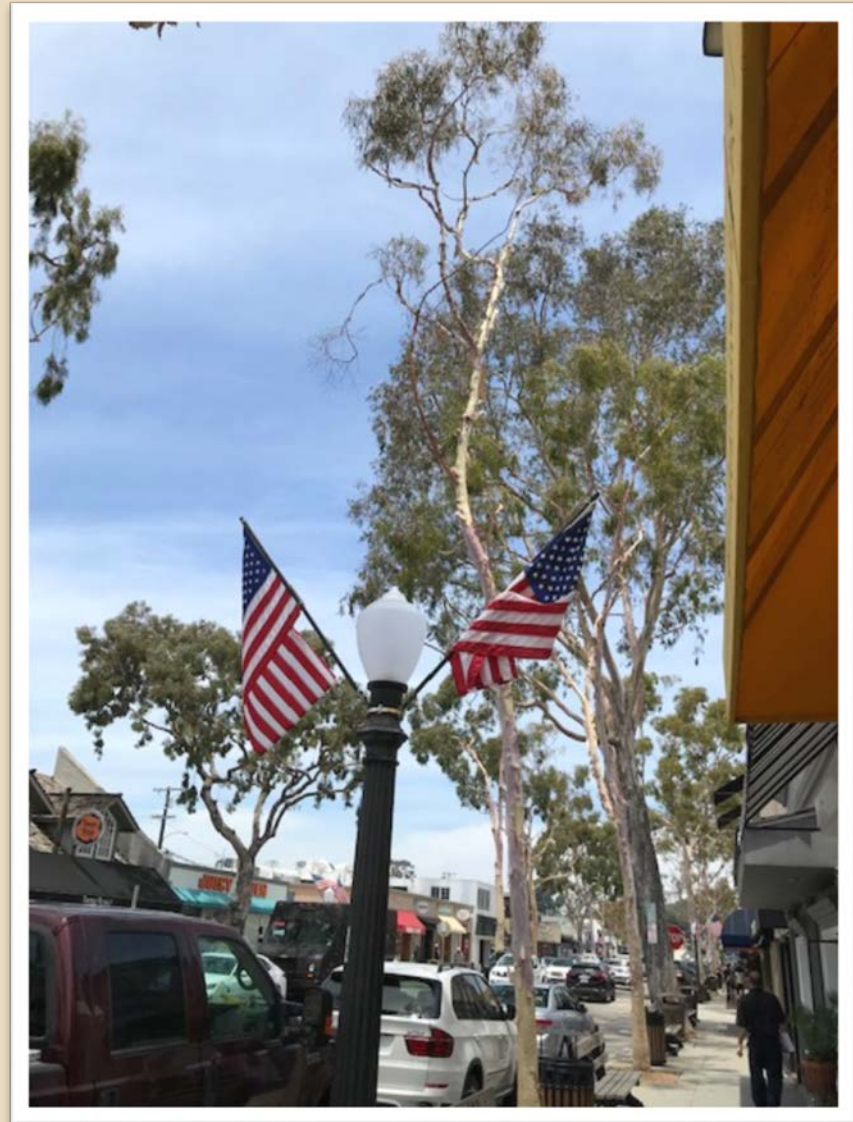
# 220 Marine Ave.

- Asymmetrical
- Moderate decline
- Deadwood
- Heartwood decay
- Visible root decay

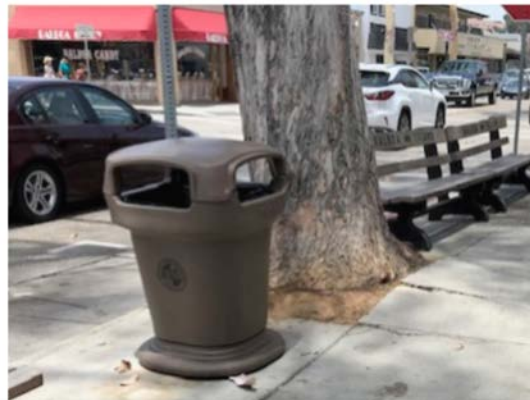
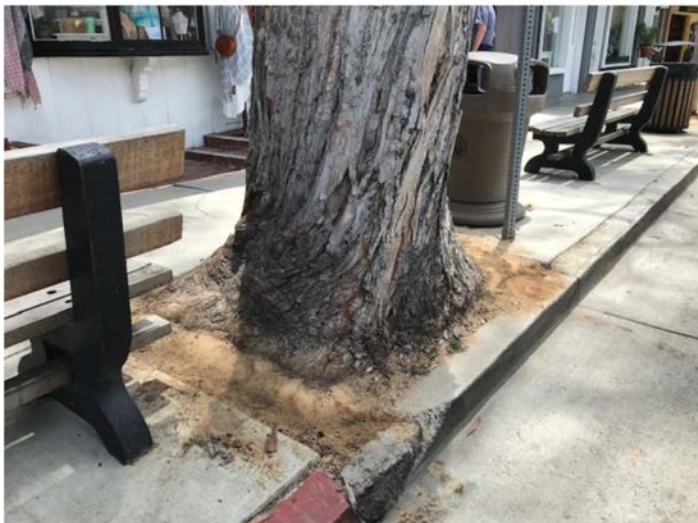
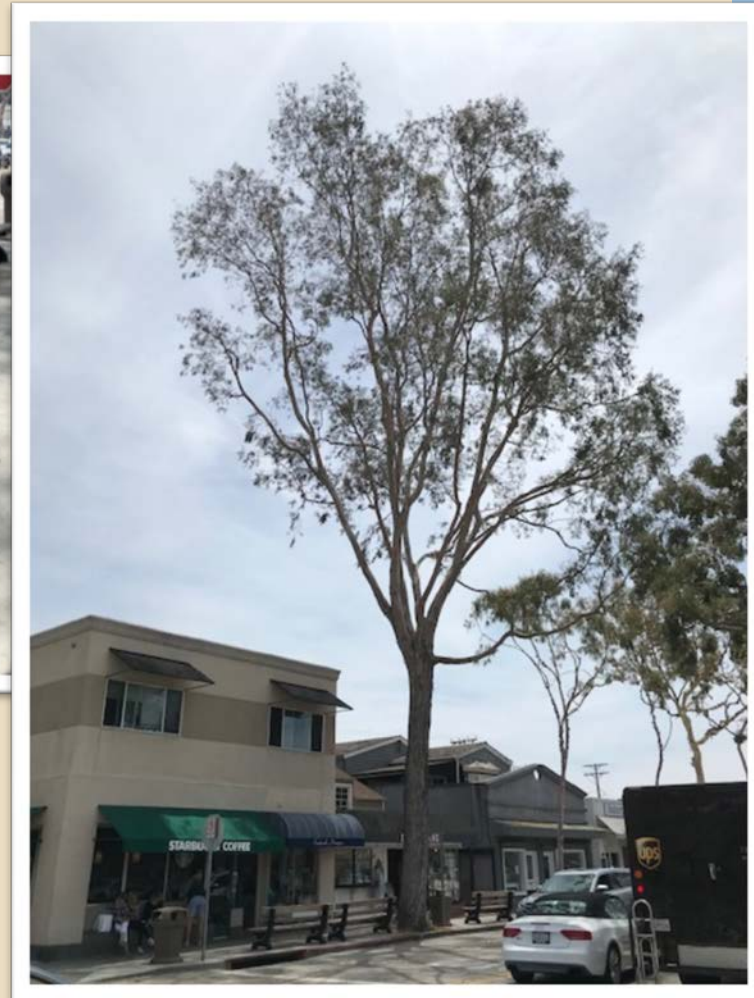
# 224 Marine Ave.

- Heaving Sidewalk/Root Plate
- Significant Leaning Trunk
- Suspected Heartwood Decay
- Co-Dominant Limbs
- Asymmetrical
- Deadwood

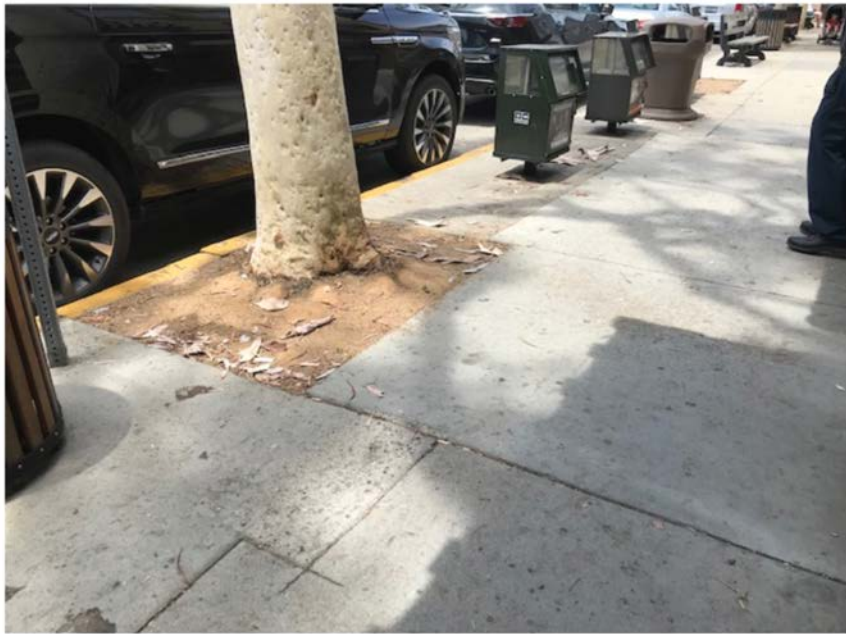
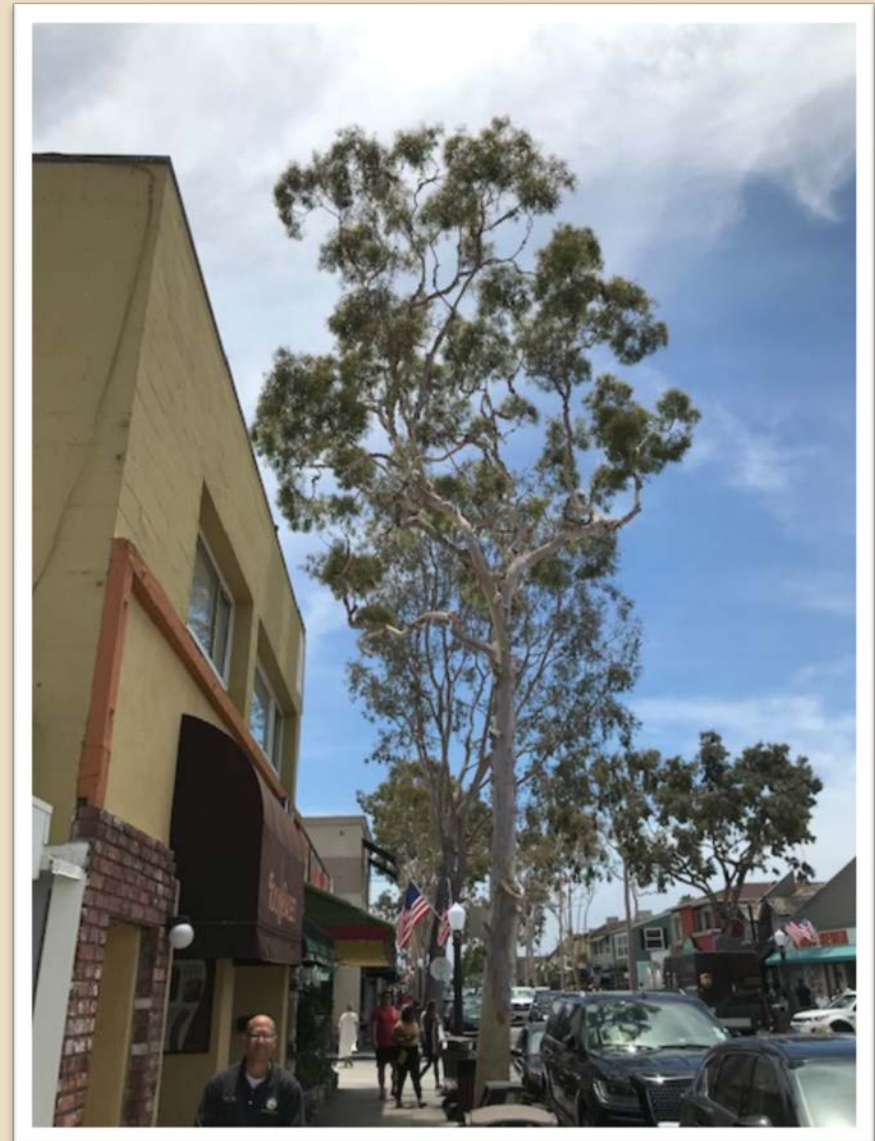
# 300 Marine Ave.

- 20% Live Crown Ratio
- Deadwood
- History of Limb Failures
- Cavity in Trunk
- Roots Pruned
- Heaving Sidewalk

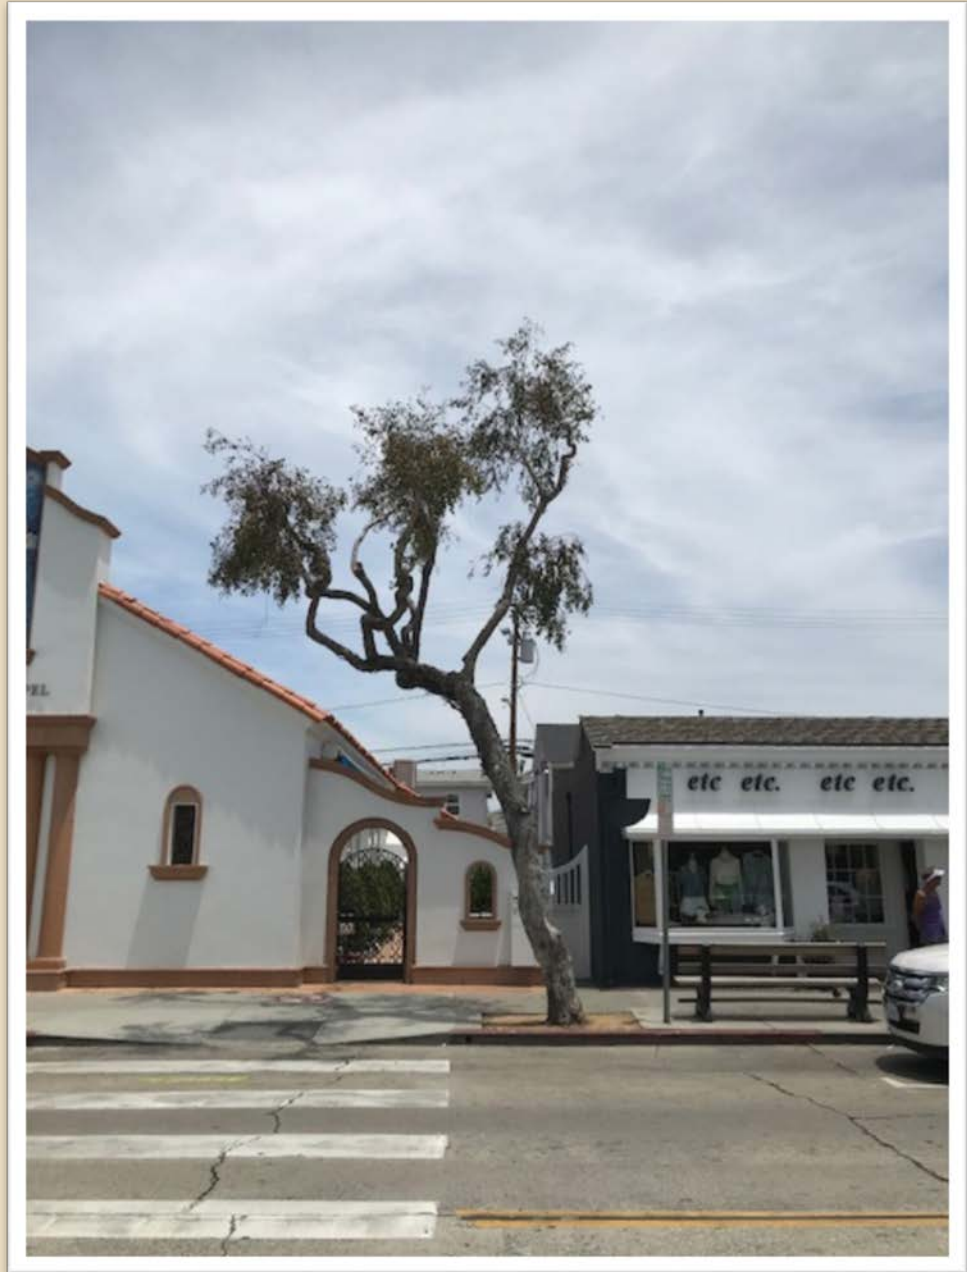
# 312 Marine Ave.

- Asymmetrical
- Poor Overall Health
- Significant Leaning Trunk
- Suspected Heartwood Decay
- Root Pruning for Sidewalk Work.

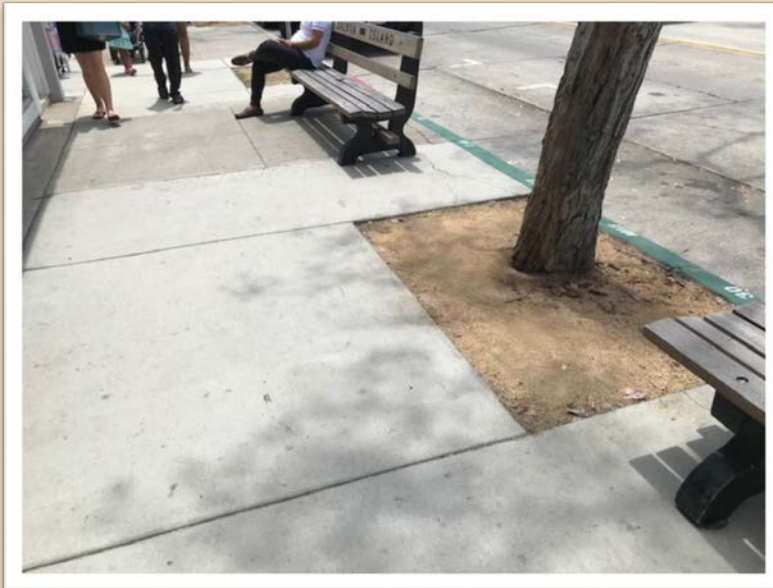
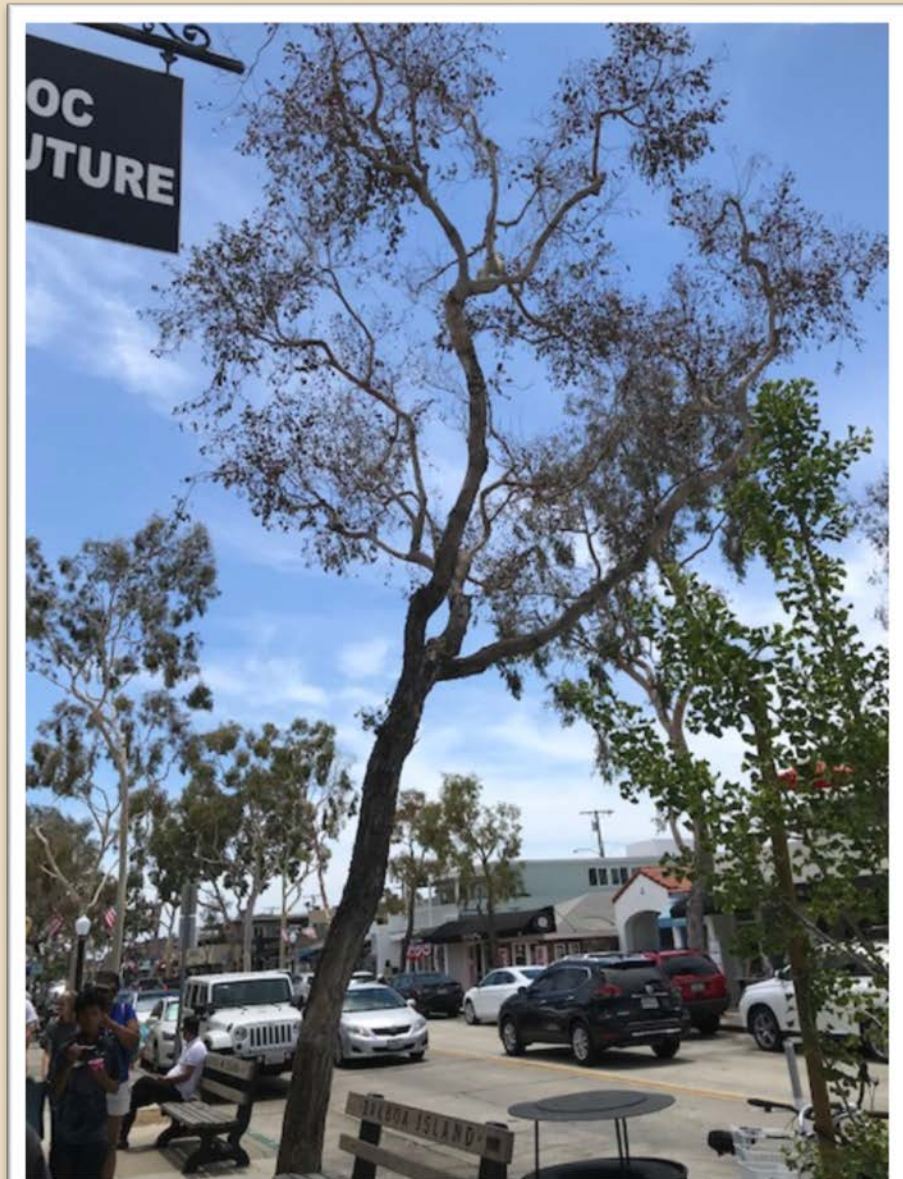
# 326B Marine Ave.

- Asymmetrical
- 15% Live Crown Ratio
- Poor Overall Health
- Significant Leaning Trunk

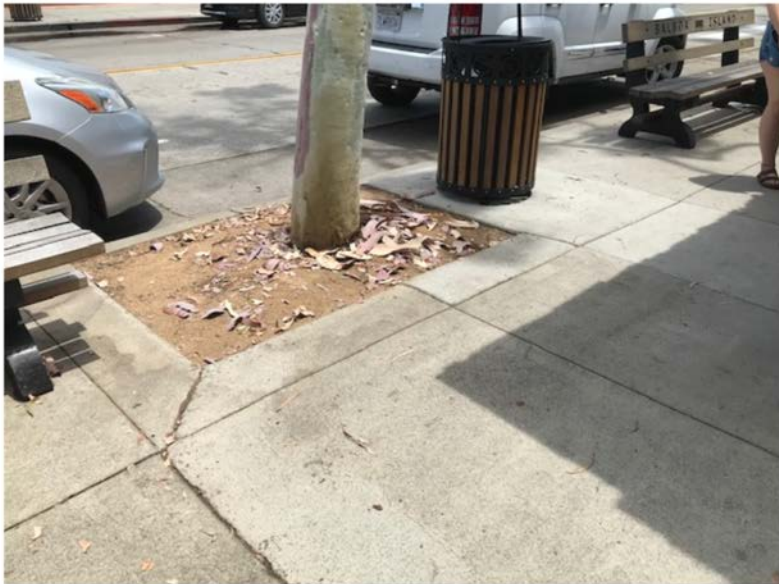
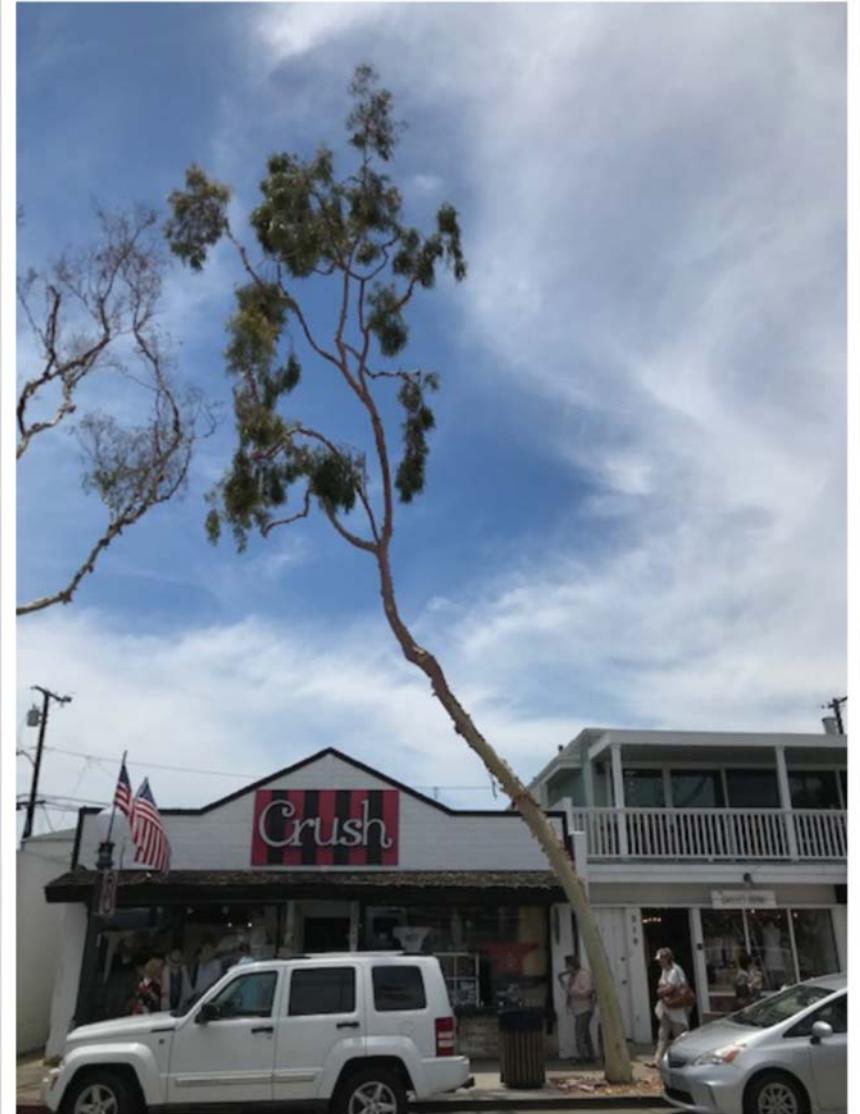
# 319 Marine Ave.

- Asymmetrical
- 15% Live Crown Ratio
- Significant Leaning Trunk
- Root Pruned / Decayed
- Heaving Sidewalk

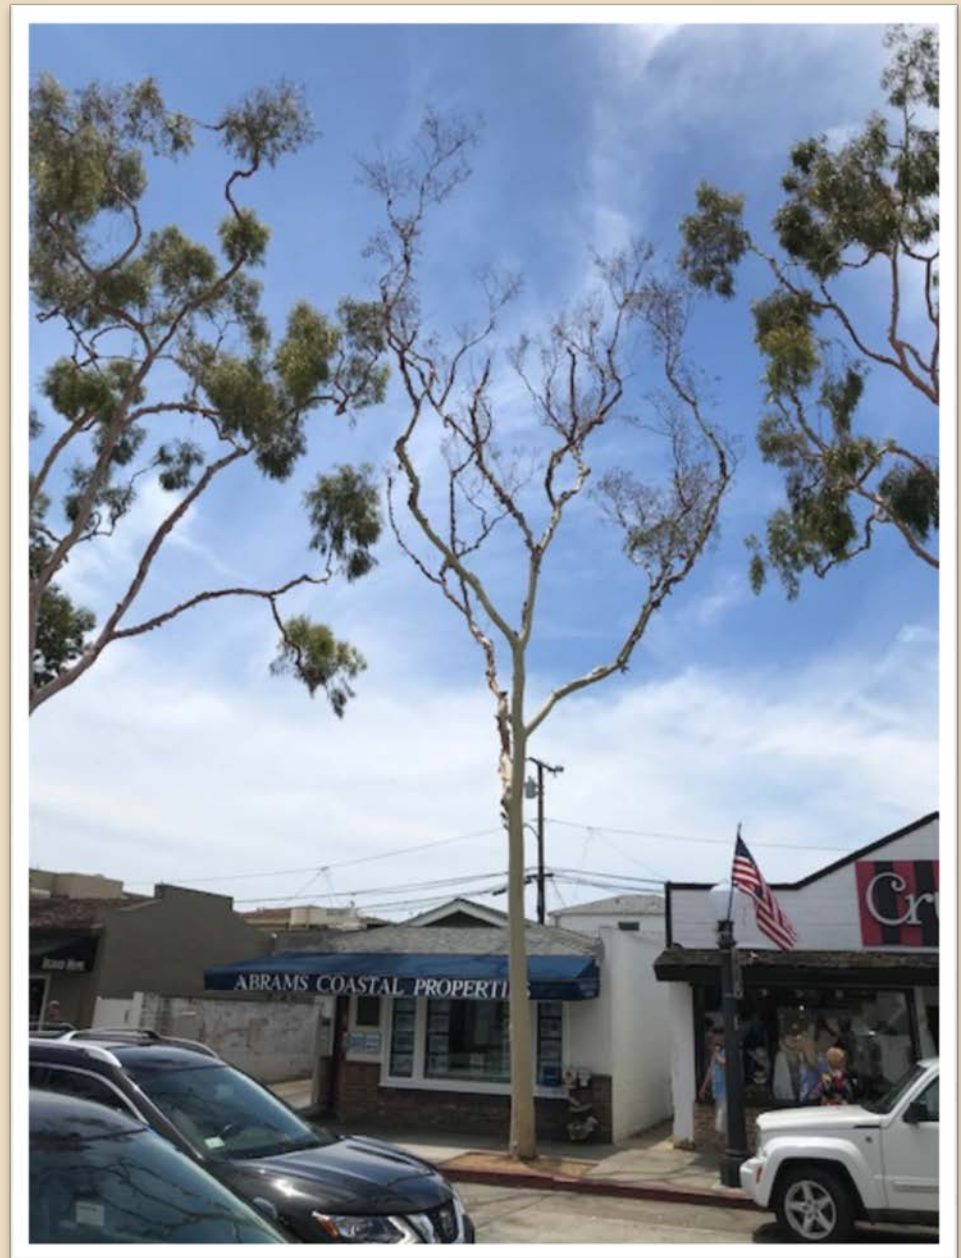
# 315 Marine Ave.

- Dead Tree
- High-Risk, Necessitates Imminent Removal
- Staff has scheduled removal for this Fall
- PB&R notified at August meeting

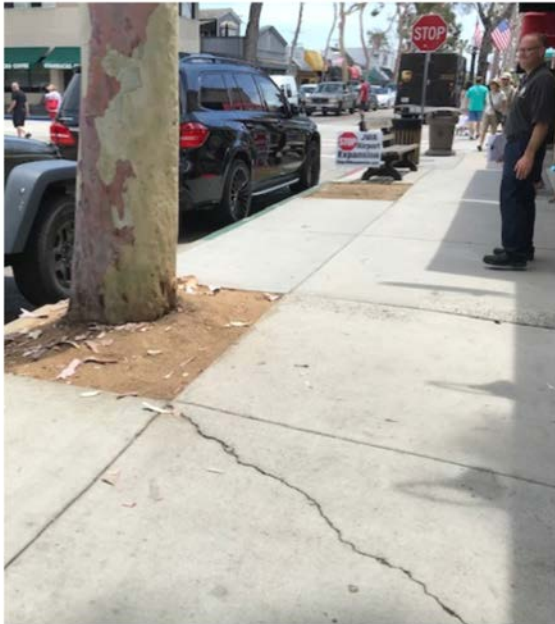
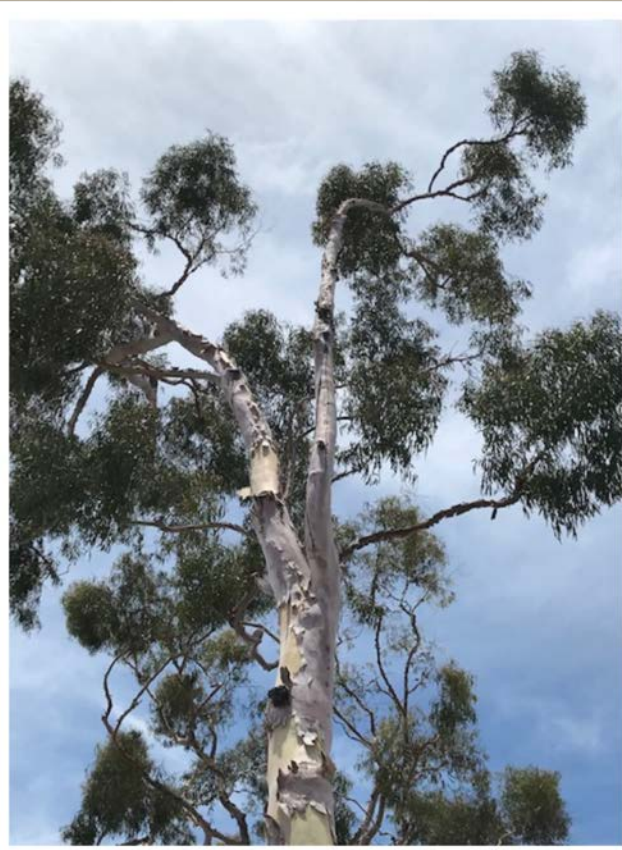
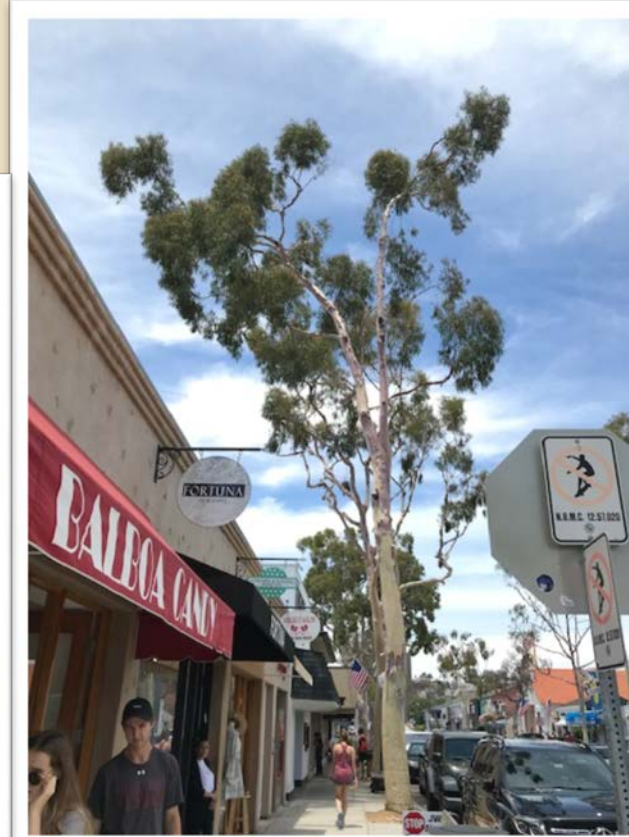
# 301 Marine Ave.

- Asymmetrical
- 15% Live Crown Ratio
- History of Limb Failures,
- Suspected Heartwood Decay
- Roots Pruned/Decayed
- Heaving Sidewalk
- Deadwood

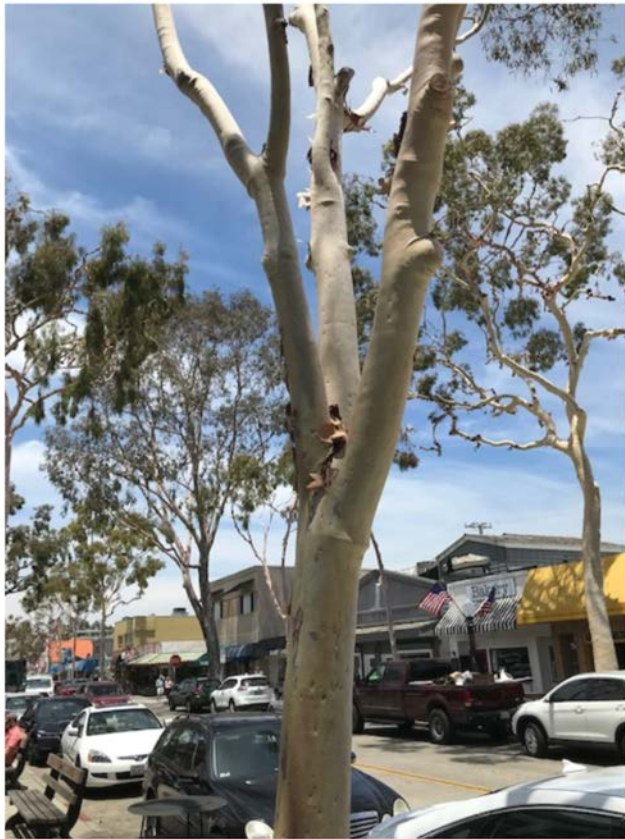
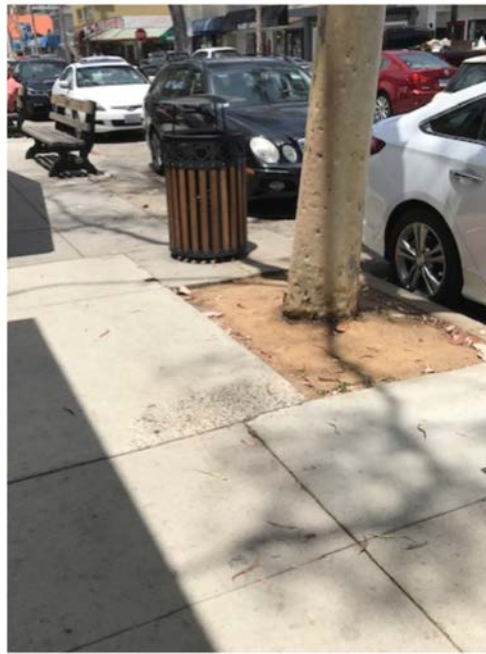
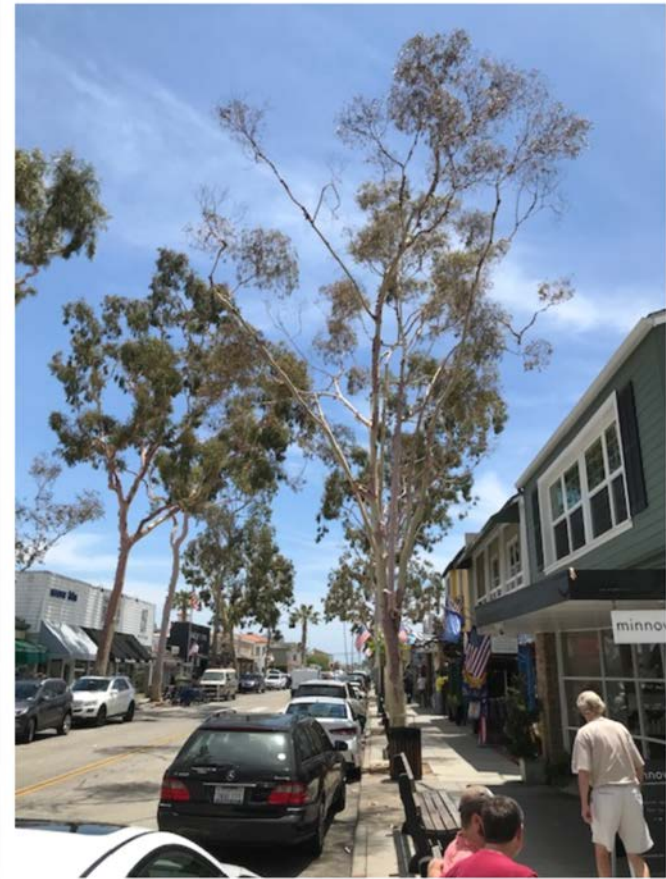
# 217 Marine Ave.

- 15% Live Crown Ratio,
- Weakly Attached, Co-Dominant Limbs (past topping)
- Cut and Decayed Roots
- Poor Overall Health

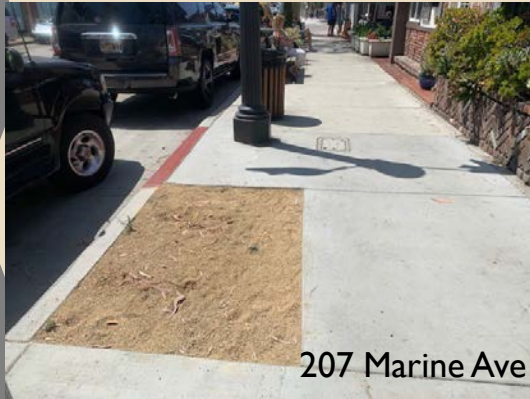
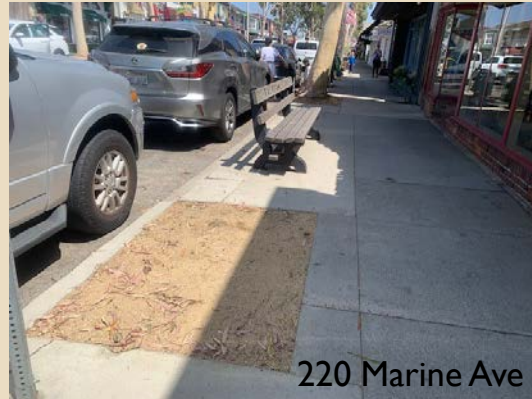
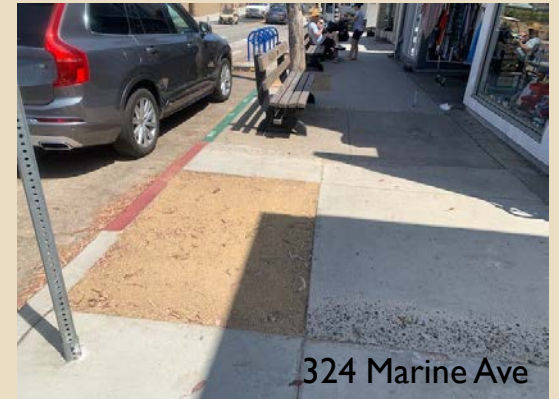
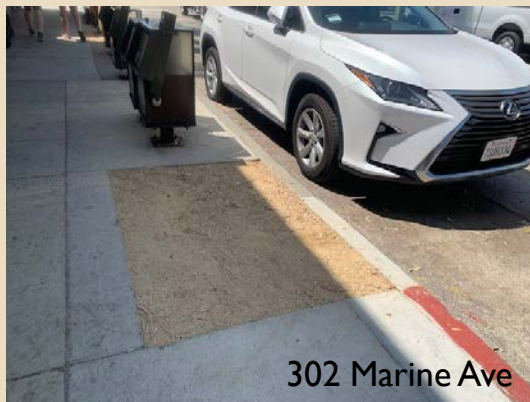
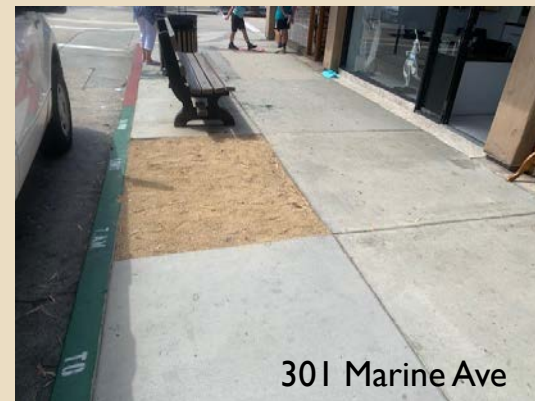
# Current Vacant Tree Sites

- Total of 5 Vacant Tree Well locations currently
