CITY OF NEWPORT BEACH

Tree Removal or Reforestation Application

The applicant, Geoffrey Darby (residing at 901 Chestnut Place), contacted the City to request the removal of a Manna Gum Eucalyptus (*Eucalyptus viminalis*) located on the Alta Vista side of his home due to previous root damage, unbalanced canopy, limited scaffolding root structure on the street side and perceived elevated risk of a whole tree failure.

Figure 1
Tree Location Exhibit
901 Chestnut Place

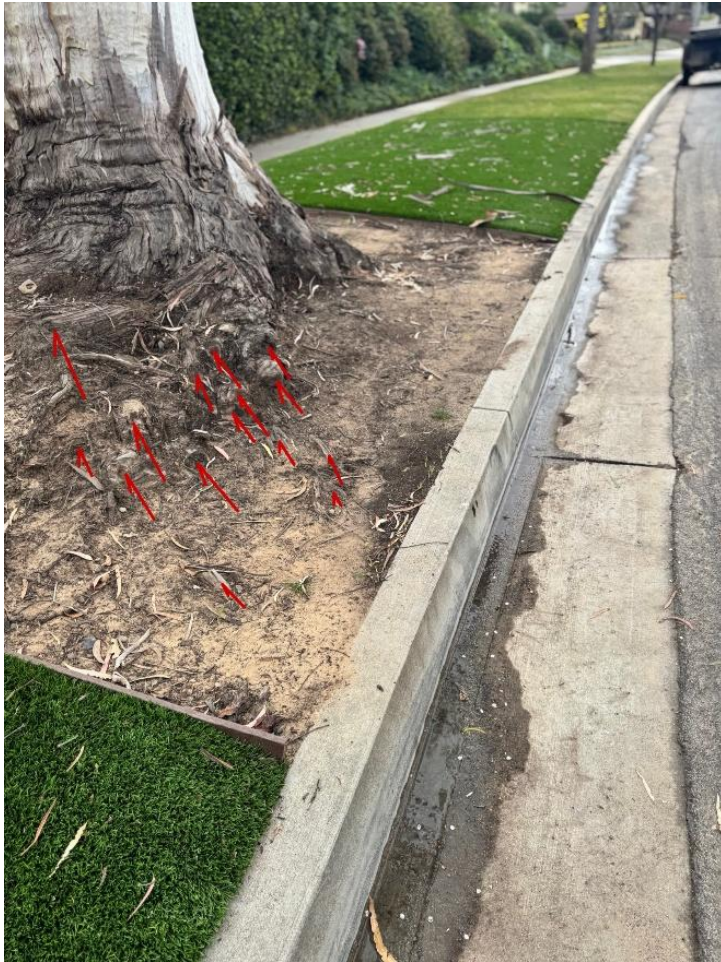
I met with Mr Hernandez when he came out to inspect the tree and I was not aware that on the side facing the road there are very visible signs that there has been significant cutting and clearing out of the main roots and there are holes right at the foot of the tree. If you look carefully at the road and concrete curb it looks as though some years ago, work was done to repair damage caused by the tree's roots. On the opposite side of the tree next to the walkway, there are also signs of significant cutting out of the roots. We have learned from our neighbors that the builder and previous owner of our property Dan Heinsfeld, who is a master architect, most likely would have installed a root barrier under the property wall which is hidden by the tall green hedge. We understand that Mr. Heinfeld was very concerned and had approached the City about the trees safety and had asked to have the tree removed.

PHOTO #1 – ARROWS INDICATE CUT ROOTS

The subject tree is relatively healthy and growing, however because of the absence of structural roots on the street side of the subject tree, the potential for catastrophic failure with potential harm to human life, living in the adjacent residence, and because this tree has little to no intrinsic value for the community where it exists, it is my opinion that this tree should be removed.

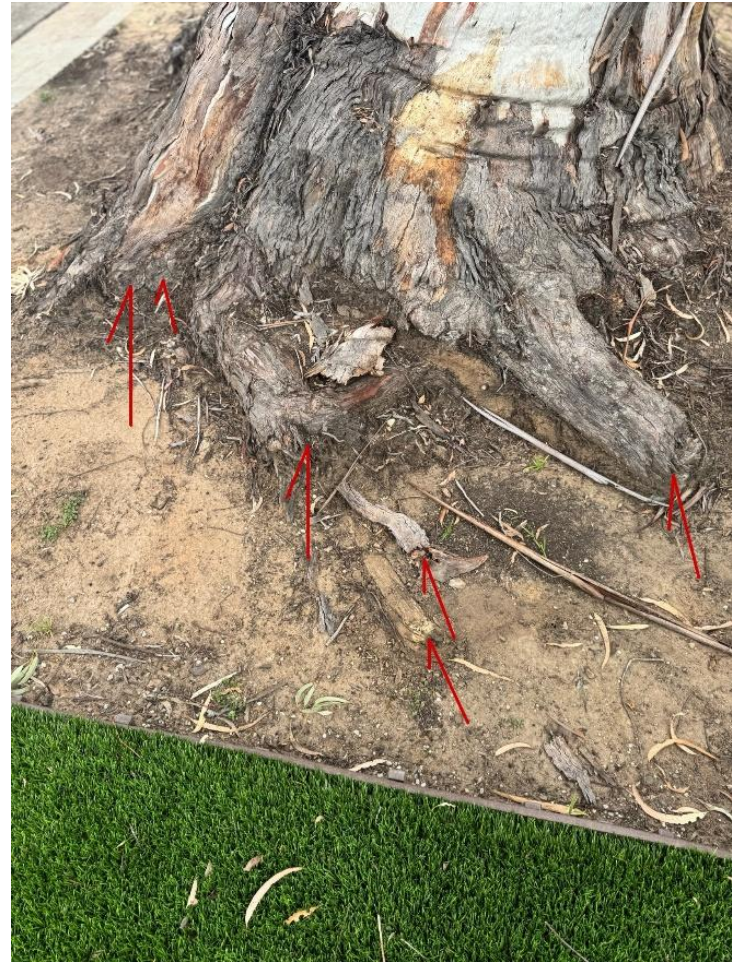
PHOTO #2 AAROWS INDICATE CUT ROOTS

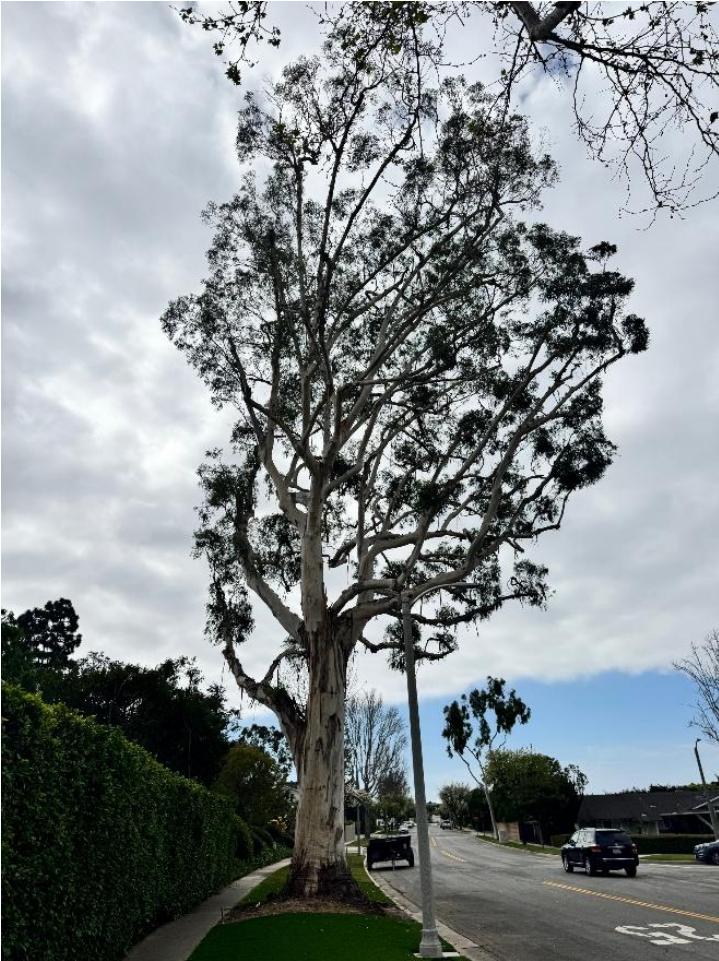
PHOTO #3 – UNBALANCED TREE CANOPY

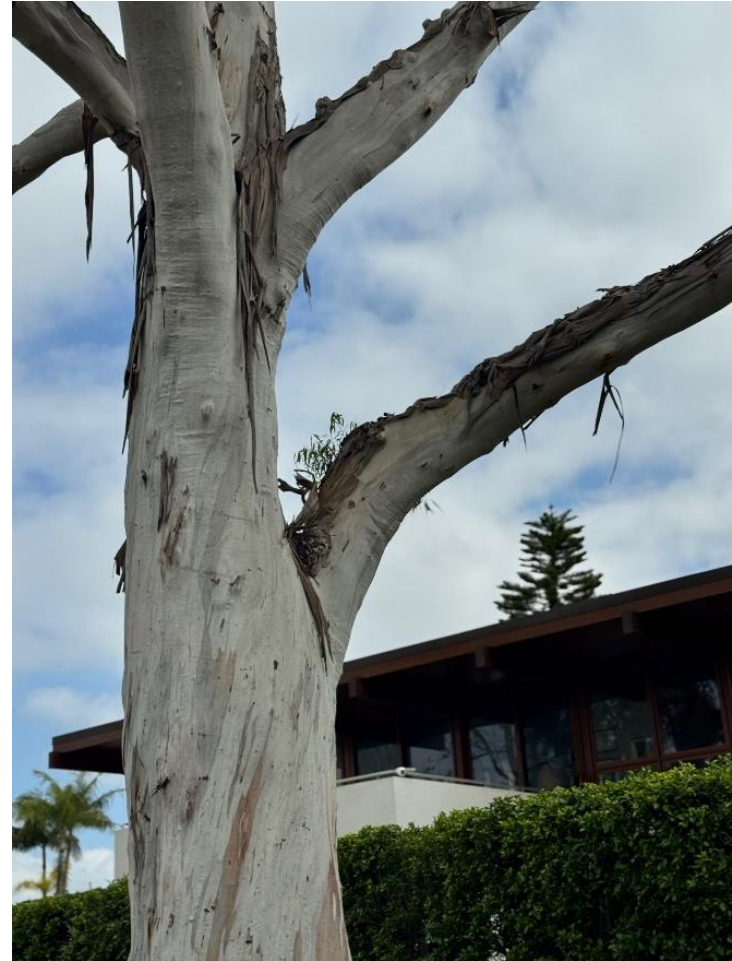
PHOTO #4 – INCLUDED BARK ON LOWER CROTCH

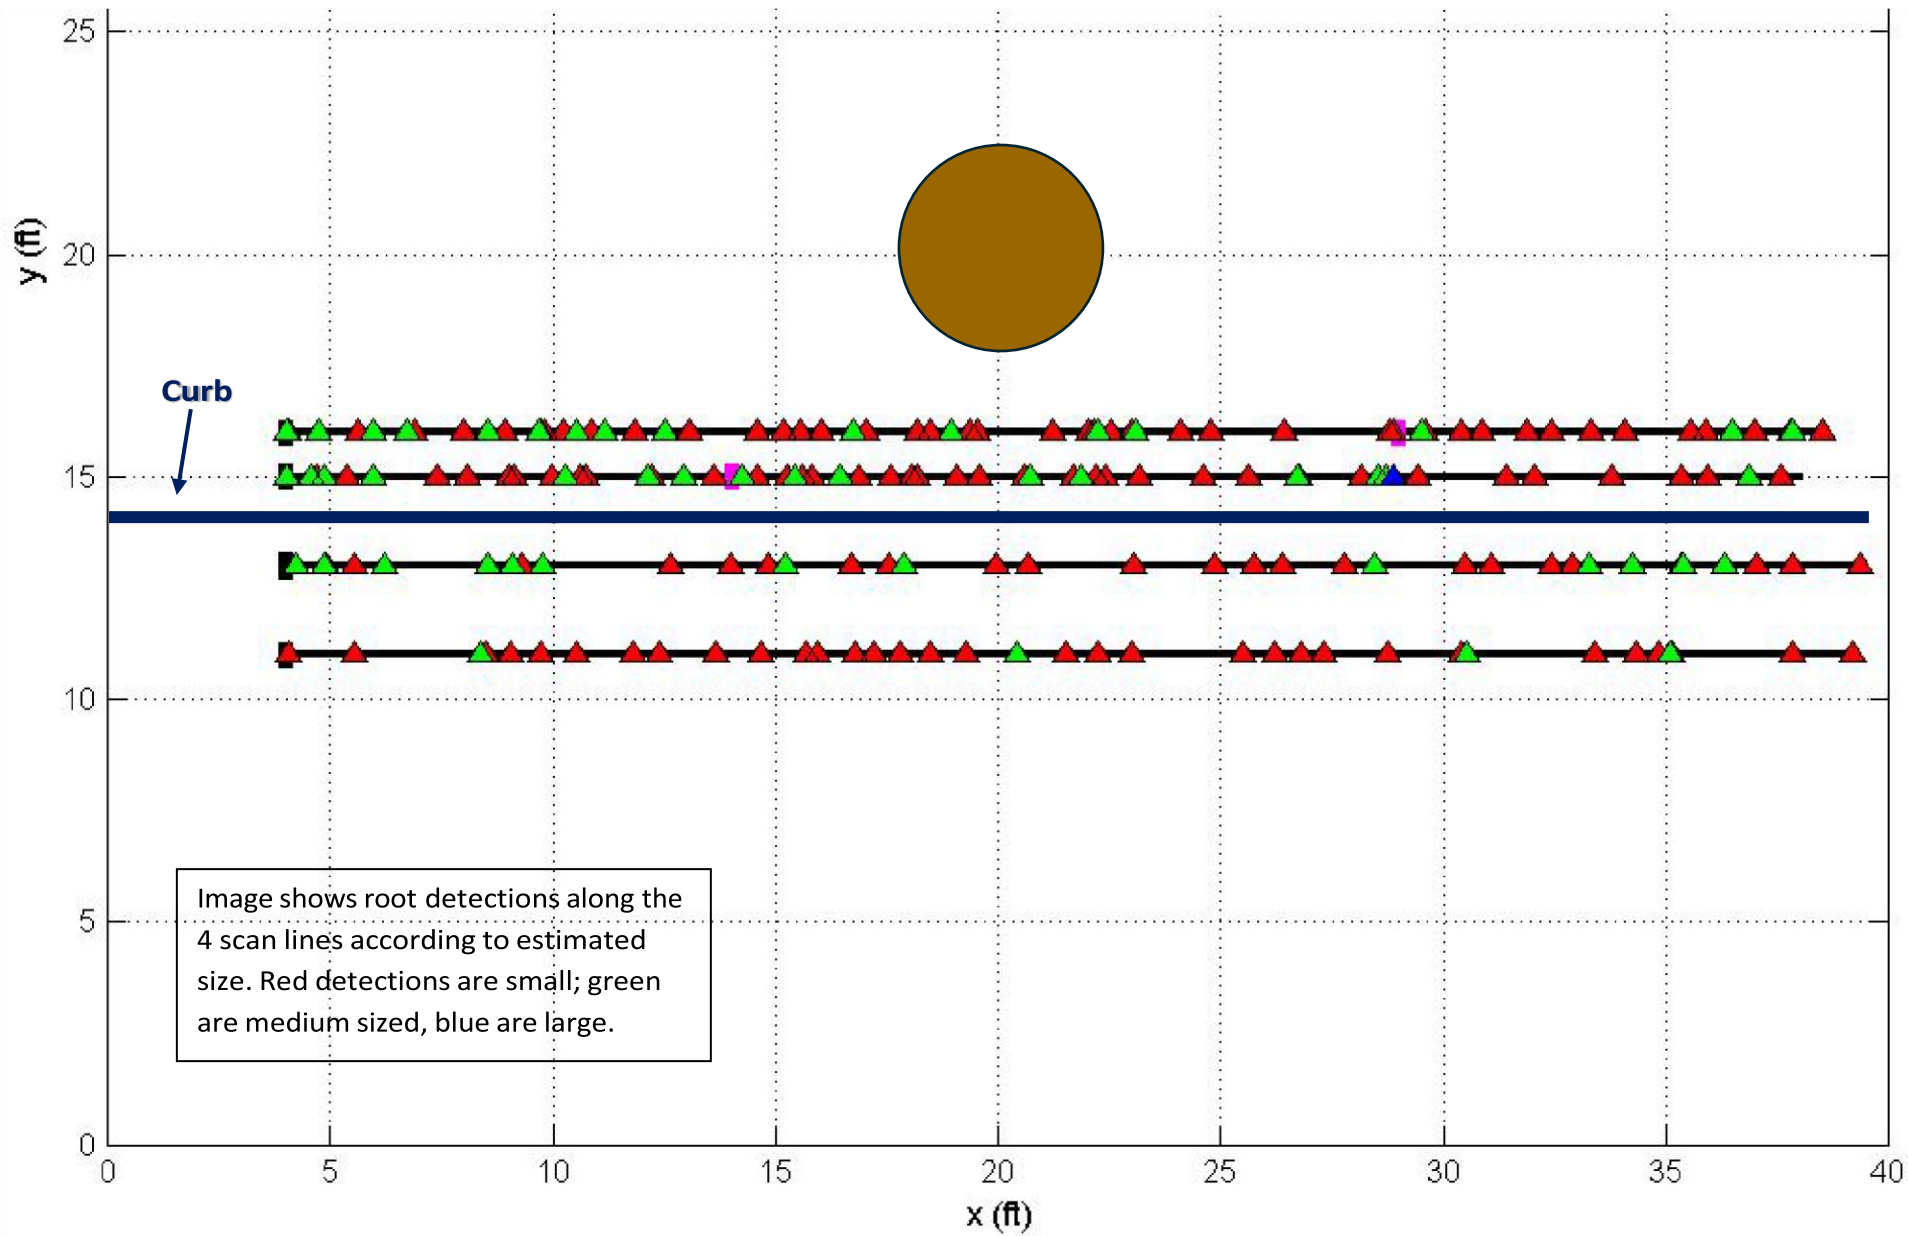
A Level 3 field inspection conducted by the applicant's consulting arborist reported that several surface roots had previously been cut, and the ground penetrating radar demonstrated the absence of structural roots on the street side of the tree. City staff confirmed both sidewalk (65 sq.ft.) and curb & gutter (21 linear feet) adjacent to the tree had been repaired in 2010. Additionally, the applicant's consulting arborist noted an unbalanced canopy, which was weighted away from the applicant's home. City staff noted this was due to repeated clearance pruning on the side of the canopy facing the home.

Top-Down View of Root Detections

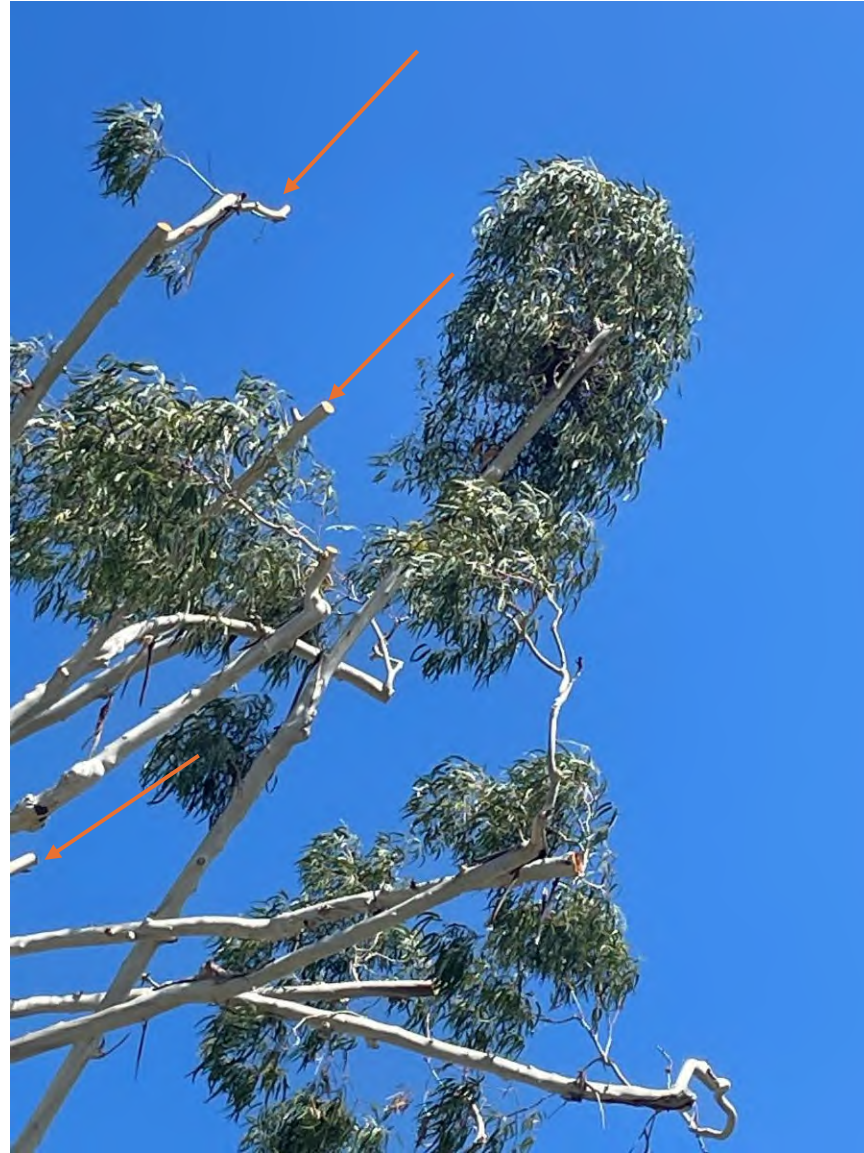
View of topping cuts Tree ID 972864

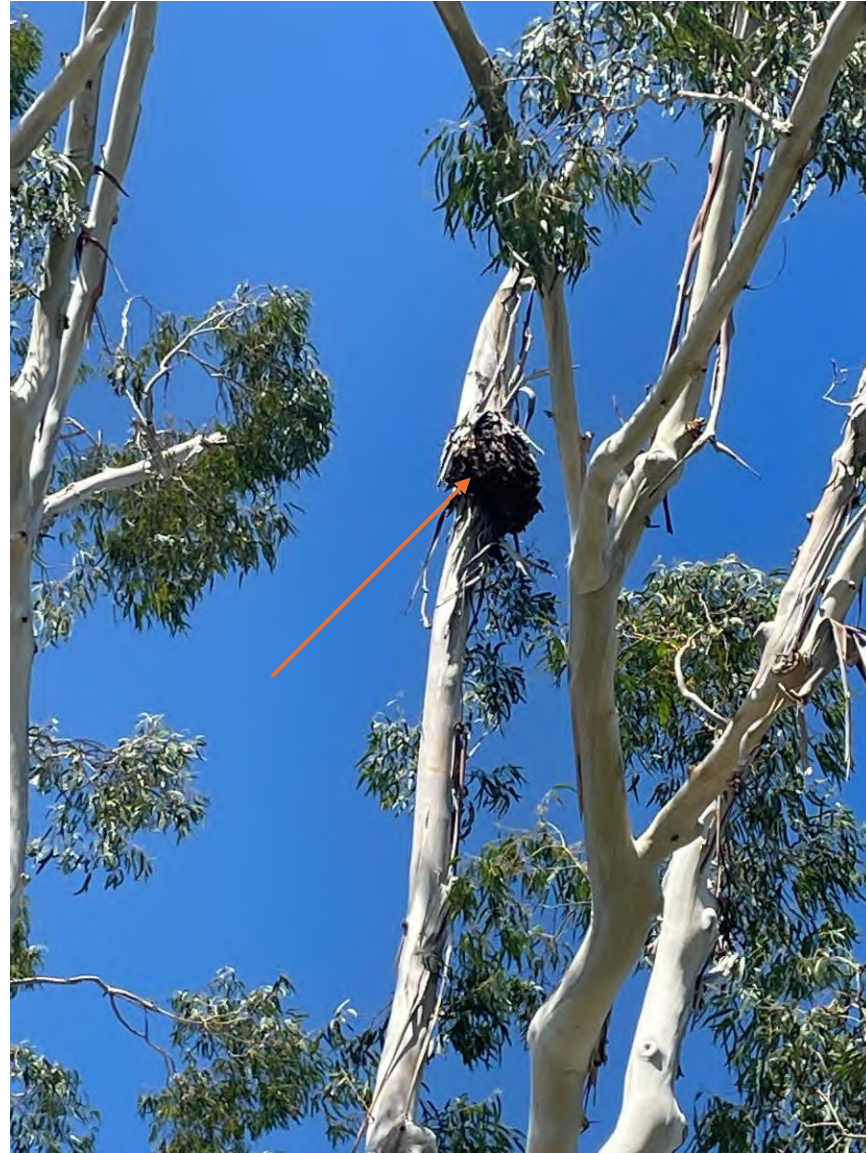
View of gall in crown of Tree ID 972864

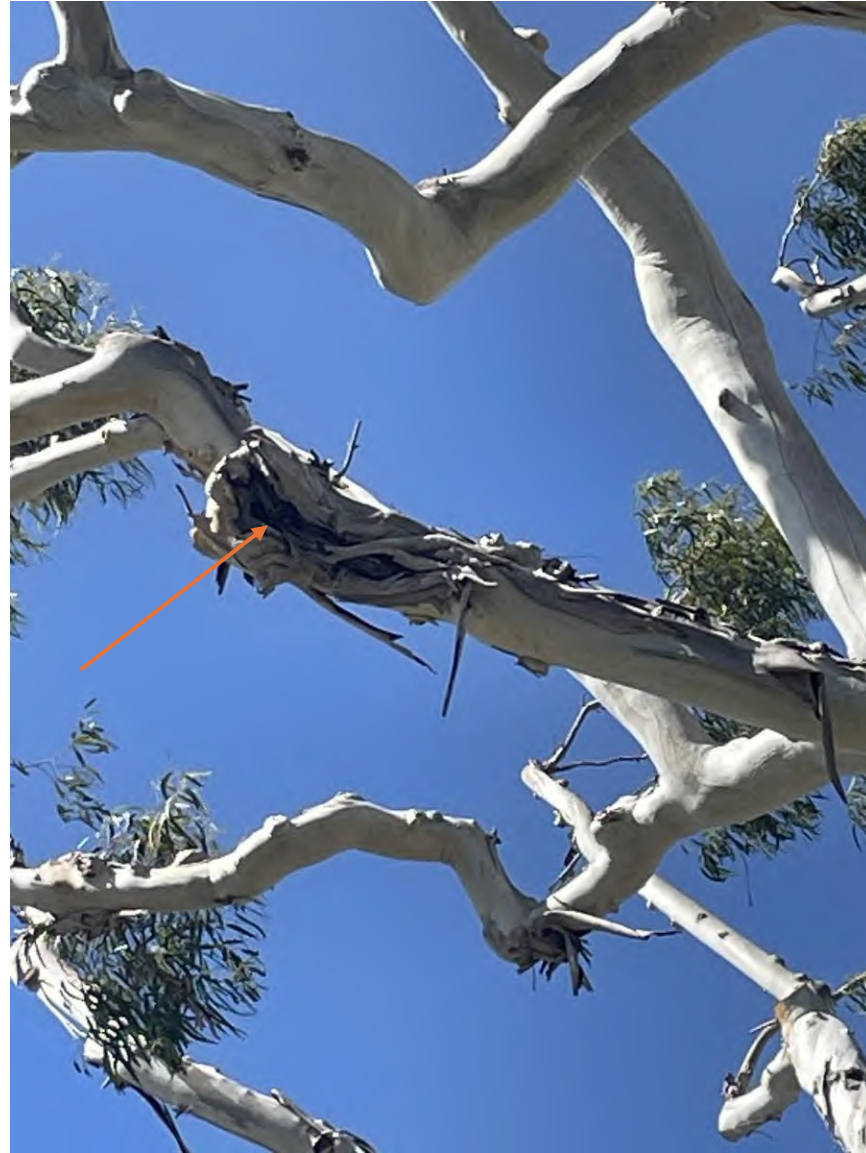
Heartwood decay <input checked="" type="checkbox"/>	Describe: 5" scaffold branch with heartwood decay & nest hole
Flush cuts <input checked="" type="checkbox"/>	Other:	Response growth: None	
Main concern(s): increased load on small to medium sized scaffold branches due to recent pruning			
Load on defect N/A <input type="checkbox"/> Minor <input type="checkbox"/> Moderate <input checked="" type="checkbox"/> Significant <input type="checkbox"/>			Describe: normal winds are 10-15mph
Likelihood of failure Improbable <input type="checkbox"/> Possible <input type="checkbox"/> Probable <input checked="" type="checkbox"/> Imminent <input type="checkbox"/>			Describe:

View of old wound with heartwood decay and nesting cavity

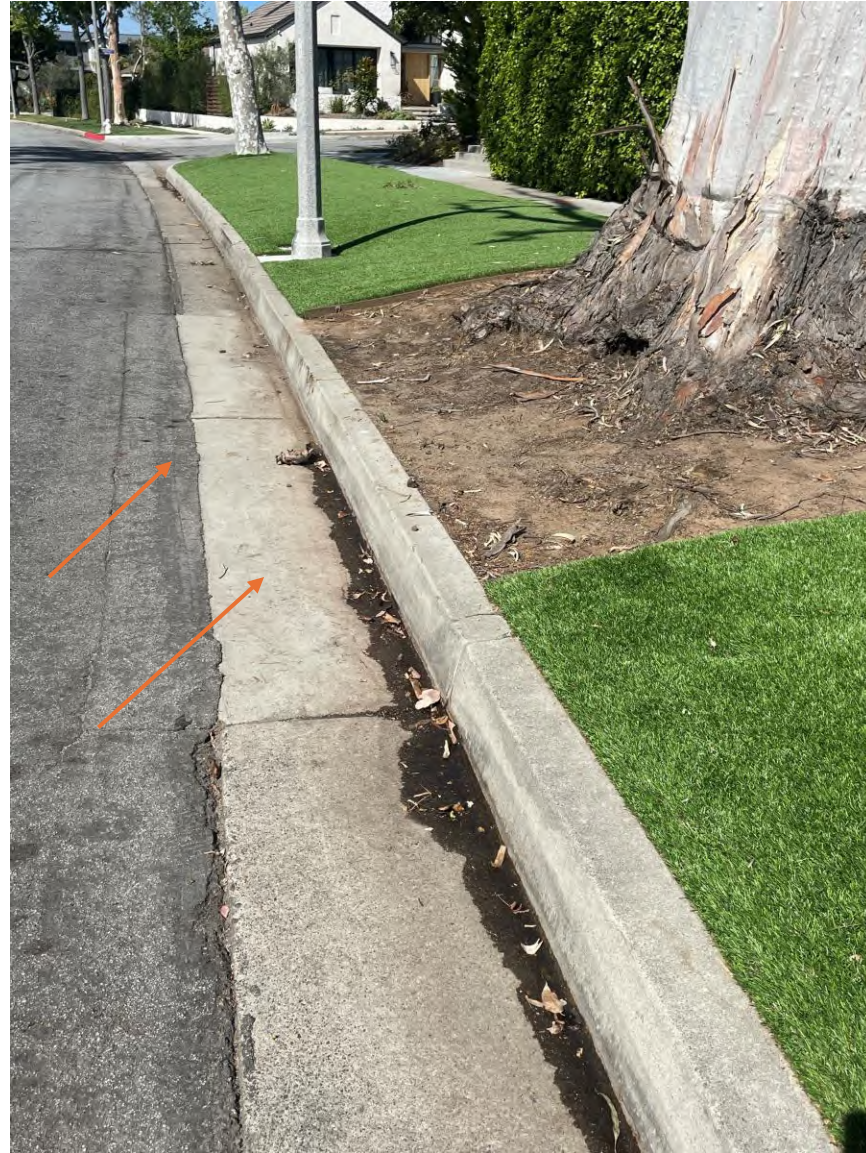
Site Observations: Dudek's site visit has confirmed the location and setting description are generally correct. The Dudek arborist observed a visual difference in color in the gutter directly adjacent to the tree indicating that the concrete had been repaired since the original infrastructure was installed. However, displacement or color difference was not observed in the curb as was described in the Arborist Report.

Gutter appears to have been replaced

View of repair gutter and asphalt street in proximity to Tree ID 972864

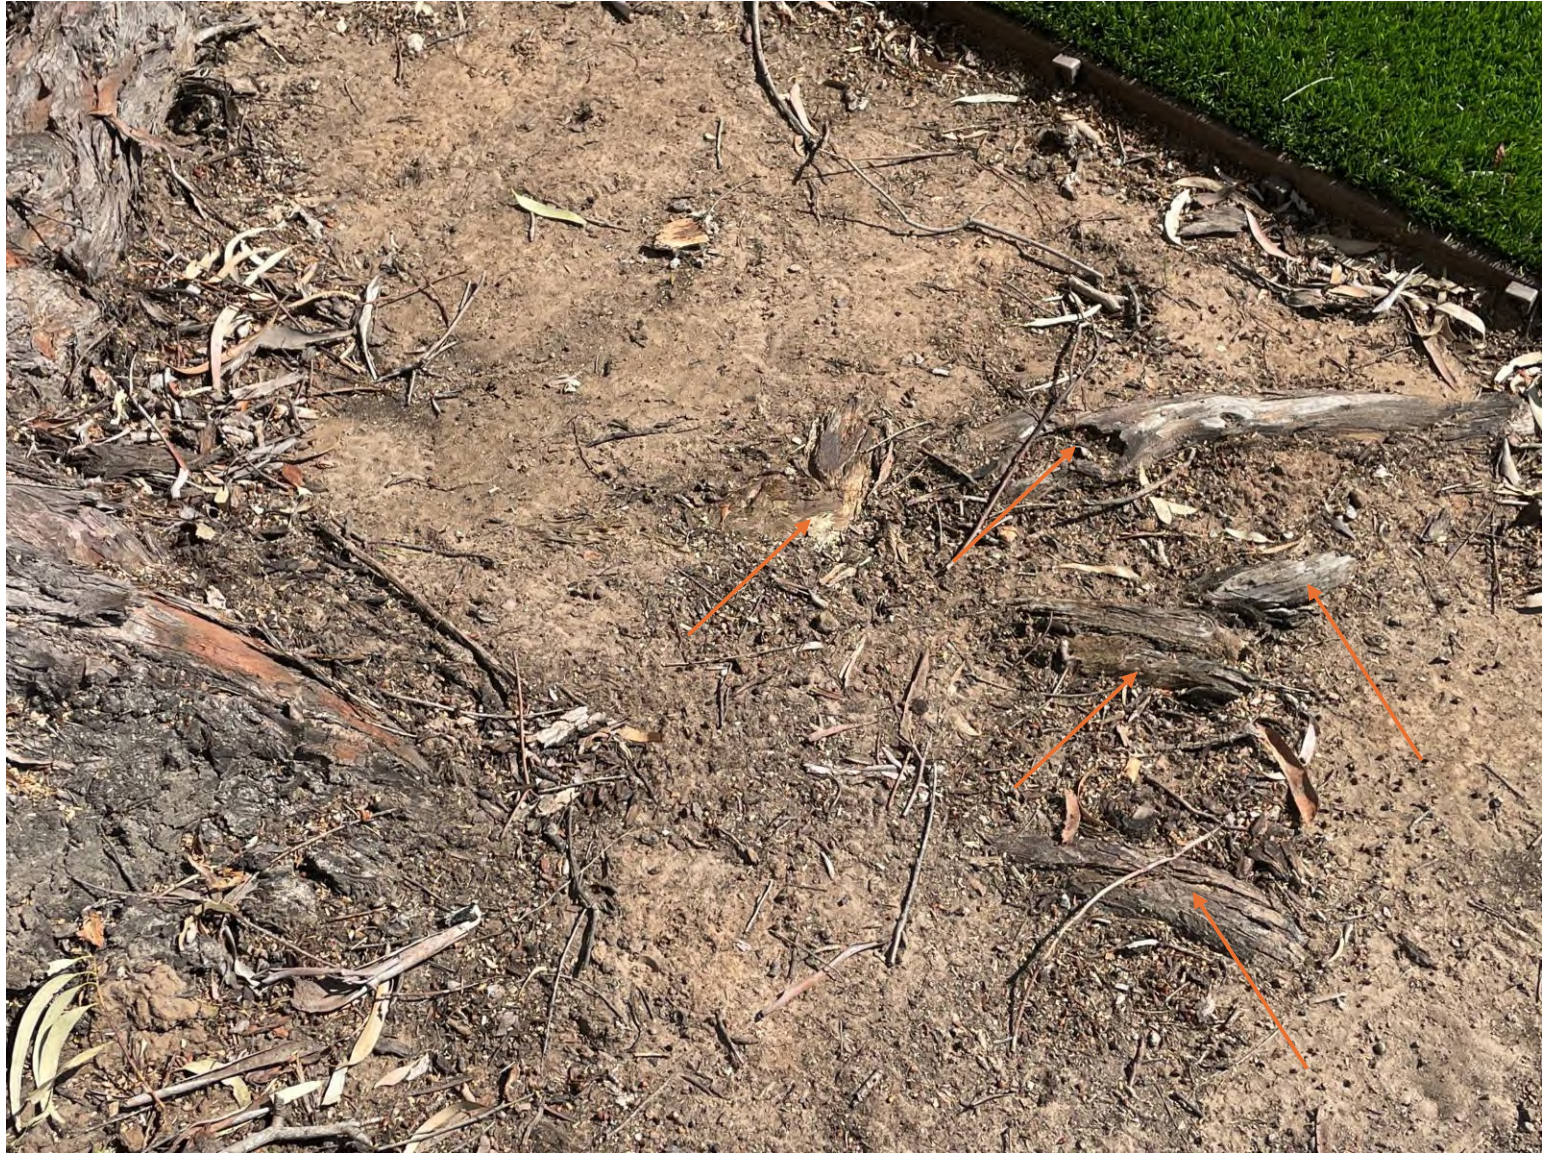
View of damaged and decayed roots

Existing Conditions: Dudek's site visit confirmed large structural roots on all sides of the tree have been previously damaged. Roots measuring as large as 6 inches appear to have been cut, and contrary to the Arborist Report are now exhibiting signs of decay. Upon further inspection, the void described in the Arborist Report, is actually a cavity in the root collar measuring approximately 6 inches deep when probed. The Dudek arborist did not observe included bark in any of the branch unions, though galls were observed in two locations.

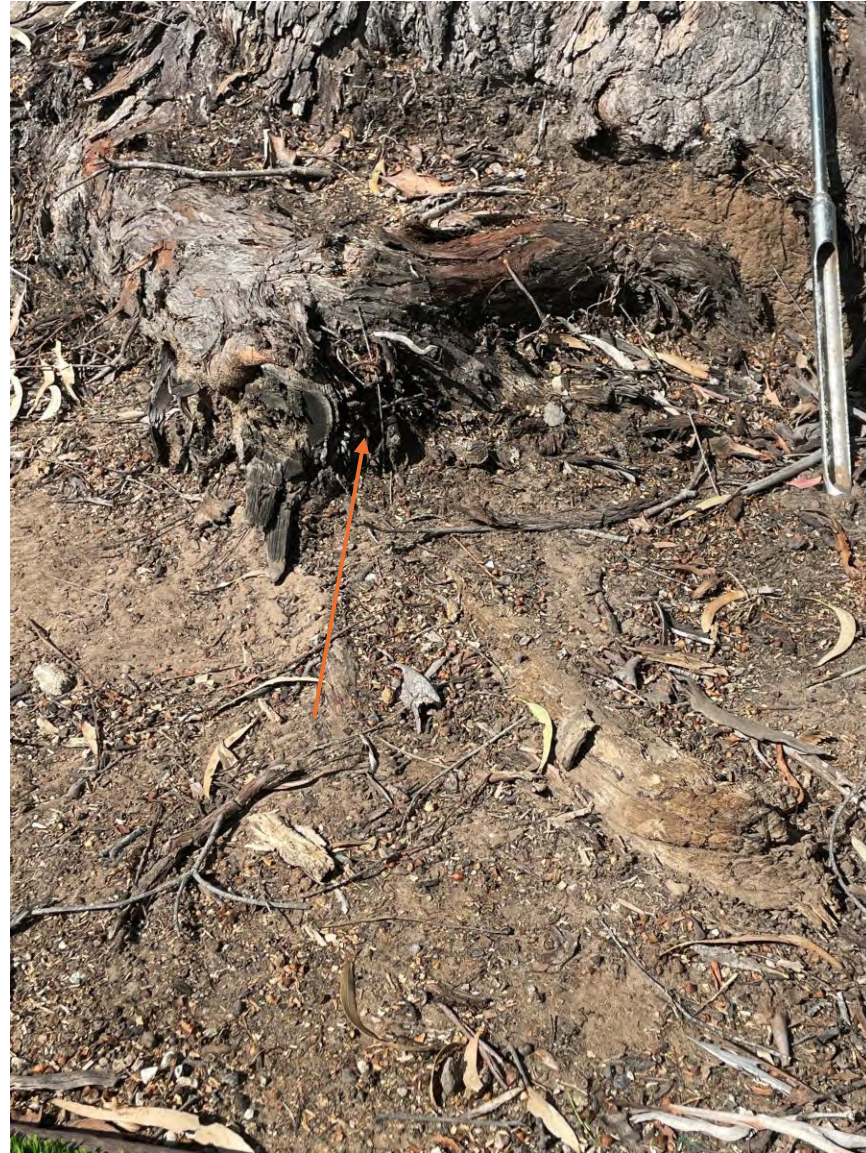
View of large damaged structural root

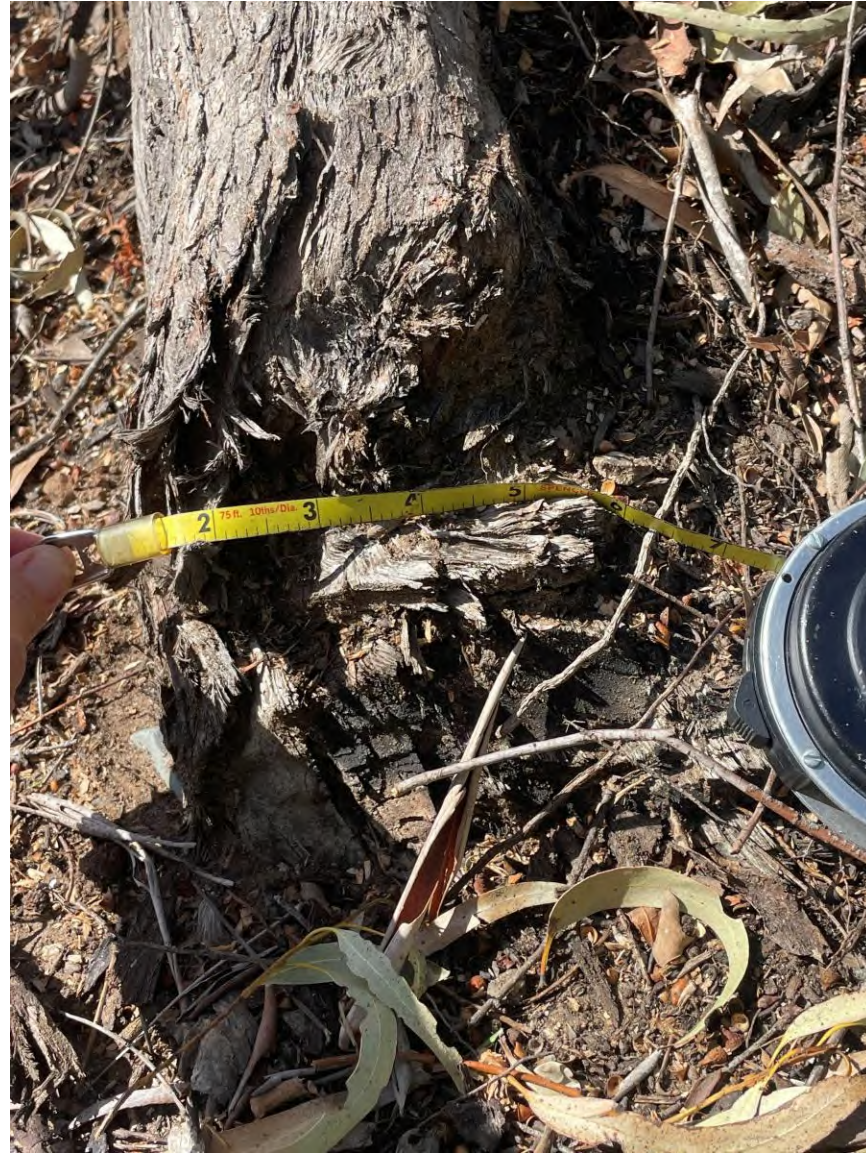
View of damaged 6 inch structural root

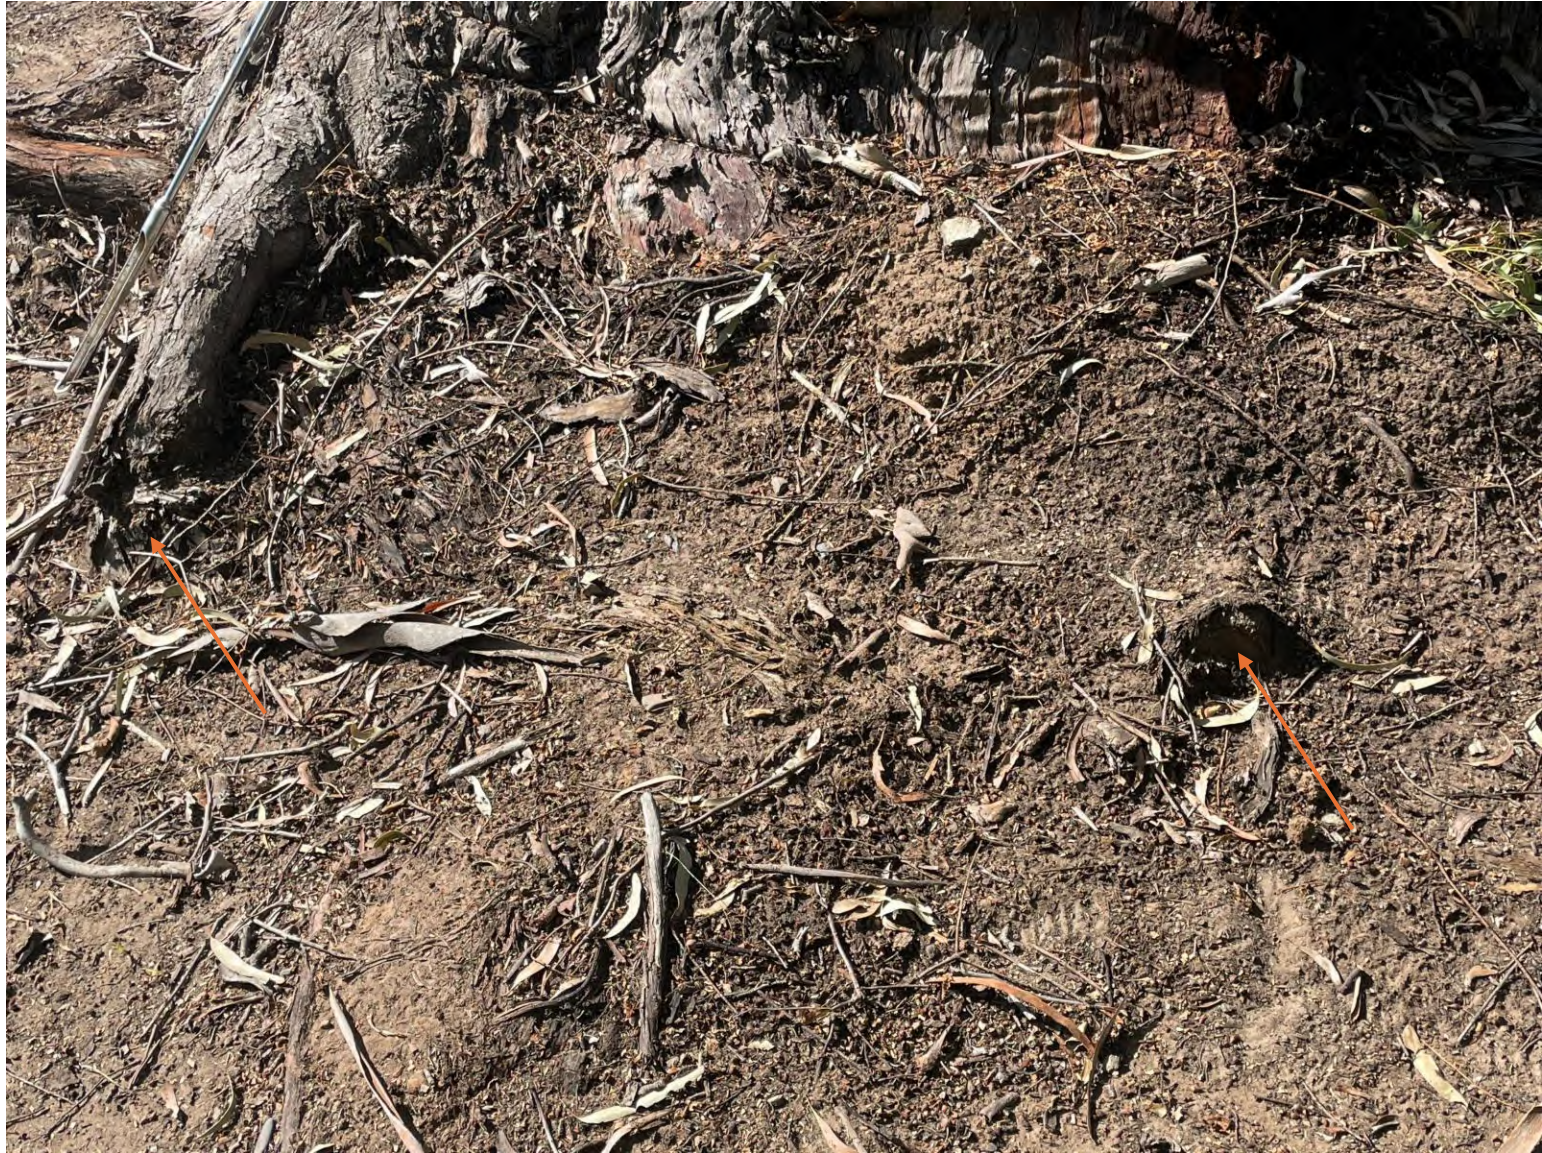
View of damaged structural roots

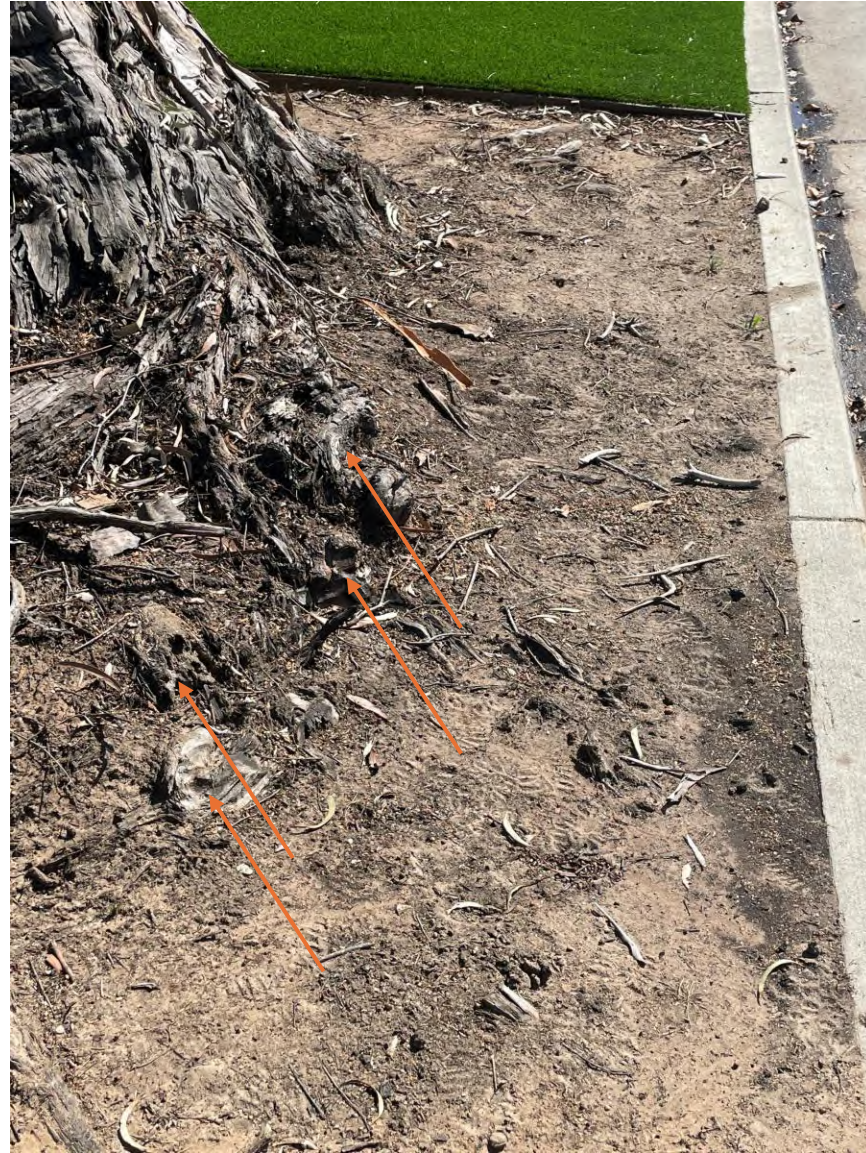
View of damaged roots

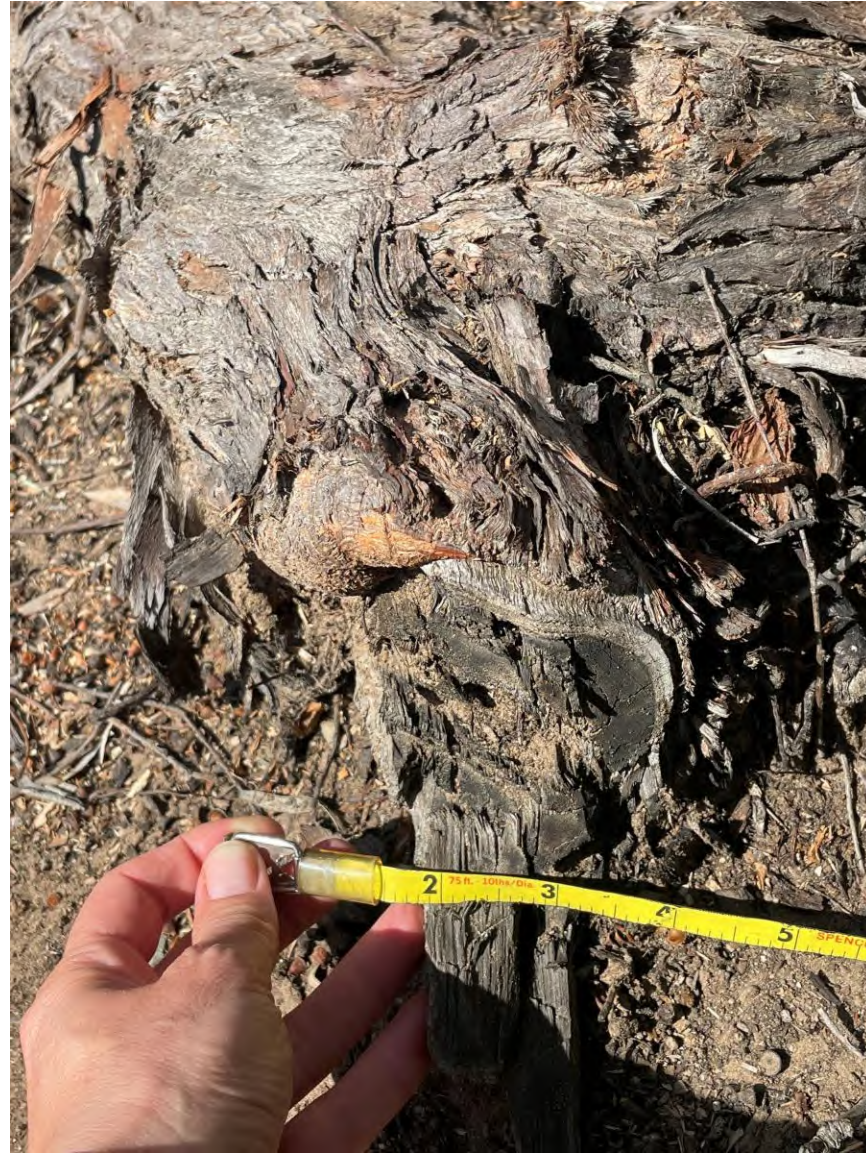
View of damaged 5 inch root

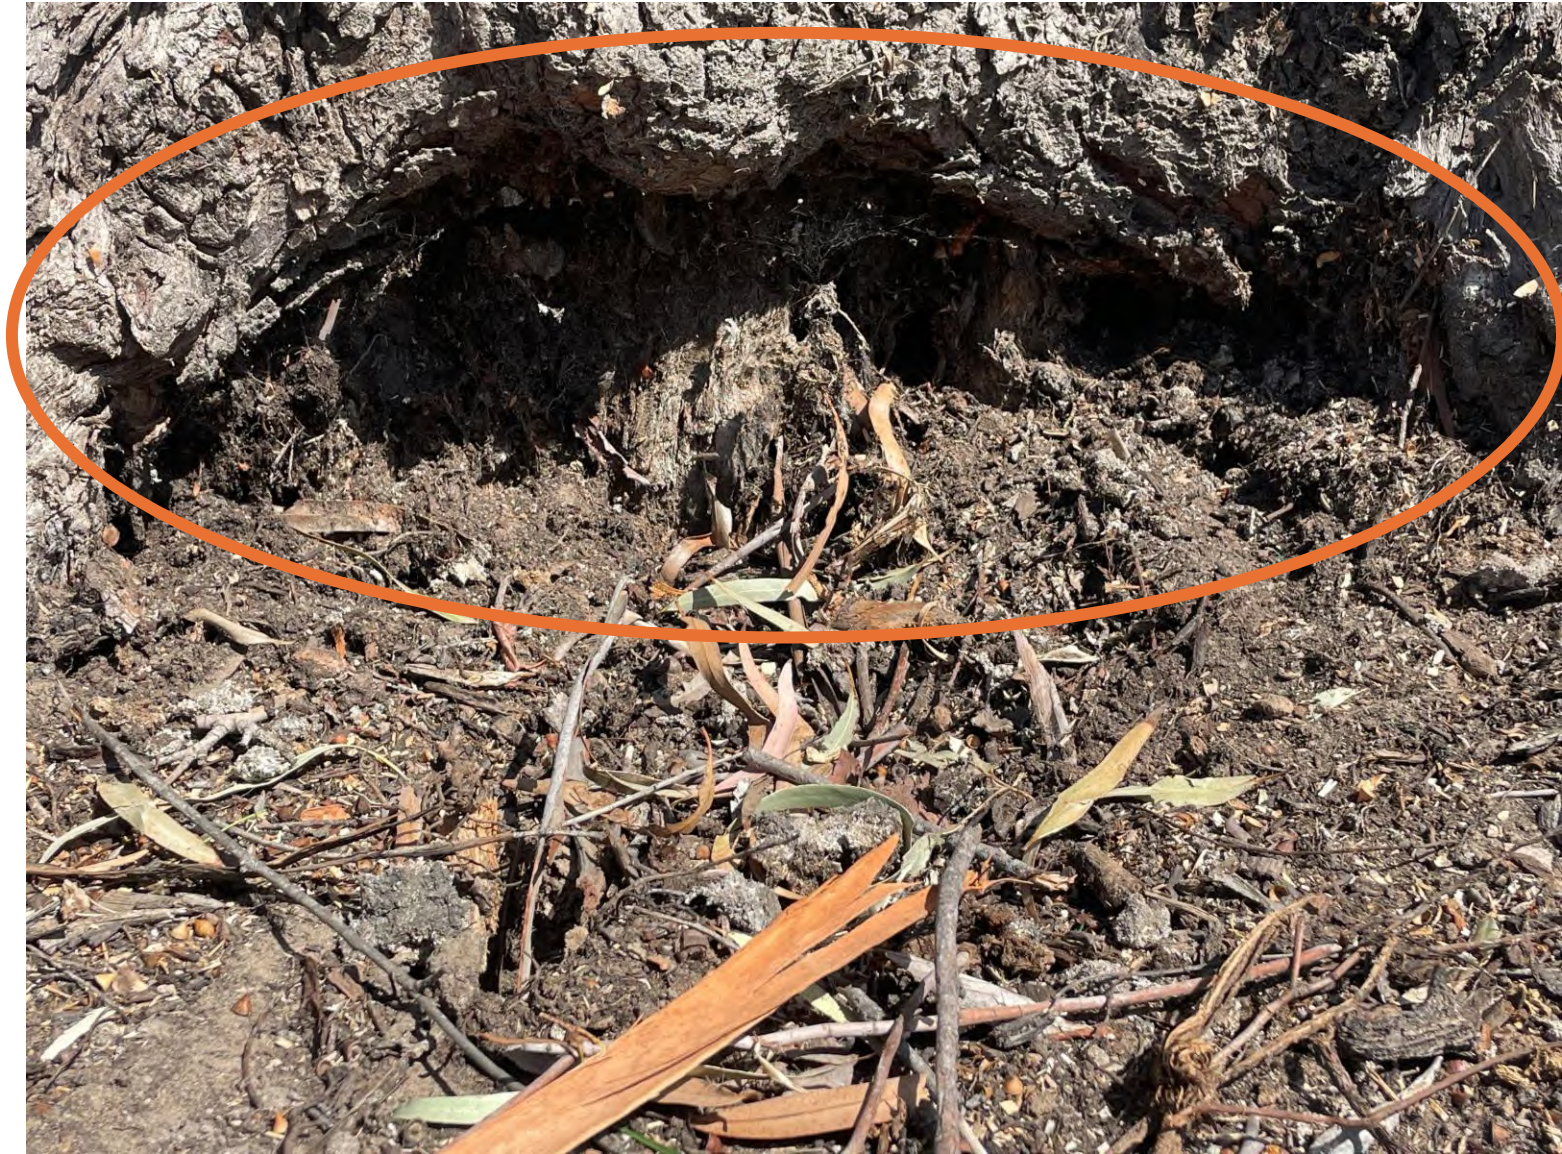
Response growth: None		
Main concern(s): Heartwood decay in root collar and past root damage		
Load on defect N/A <input type="checkbox"/> Minor <input type="checkbox"/> Moderate <input type="checkbox"/> Significant <input checked="" type="checkbox"/>		
Likelihood of failure Improbable <input type="checkbox"/> Possible <input checked="" type="checkbox"/> Probable <input type="checkbox"/> Imminent <input type="checkbox"/>

Cavity in root collar; wind coming from south/southwest

View of cavity on west side of root collar

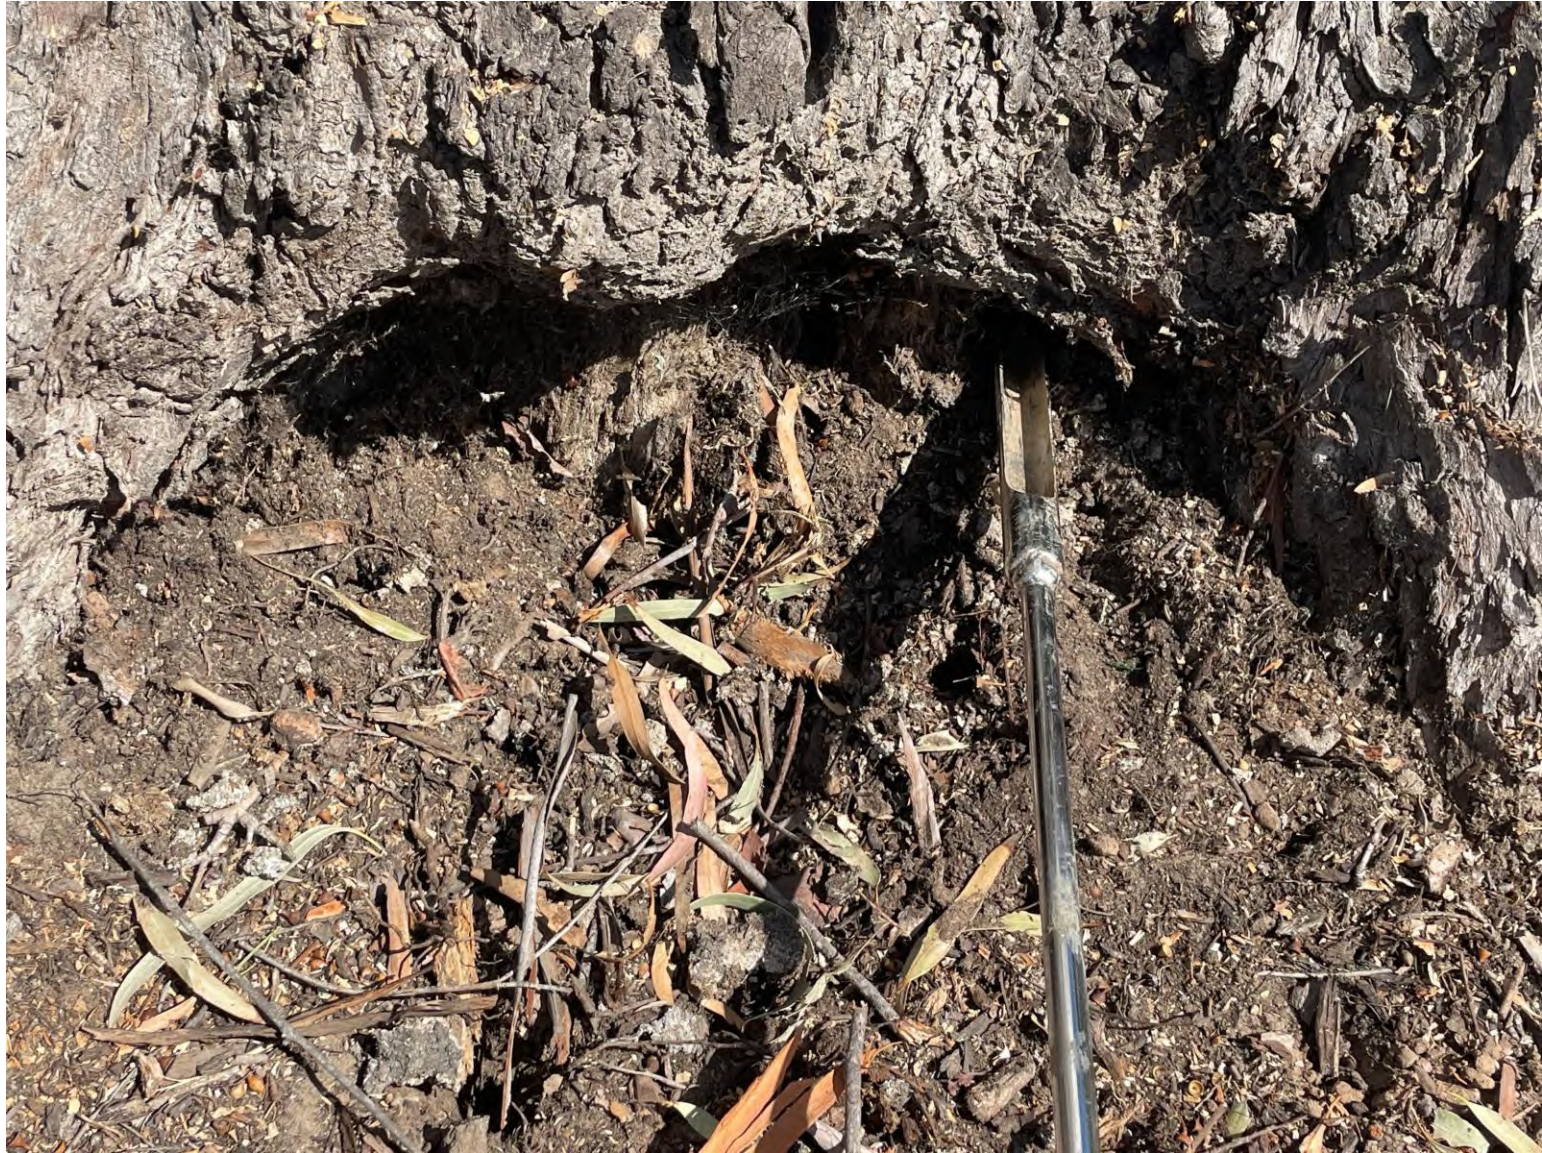
Photo of cavity depth
