CITY OF NEWPORT BEACH

Tree Removal or Reforestation Application

The applicant, Geoffrey Darby (residing at 901 Chestnut Place), contacted the City to request the removal of a Manna Gum Eucalyptus (*Eucalyptus viminalis*) located on the Alta Vista side of his home due to previous root damage, unbalanced canopy, limited scaffolding root structure on the street side and perceived elevated risk of a whole tree failure.

Figure 1
Tree Location Exhibit
901 Chestnut Place

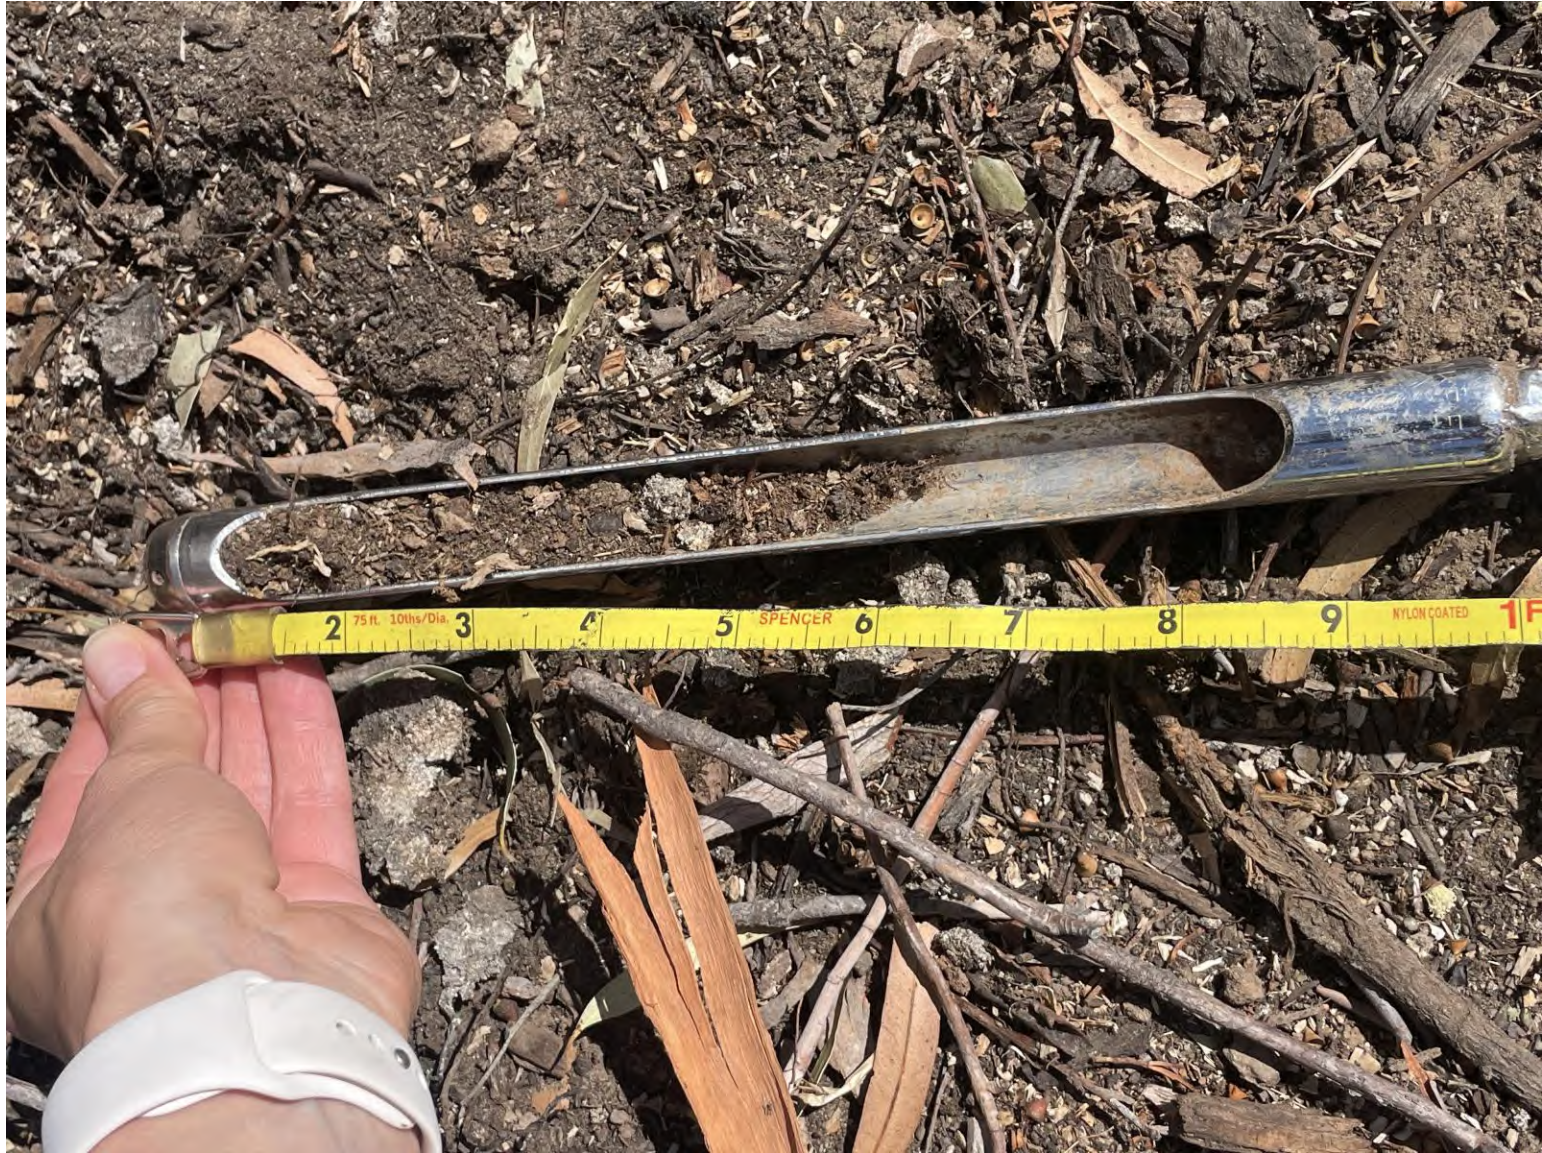
Depth of cavity is approximately 6 inches

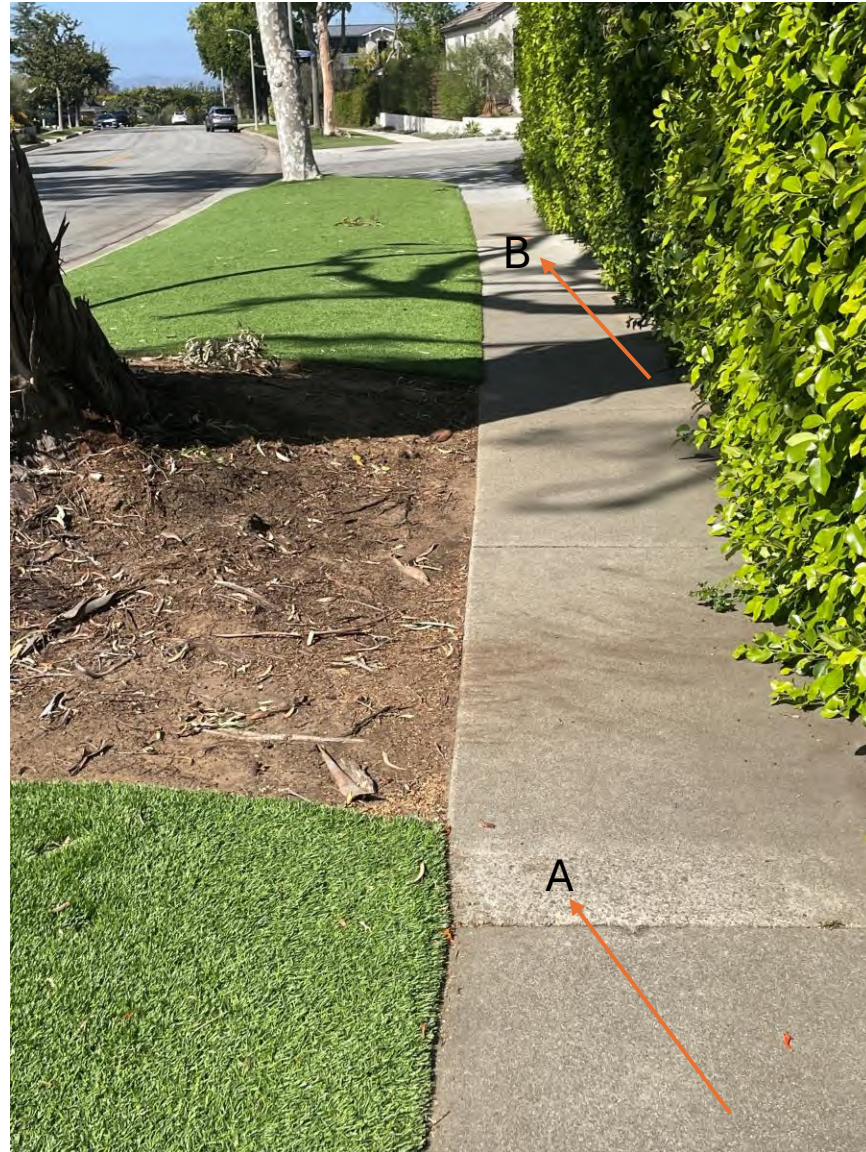
Sidewalk has been ground down, but doesn't appear to have been replaced

Proximity of sidewalk lifting (A) and replacement (B)

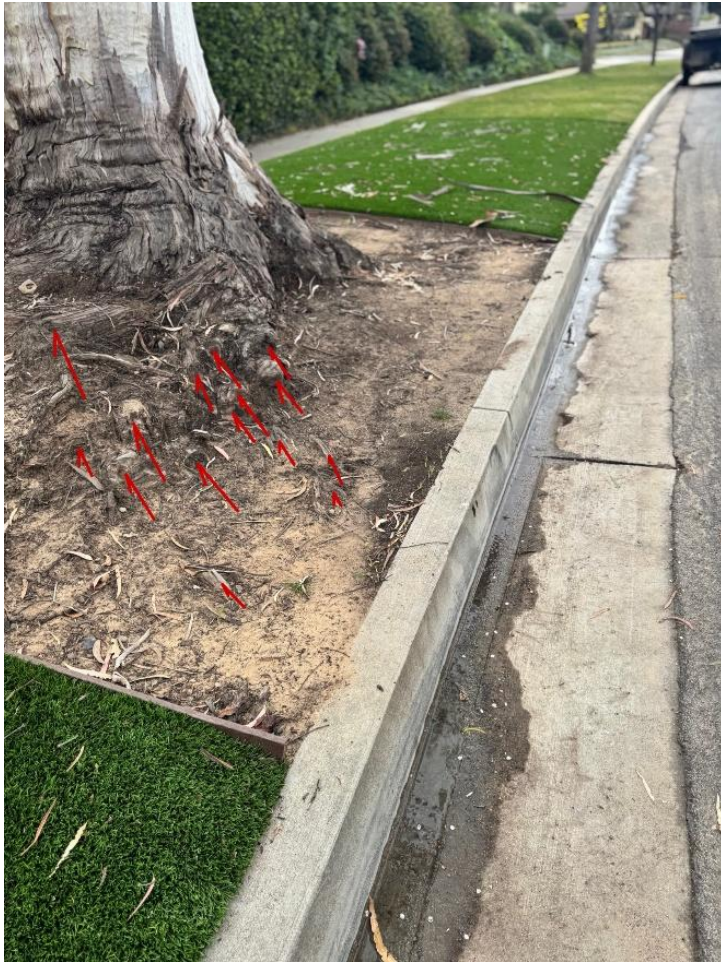
PHOTO #1 – ARROWS INDICATE CUT ROOTS

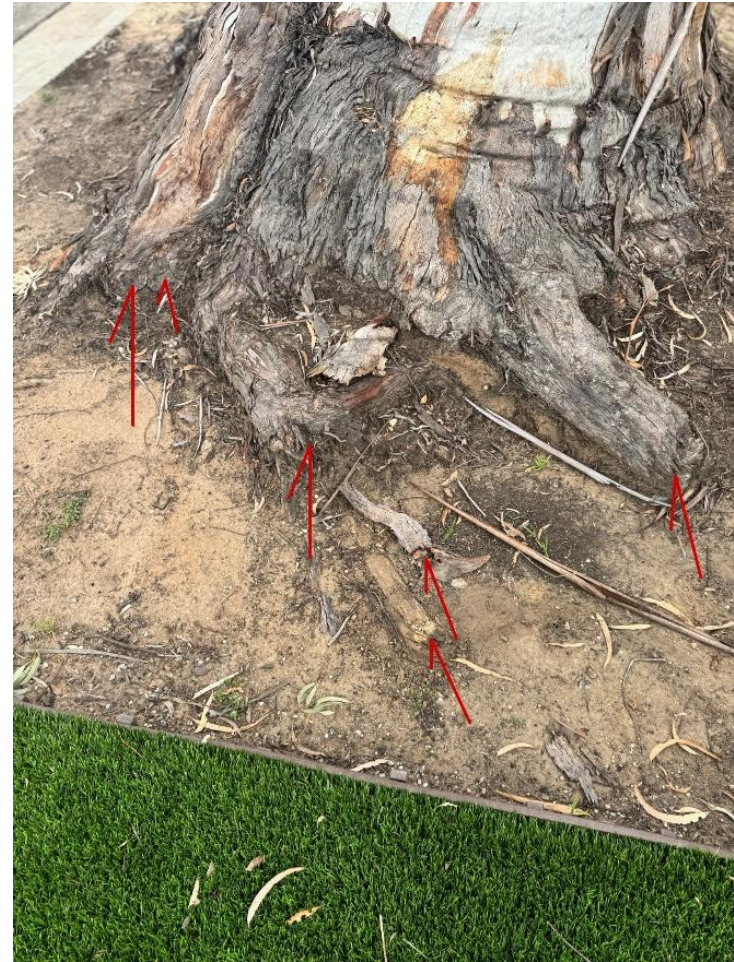
PHOTO #2 AAROWS INDICATE CUT ROOTS

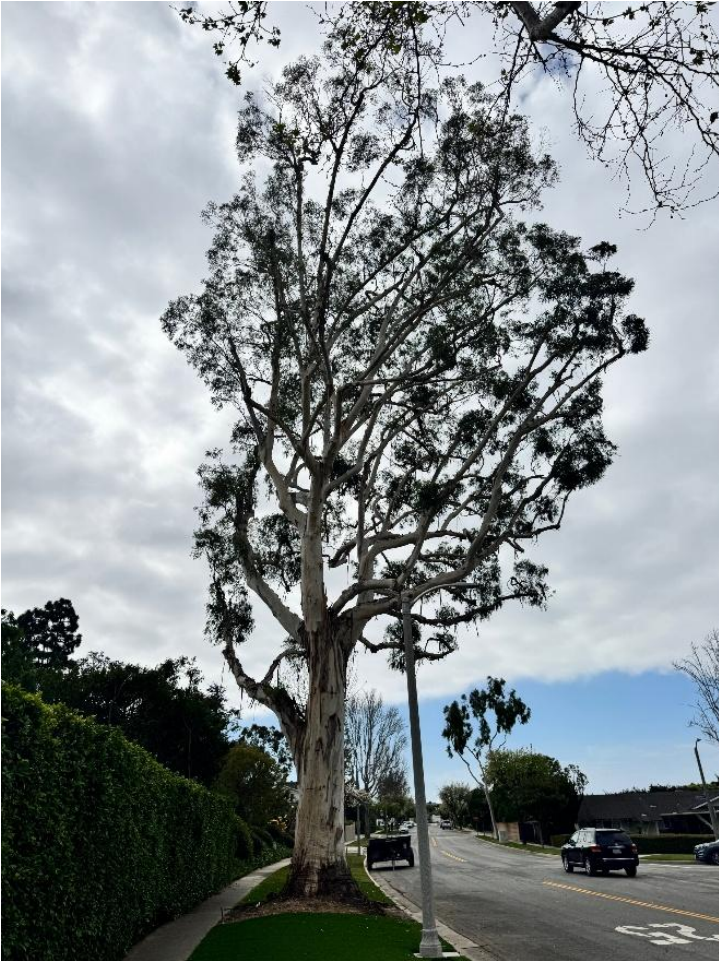
PHOTO #3 – UNBALANCED TREE CANOPY

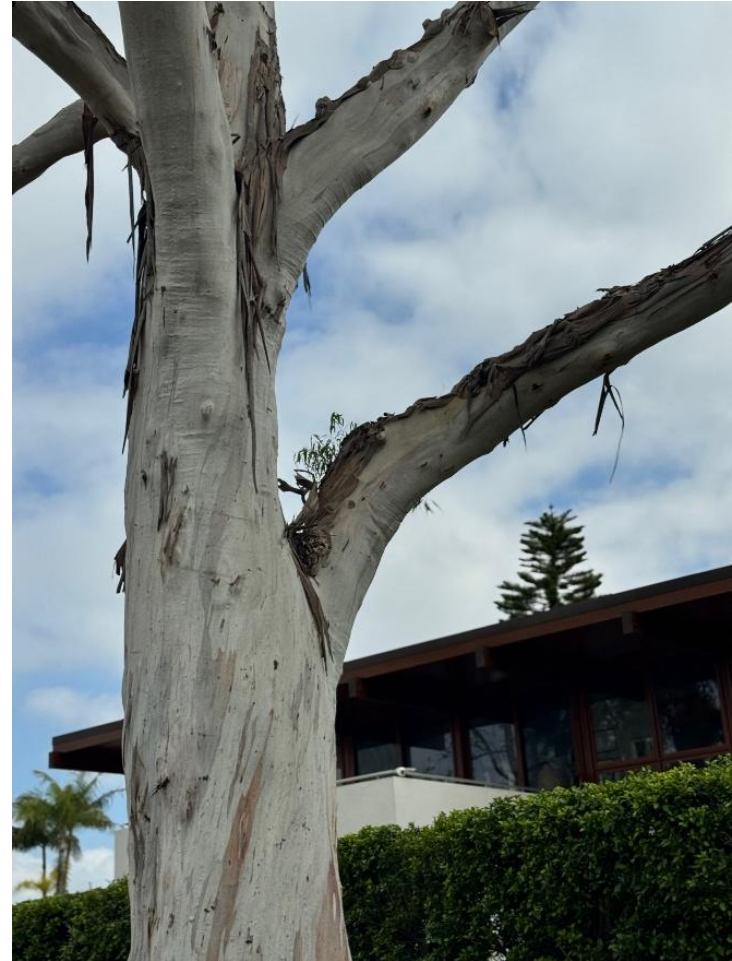
PHOTO #4 – INCLUDED BARK ON LOWER CROTCH
