CITY OF NEWPORT BEACH

Tree Removal or Reforestation Application

(1) EUCALYPTUS TREE

1848 PORT ABBEY PL, NEWPORT BEACH, CA 92660

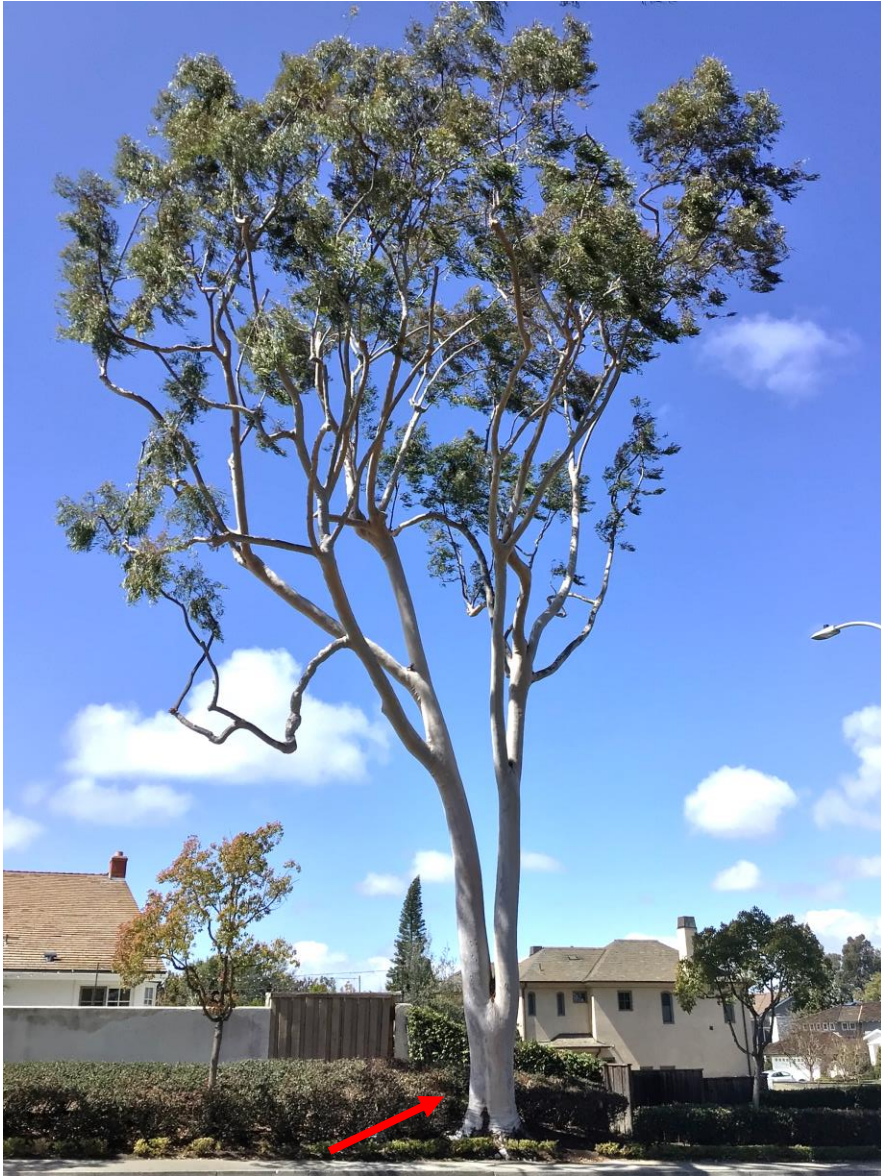
Photograph 1: Overview photograph of Tree ID 970872, facing west.

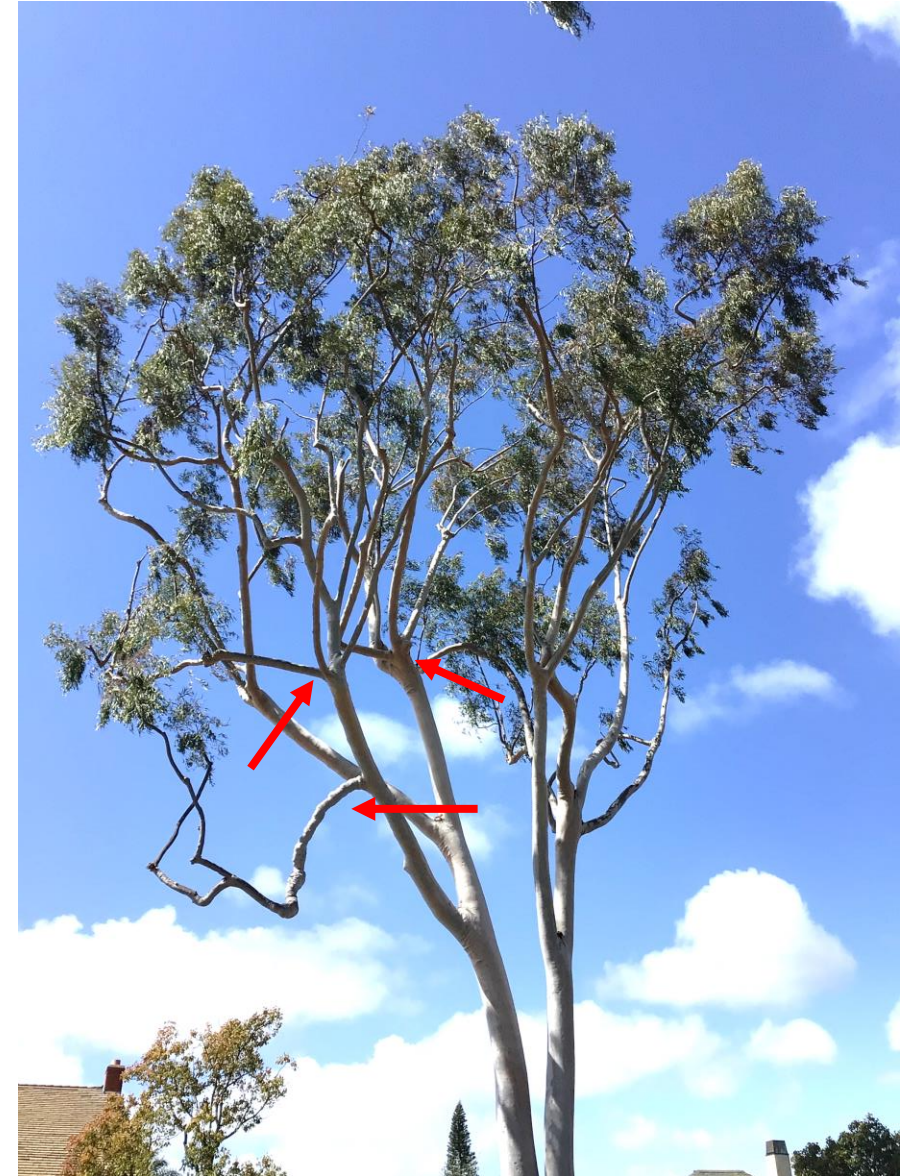
The tree's crown and branches were assessed on conditions such as crown balance, live crown ratio, and other factors that reflect weak attachments like co-dominant stems, included bark, and response growth from previous pruning. The tree's crown reaches approximately 75 feet in height and is approximately 45 feet across at its widest point. The tree has a live crown ratio of approximately 55% (the ratio of the height of the live crown to the height of the entire tree) and is composed of larger- and smaller-diameter **scaffold branches**. Observable pruning history consisted of crown cleaning and thinning, and reductions. Based on a review of the tree's work history, the tree is maintained on an approximately 2-year maintenance cycle. It should be noted that several **stub cuts** were observed in the tree's crown. Furthermore, crown reductions were observed on the residential side of the tree. The scaffold limbs vary about their evaluated "weak" or "strong" attachments. Examples of weak attachment points include **co-dominant** branches, **overextended limbs**, and fused limbs. Conversely, stronger attachments consisted of accommodating attachment angles with no included bark and sound branch architecture. The main conditions of concern in the tree's crown included overloaded weak attachments, and overextended limbs. Based on the observed defects, the likelihood of failure for a tree part in the crown is considered possible.

Photograph 2: Detailed photograph of the crown of Tree ID 970872, facing west. Note the poor branch structure and weak attachments.

1. **Crown Thin:** Crown thinning and corrective pruning will help correct the observed weak branch attachments. The recommended crown cleaning should remove no more than 20% of the crown, unless it is necessary to correct branching defects. During the crown thinning, the maintenance contractor should reduce any overextended limbs. Reduction of the overextended limbs will reduce the likelihood of branch failure as a result of the leverage effect. Crown thinning and removal of structurally unsound limbs will reduce identified hazards, including dead and declining branches/limbs. All pruning should be done in accordance with ANSI A300 Pruning Standards.

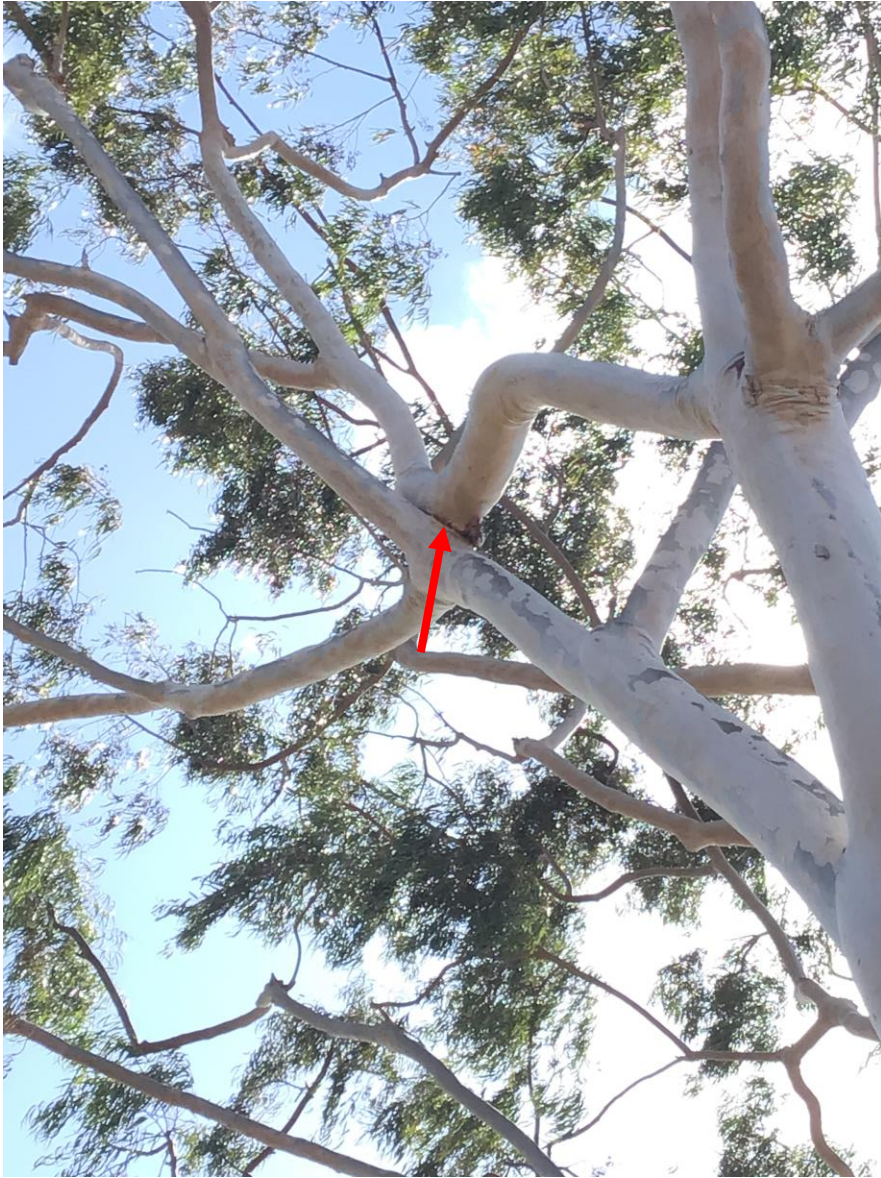
Photograph 3: Detailed photograph of the fused limbs in the crown of Tree ID 970872.

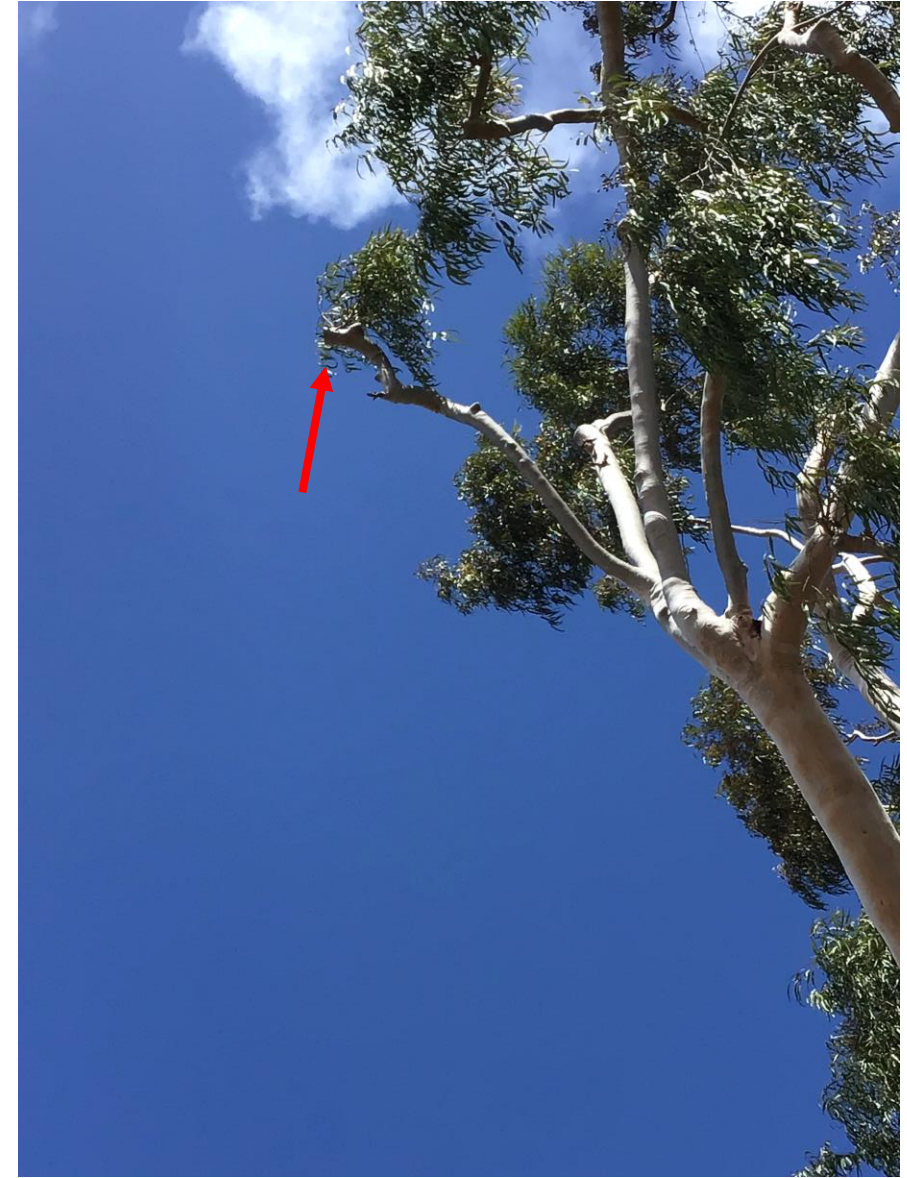
Photograph 4: Detailed photograph of stub cuts in the crown of Tree ID 970872.

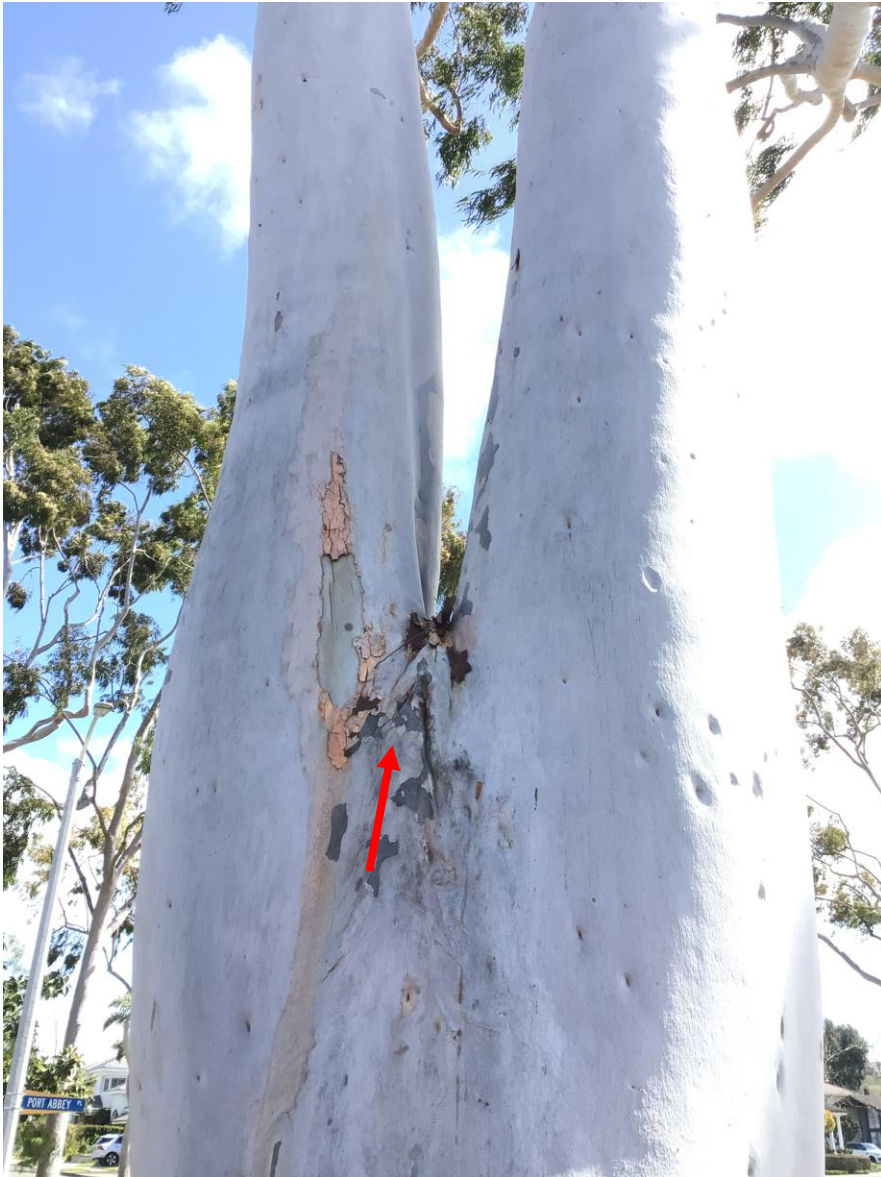
The tree is single-stemmed and has a **diameter at standard height** of 36.5 inches. The tree was observed to have a minor corrected lean (from vertical) of approximately two degrees to the east. The tree has two large co-dominant stems that bifurcate at a height above ground level of approximately 10 feet. The two co-dominant stems did not appear to have included bark. The main concern observed with the tree's trunk was the two co-dominant stems. However, as noted the two stems did not appear to have included bark. Included bark often develops where two or more stems grow closely together, over time, included bark may result in branch, limb, or stem failure. The load on the observed defect was significant, and the likelihood of failure is considered improbable.

Photograph 5: Detailed photograph co-dominant stems on Tree ID 970872, facing east.

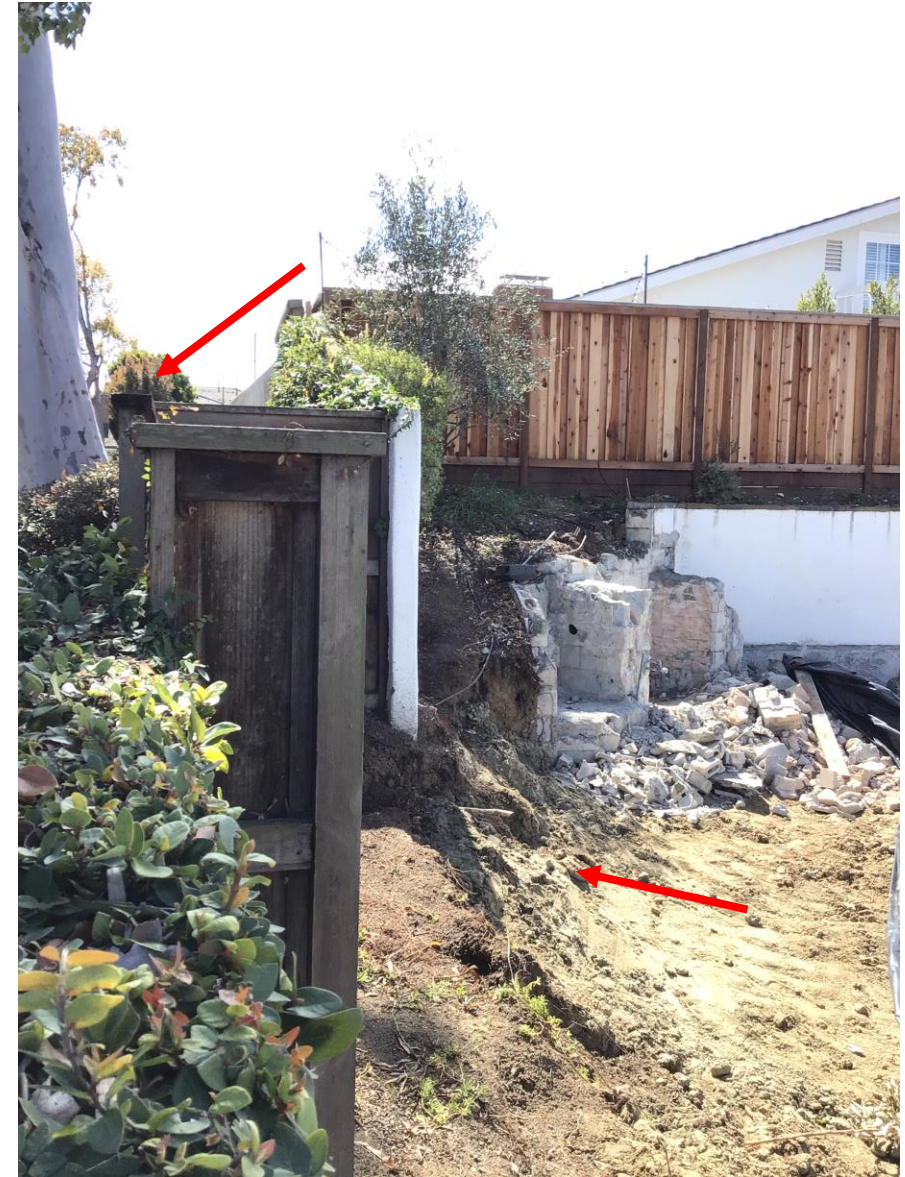
The roots and root collar of the tree were buried at the time of the evaluation. As such, a root crown evaluation of the tree was limited to the visible portion of the crown. However, it should be noted that active construction was observed in the backyard of 1853 Port Sheffield Place. The active construction was observed to be the excavation of the backyard of 1853 Port Sheffield Place. The active construction is approximately 15- feet to the northwest of the tree's trunk. At the time of inspection, only smaller diameter roots (less than 1 inch) were observed to have been cut. The observed damage was located outside of the tree's dripline. Based on observations of the excavation site, from public property, no major structural root damage appeared to have occurred (see Attachment C – Photograph Log). The main concern observed with the roots and root collar was the adjacent excavation at 1853 Port Sheffield Place. The load on the observed defect was significant, and the likelihood of failure is considered possible.

Photograph 5: Detailed photograph active construction in the backyard of 1853 Port Sheffield Place, facing south. Note the location of Tree ID 970872 to the active construction.

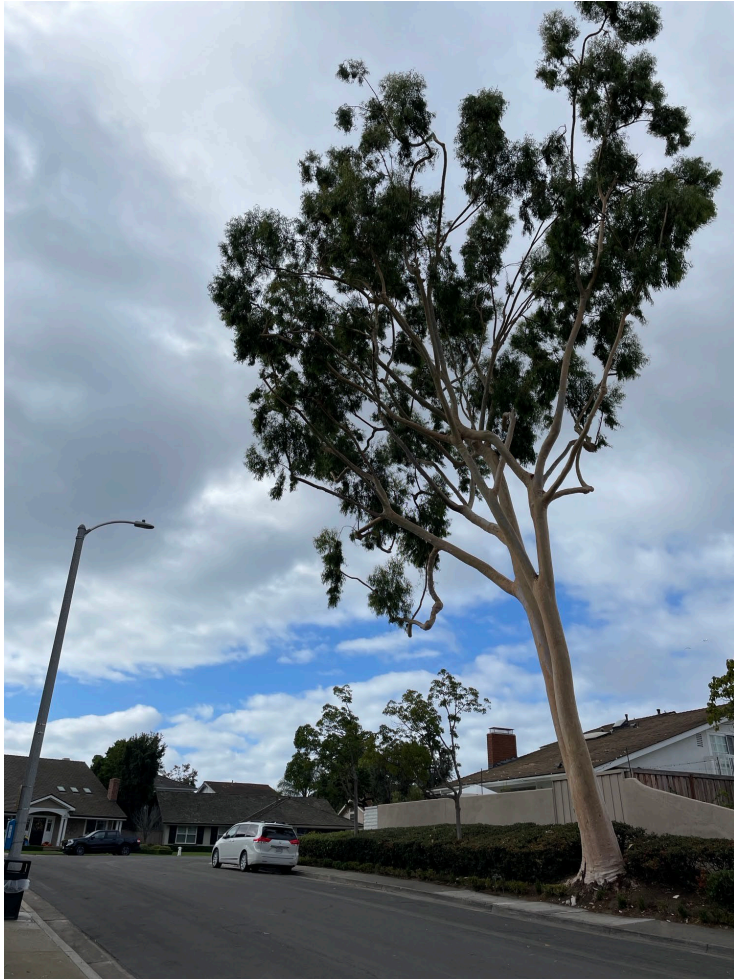
Photograph 1 – Overview of lemon-scented gum.

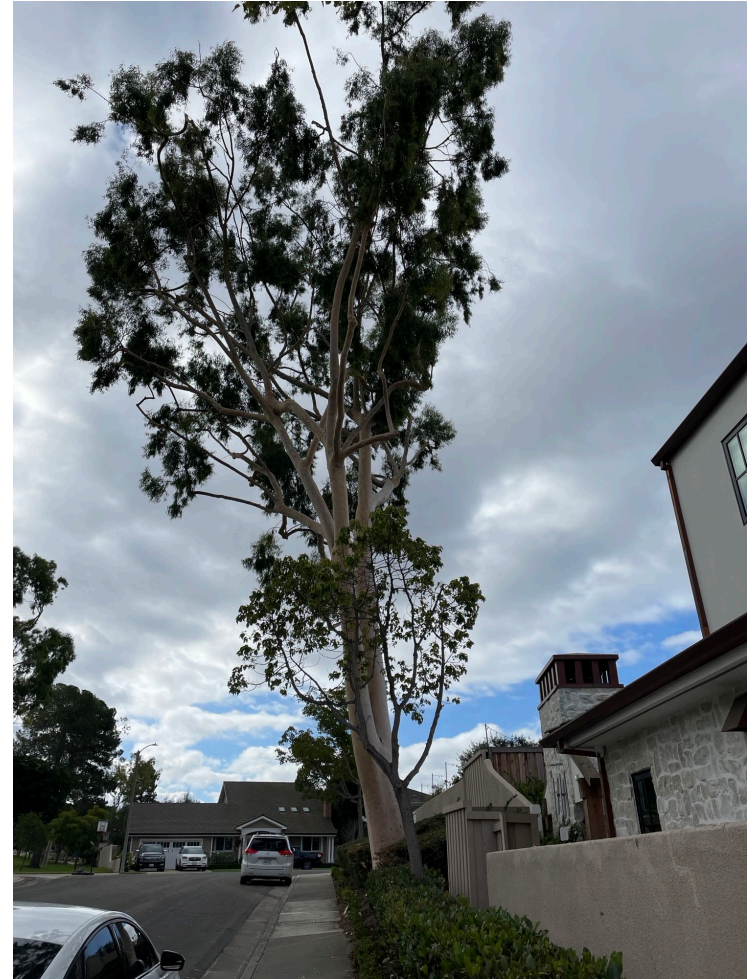
- Lean: The trunk has a 23° lean toward the east, which is toward the street and away from the adjacent residential homes. While the tree has an observable lean, typically a tree's lean will result in a failure of the root system, and not a breaking of the trunk itself.
- Weak attachments: Tree ID 970872 has two large co-dominant stems that bifurcate from the primary trunk at approximately 7 feet above grade. The angle of attachment for the two stems is considered acute.
- Main concern: The sudden failure of co-dominant stems with significant loads.
- Likelihood of failure: The main concern was classified as possible to fail within the established 12-month time frame.

Photograph 2 – View of lemon-scented gum (facing north). Note slight lean away from buildings and toward the roadway and adjacent park.

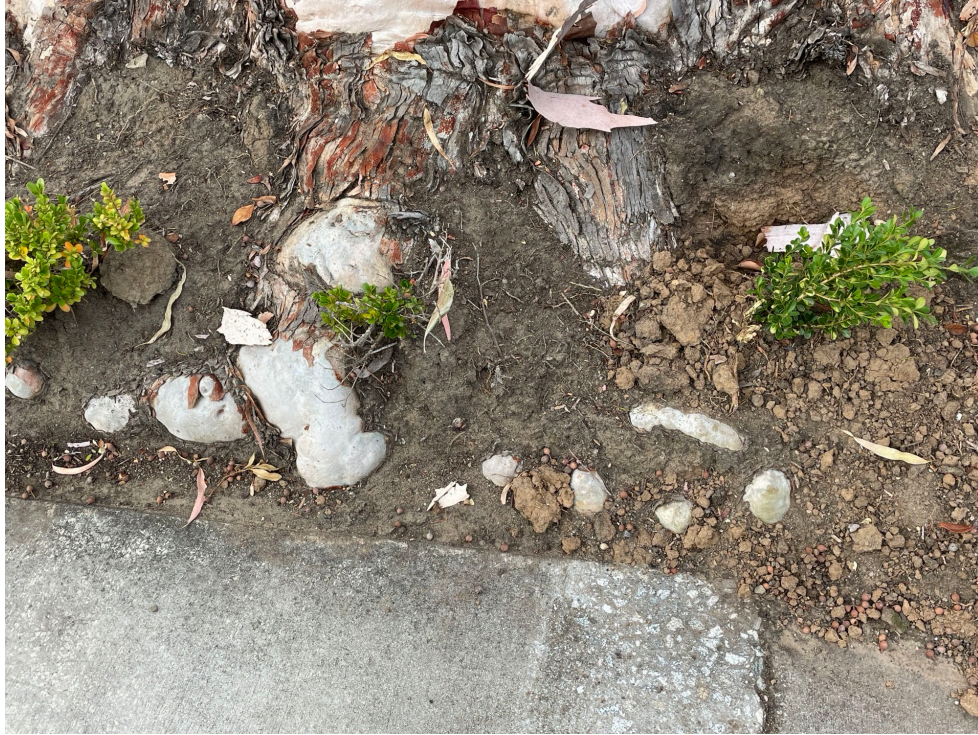
Site history was evaluated and includes factors such as previous land uses, grade changes, and cut and/or damaged roots from construction-related activities, landscaping, irrigation installation, or sidewalk and street repairs. The assessed tree appears to be subject to a mixture of direct and indirect impacts that may have resulted from the development process. One such event occurred in March 2021, when active construction was observed in the backyard of 1853 Port Sheffield Place. The active construction was observed by Dudek in 2021 to be the excavation of the backyard of 1853 Port Sheffield Place. The active construction was approximately 15 feet to the northwest of the tree's trunk. At the time of inspection by Dudek, only smaller diameter roots (less than 1 inch) were observed to have been cut. The observed damage was located outside of the tree's dripline, and based on observations of the excavation site, from public property, no major **structural root** damage appeared to have occurred.

Photograph 3 – Close-up view of potentially damaged roots from sidewalk replacement and grinding.

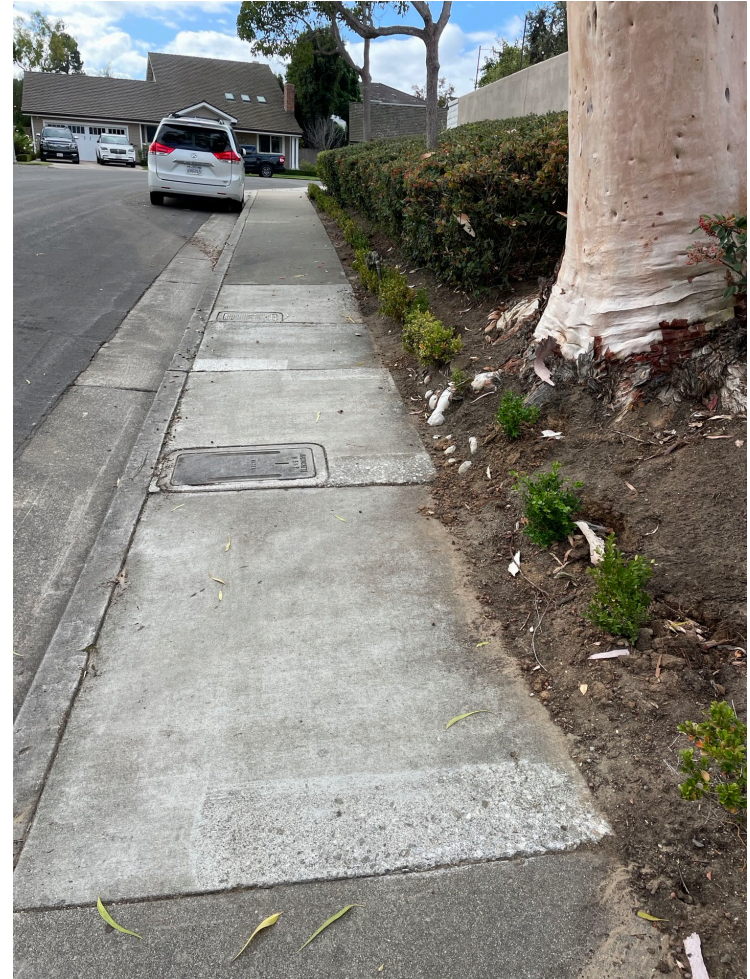
Photograph 4 – View of sidewalk replacement work as indicated by “newer” concrete.

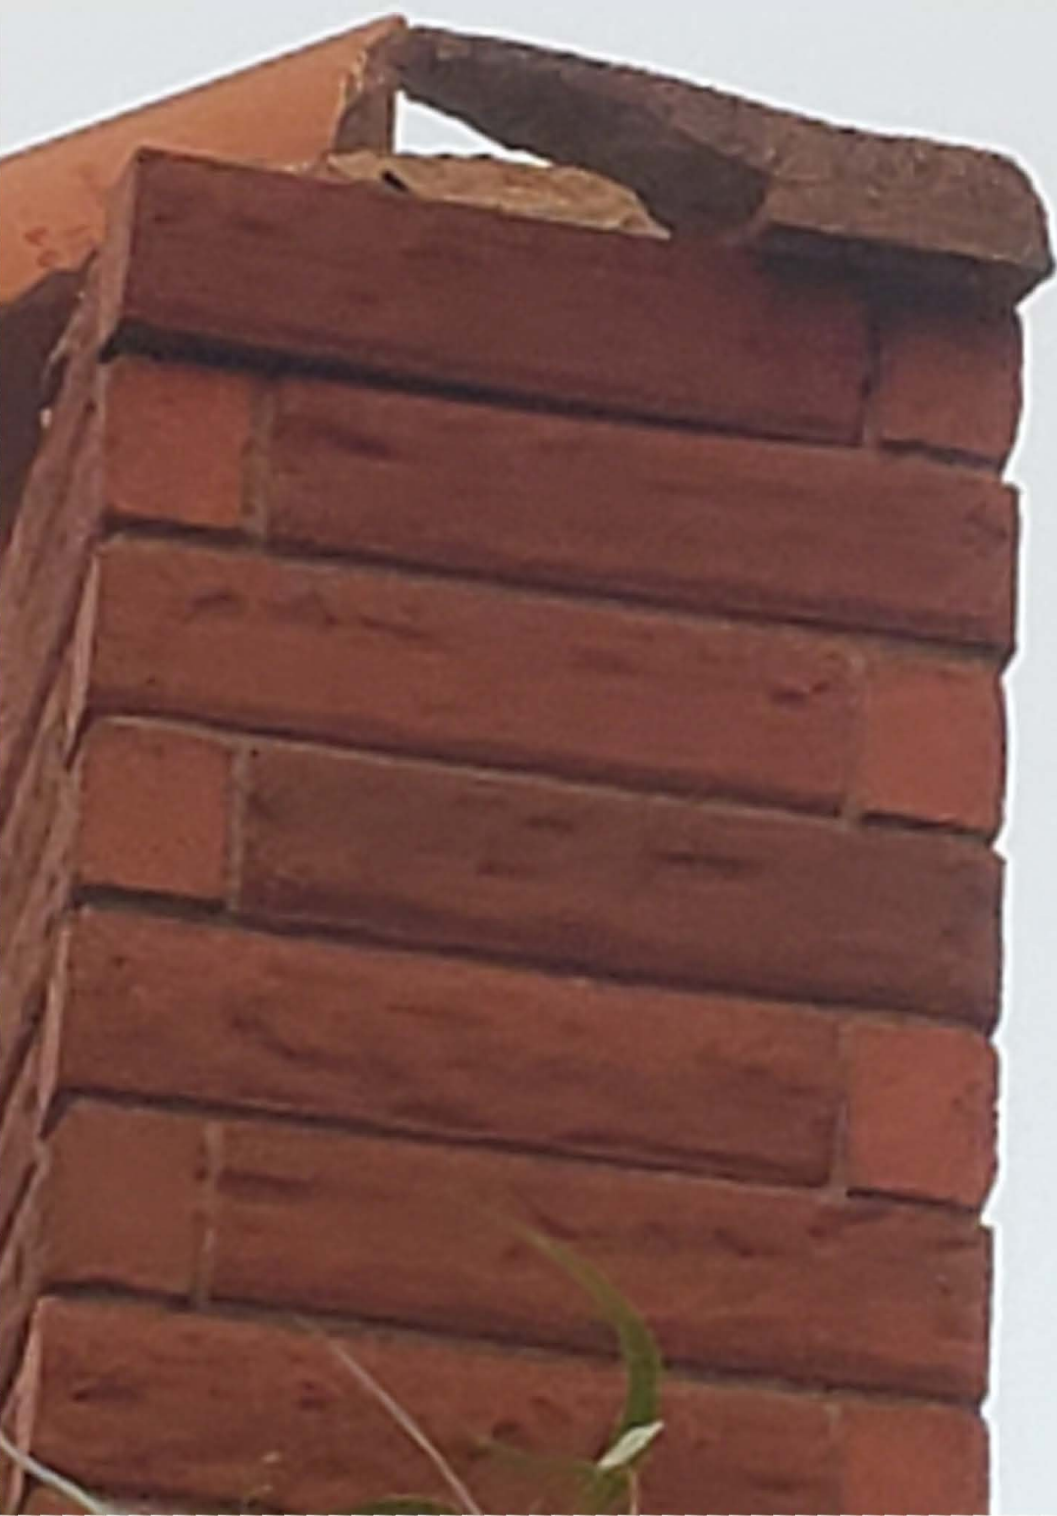
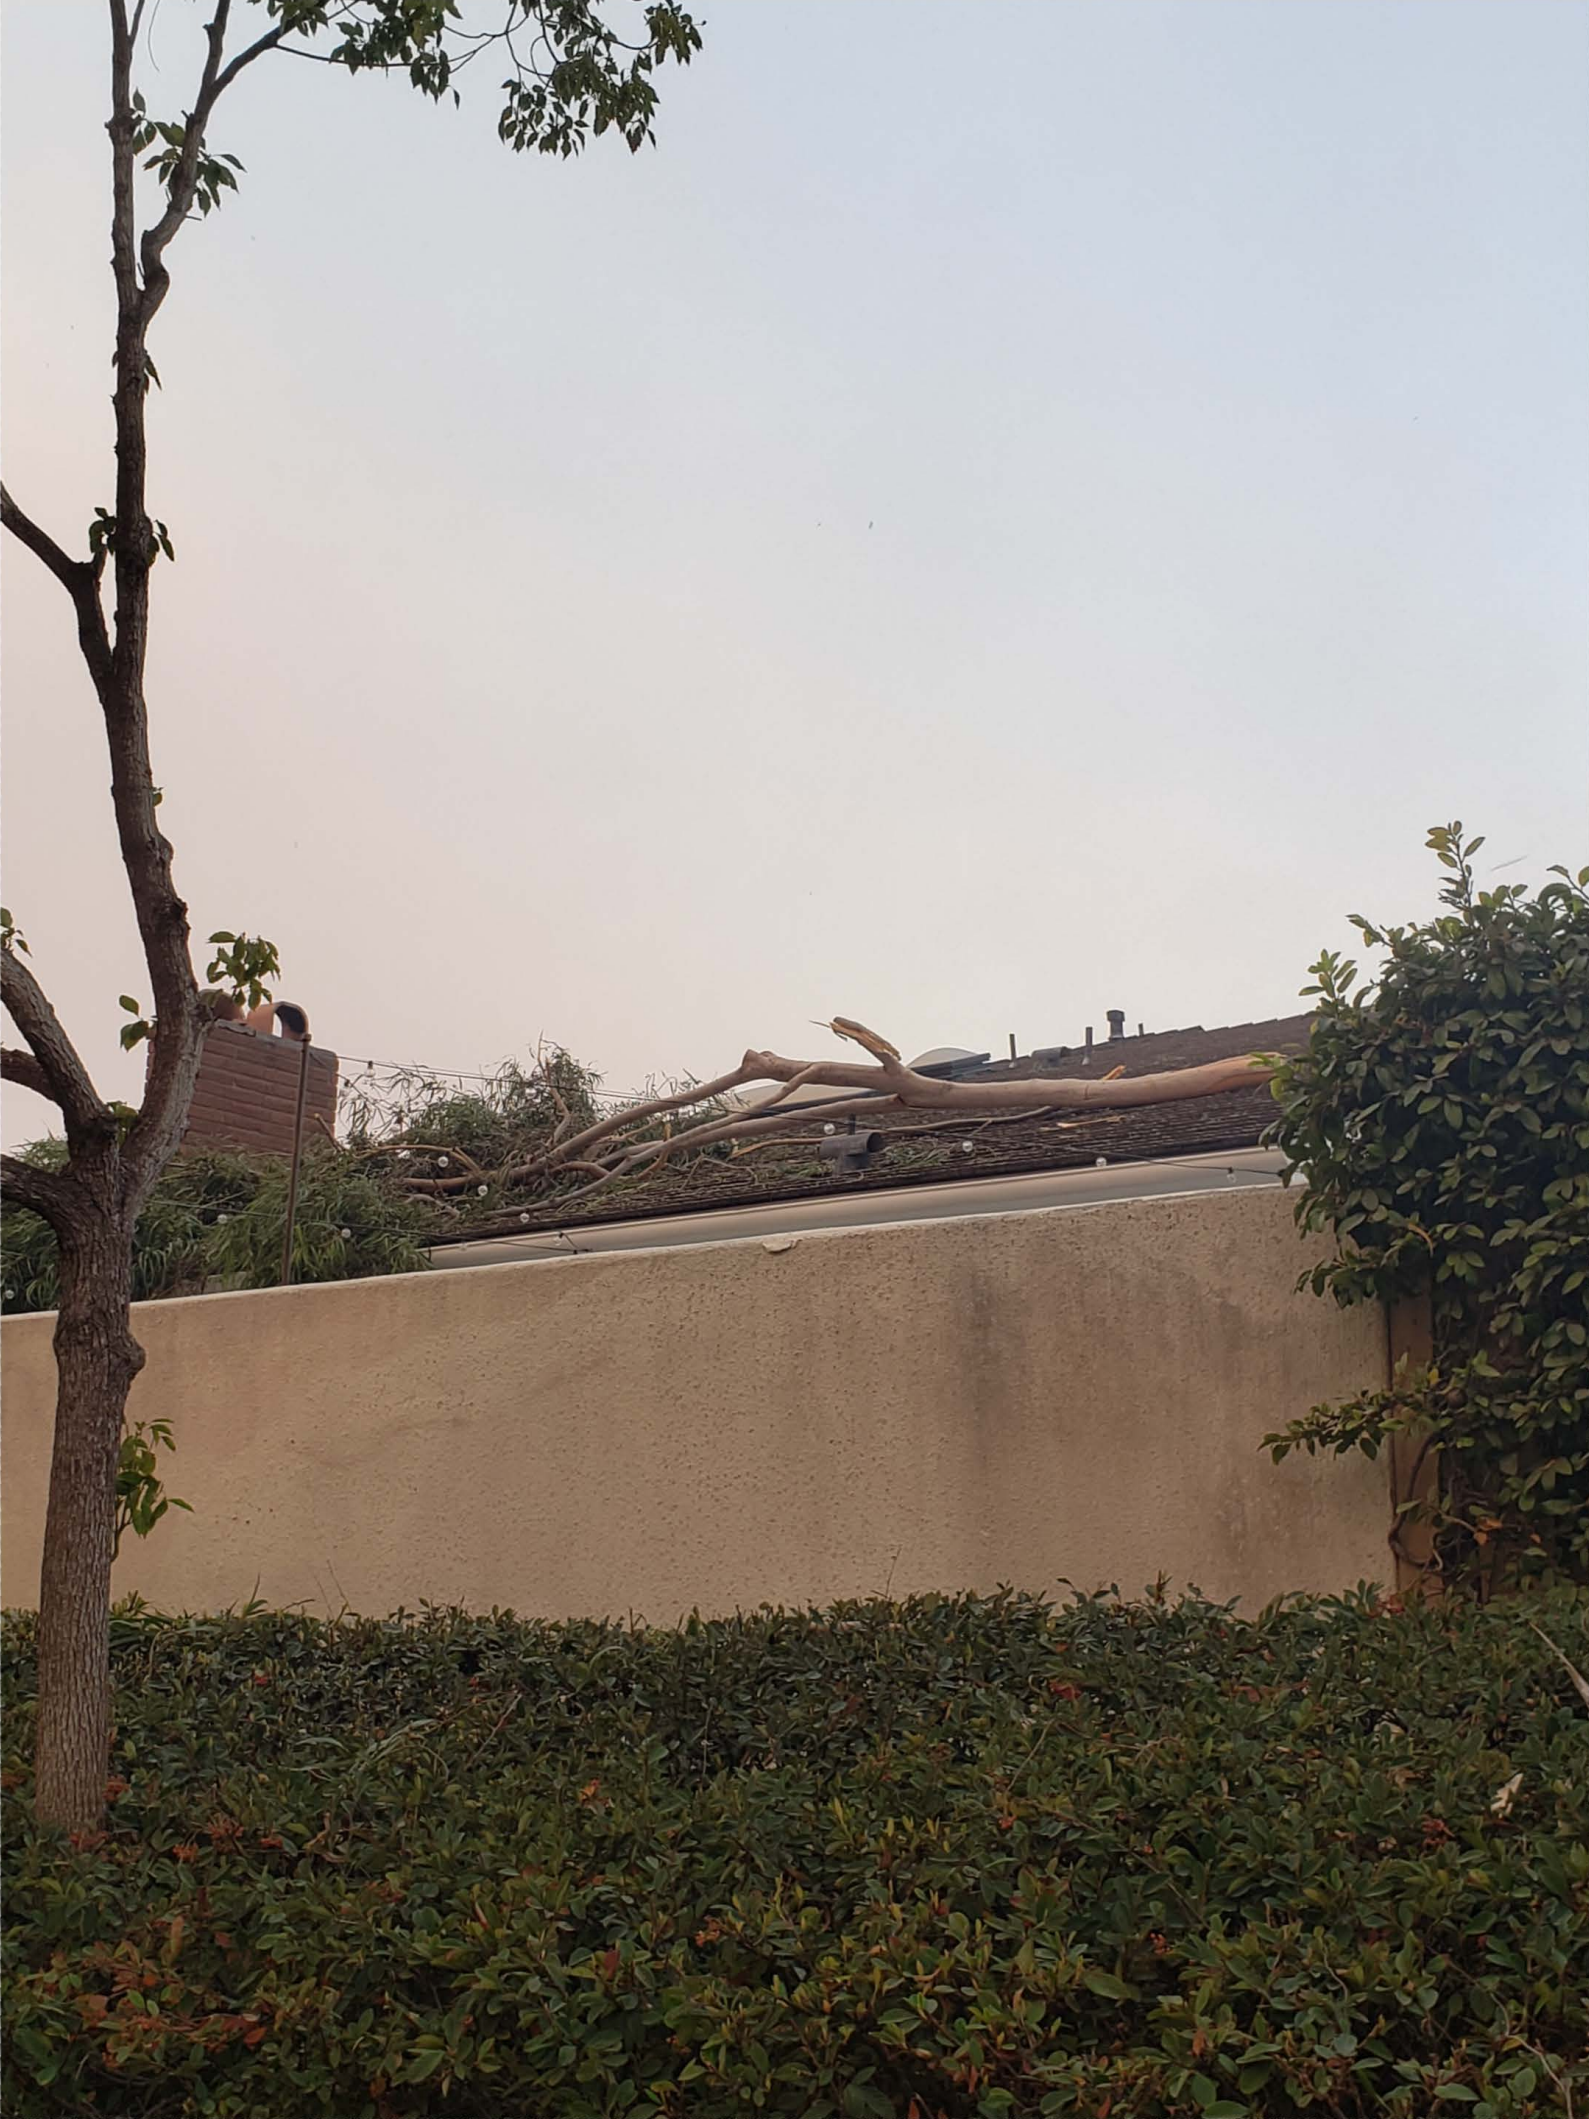
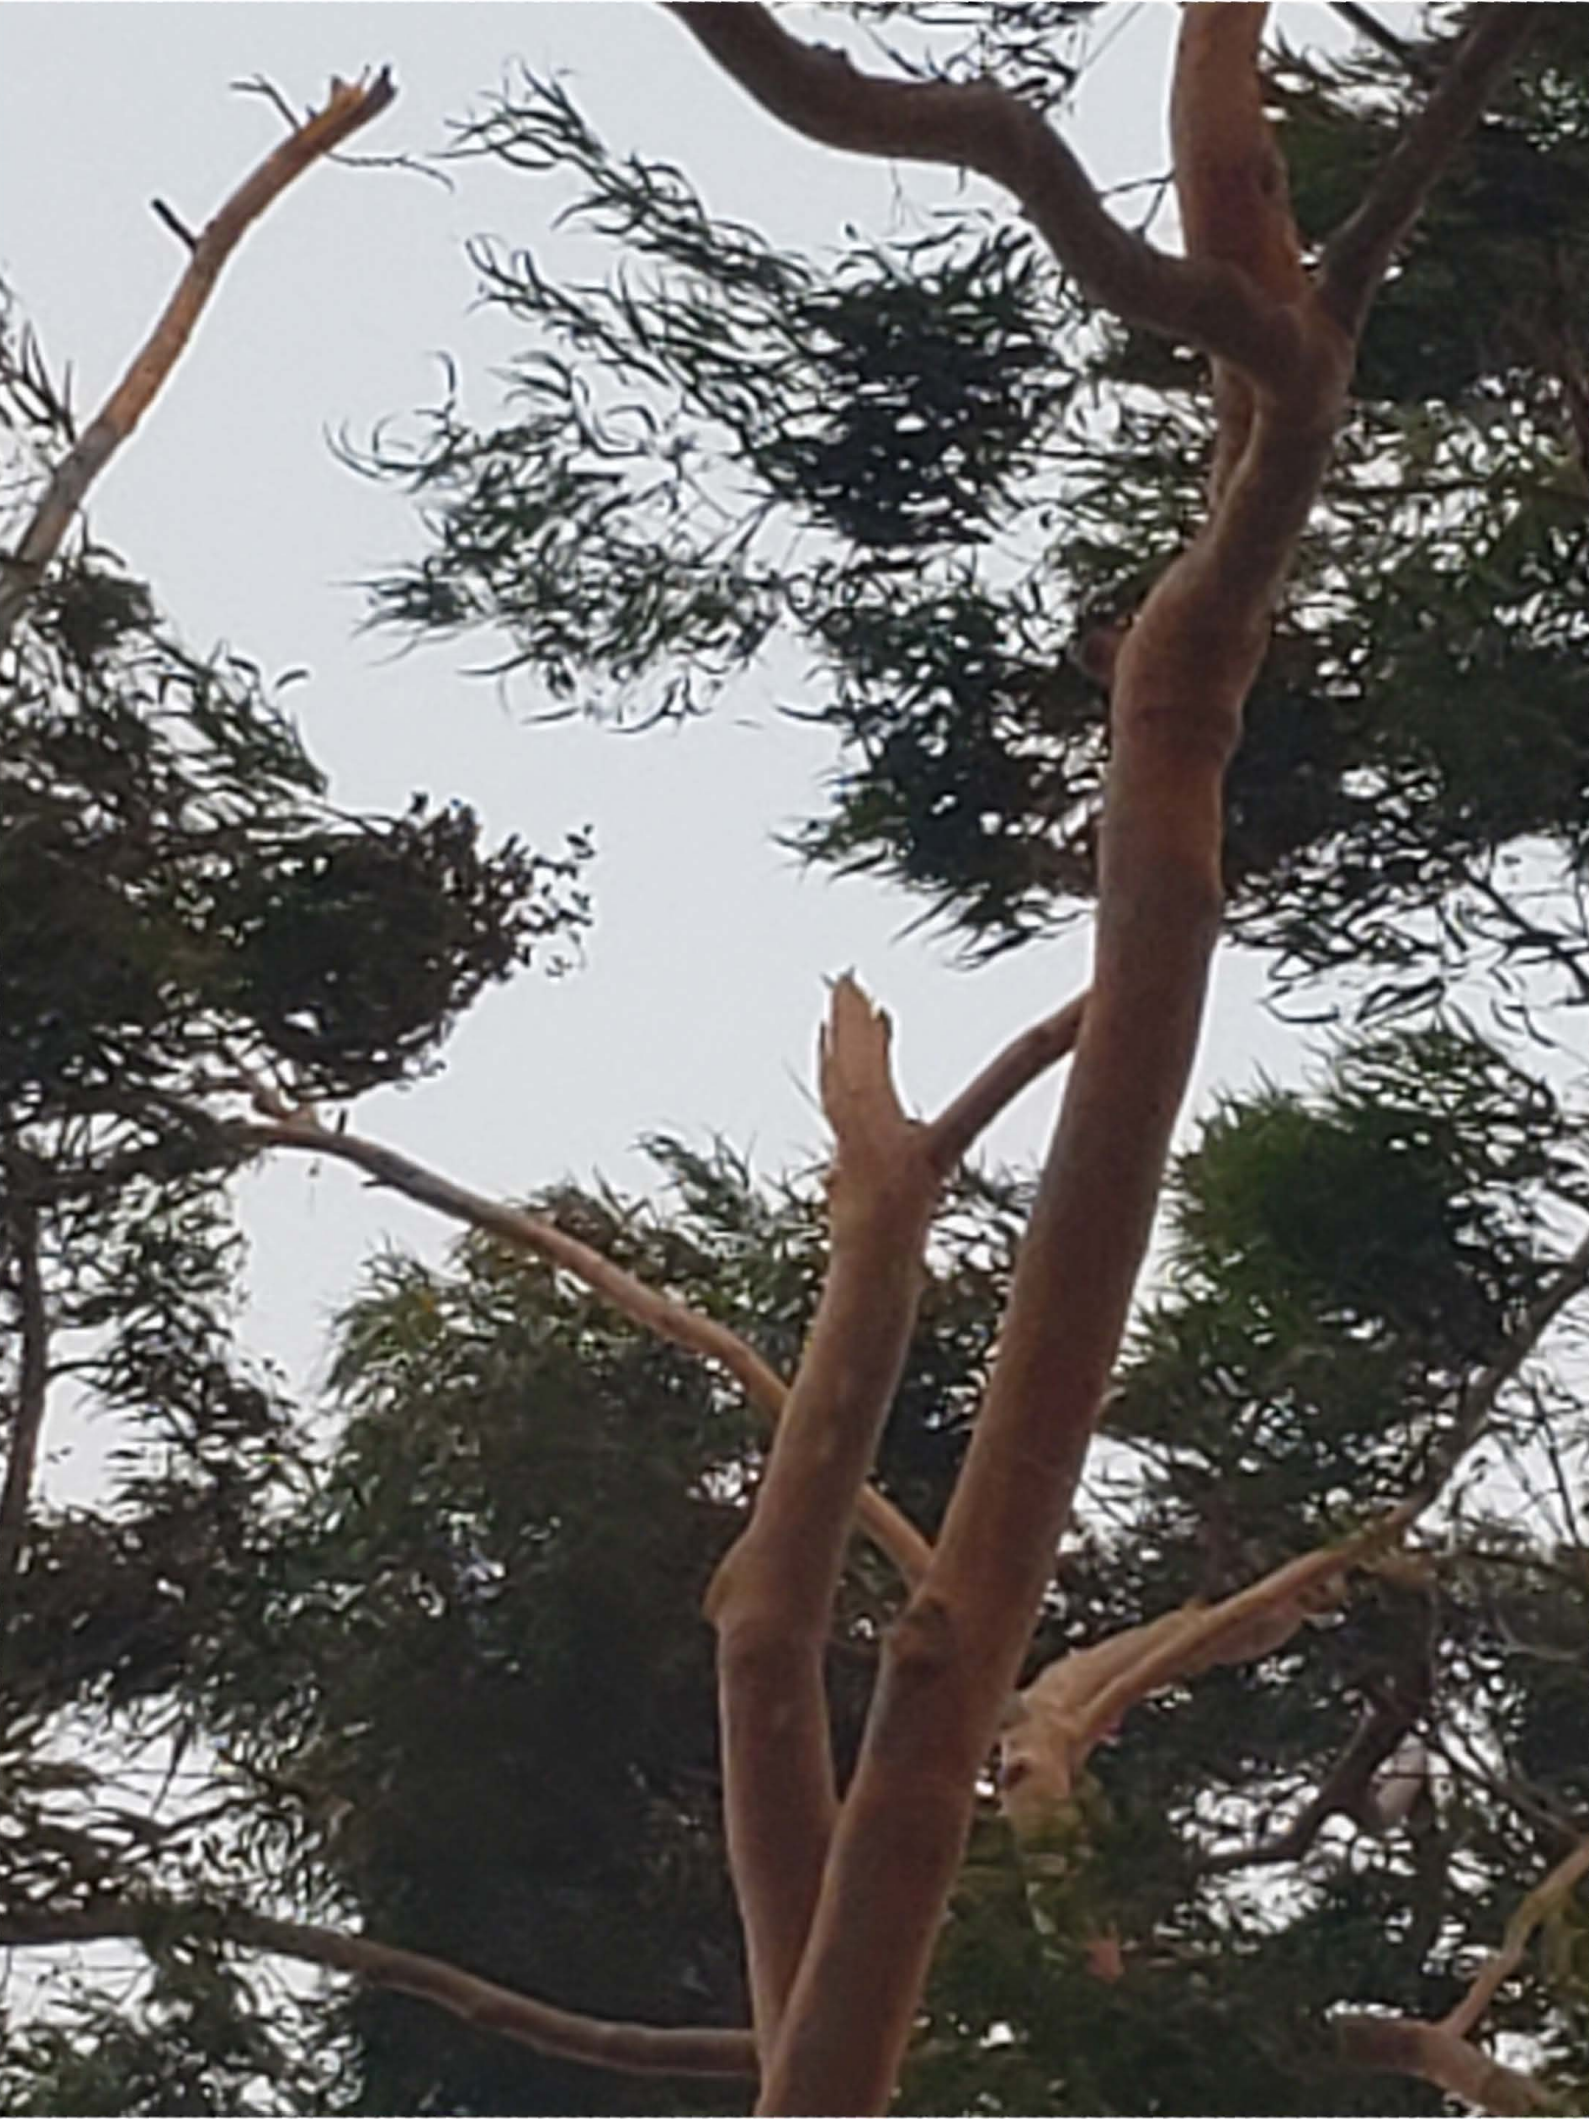
1848 Port Abby Place
10/26/20

We have had multiple scares from falling branches during wind storms over the past several years. The most significant occurred in October 2020 during when 30-40mph gusts resulted in an approx. 30ft+ branch breaking off of the tree and falling onto our roof in the early hours of the morning. The branch landed less than 10 feet from our master bedroom where our family was reading a book together before the elementary school day. We were very fortunate nobody was physically injured, but the falling branch caused approx. \$3,000 to our roof and chimney – a cost we covered – in addition to introducing anxiety during future windstorms, which are seasonally common to the area. Since that day, whenever winds have picked up above 30pmh we have felt unsafe in our home. Most recently, during Hurricane Hilary (August 20th 2023, the night prior to the first day of school), winds picked up to over 50pmh. Fearful of large debris falling from the tree, our family found a place to stay in Irvine out of an abundance of caution. We returned the next morning to several large branches which had broken off and landed in our yard and the nearby sidewalk.
