City of Newport Beach - Ocean Piers Inspection and Design Services

#### Subject: Request for Proposals (RFP NO. 24-83) Ocean Piers Assessment and Design Services

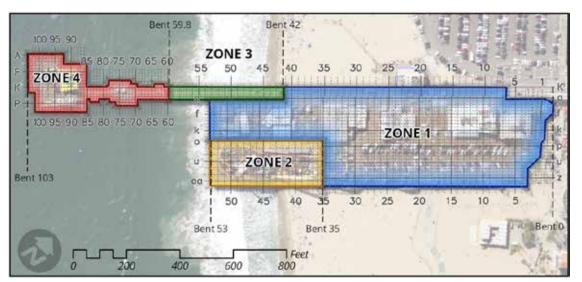
Figure 4-1: Pier Area Identification System

To achieve acceptable and safe results, M&N used two four-person teams for the Above Water (AW) and Underwater (UW) inspections. AW inspections took place between July 24 and September 7, 2018. UW inspections took place between August 27 and August 31, 2018. For the underwater portion of the inspection, inspectors used SSA (Surface Supplied Air) from our company boat, and inspectors used all necessary safety equipment and precautions when preforming the inspections. In addition, two iPads were utilized to gather digital data entry for both the UW and AW inspections. The Pier inspection went from Bent 0 though Bent 103, splitting up the inspection into four sections, as shown in Figure 4-1.

The existing Pier is configured in a general rectangular shape on the larger landside portion and transitions to a narrower waterside approach and platform. Bents 0 through 53 form the larger landside abutment area while Bent 53 through 103 makeup the approach walkway that leads to the end platform and the west-end platform itself. The number of total piles that support the pier is approximately 2,180. The existing Pier has various previous repairs visible, which have been completed at various intervals in the past. This condition is typical for similar pier structures with regular maintenance cycles. Photos depicting the different Pier framing systems are provided below.

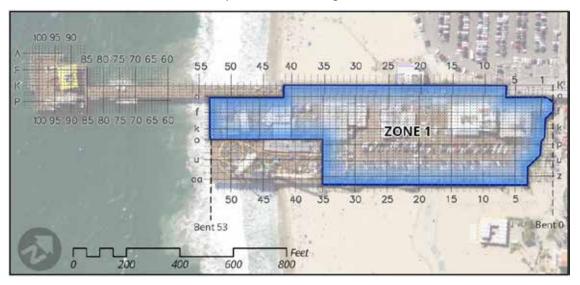
Figure 4-2: ZONE 1 Site Plan - Timber East-End Portion of Pier

This area of the Pier represents the remaining timber portion of the Pier; the newer concrete portions will be addressed later in the report. The Pier substructure and structural elements within this portion of the Pier include timber piles, timber pile caps, timber stringers, timber and steel lateral and transverse bracing, and timber deck elements. This portion of the Pier extends from Bent 0 from a concrete retaining wall to Bent 53, which includes in-water portions. Refer to Figure 4-2 below.

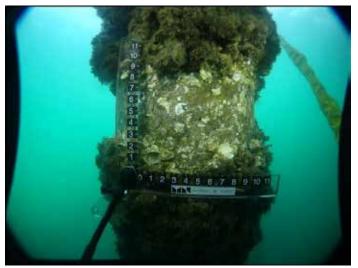
The timber piles were inspected above and below water. Below water inspection comprised a Level I effort on all piles, and Level II effort on 10% of all piles. Level I effort is defined as visual inspection only, and Level II involves the removal of marine growth in three 1-foot wide bands near the waterline, at middepth, and near the mudline, as seen in Photo 4-7.

Photo 4-7: Typical timber pile condition under water (Level II inspection effort).

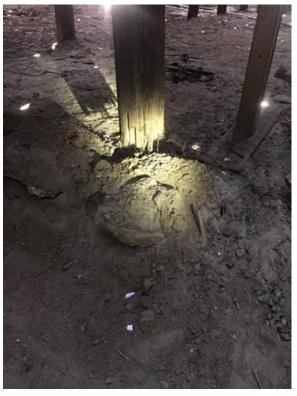
**ZONE 1 - Timber Pile Severe Defect,** Photo 4-8: Pile 11.5q

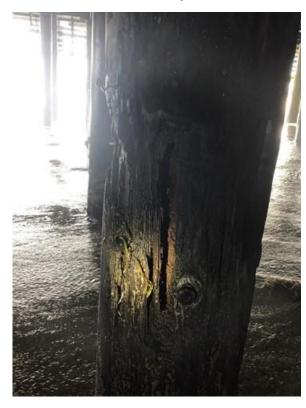
Photo 4-10: ZONE 1 - Timber Pile Major Defect, Pile 46f

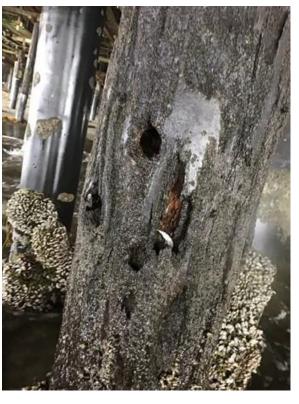
Photo 4-11: ZONE 1 - Timber Pile Moderate Defect, Pile 47c

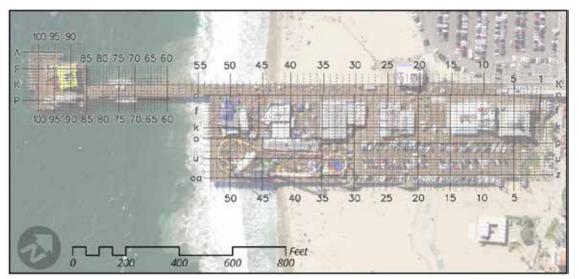
Figure 5-1: Site Plan - GIS Map Used for Field Investigations

The digital inspection records detailing the existing pier condition ratings and observations are provided as an ESRI (Environmental Systems Research Institute) file GIS geodatabase. The geodatabase contains the geometry of the Pier elements, inspection records, and inspection photographs. Relationships configured within the geodatabase link the structural elements to the inspection photographs. The ESRI file geodatabase must be viewed using ESRI software such as ArcMap and ArcGIS Pro. The inspection photos are also provided separately, as a zip file, so they can be viewed outside of the ESRI software suite. Refer to figures in Appendix B for a summary.
