## Survey Report

### Crystaliner 29

### Sea Watch III

<b>FILE NUMBER.....</b>	24-1023
<b>DATE AND TIME OF SURVEY.....</b>	23 Oct 2024
<b>PLACE OF SURVEY.....</b>	Newport Beach, CA
<b>SURVEY PREPARED FOR.....</b>	Southcoast Shipyard
<b>TYPE OF SURVEY.....</b>	Condition and Value
<b>NAME OF VESSEL.....</b>	Sea Watch III
<b>OVERALL VESSEL RATING.....</b>	Above Average
<b>ESTIMATED MARKET VALUE.....</b>	\$40,000
<b>ESTIMATED REPLACEMENT COST.....</b>	200,000
<b>HULL IDENTIFICATION NUMBER (HIN)...</b>	Not Readable
<b>CALIFORNIA REGISTRATION NO.....</b>	CF 2303 XC
<b>MAKE OF VESSEL.....</b>	Crystaliner
<b>MODEL OF VESSEL.....</b>	29
<b>BUILDER.....</b>	Crystaliner Corp, Costa Mesa, CA
<b>YEAR BUILT.....</b>	Information not Available
<b>HULL MATERIAL.....</b>	Fiber Reinforced Plastic
<b>HULL TYPE.....</b>	Modified V
<b>LENGTH OVER ALL (LOA).....</b>	29' 5" (per BUC Guide)
<b>BEAM.....</b>	11' 0" (per BUC Guide)
<b>DRAFT.....</b>	2' 6" (per BUC Guide)
<b>DISPLACEMENT.....</b>	11,000 Lbs (per BUC Guide)

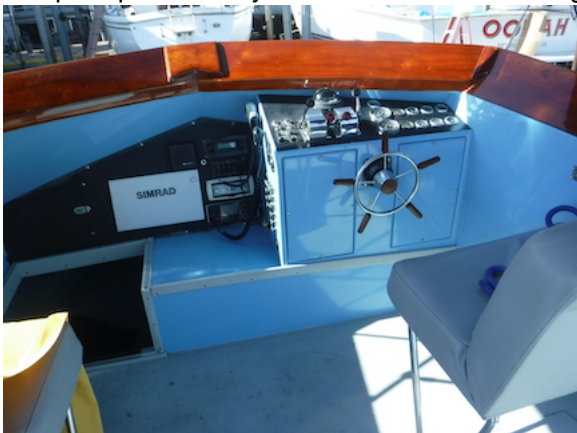
The vessel is operated from the cockpit offering good visibility with a full set of controls and gauges. The cockpit is protected by a canvas bimini that is in good condition.

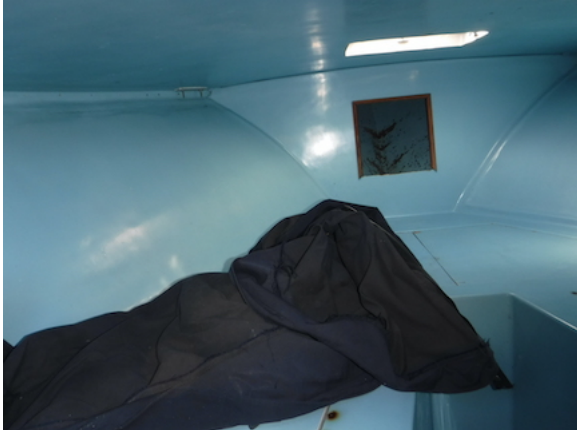
The interior is in good condition with typical wear. The cabin lights are operational. The skylight is operational with good seals. The cabinets are in good condition. The upholstery in the cockpit is in good condition.
