CITY OF NEWPORT BEACH

Tree Removal or Reforestation Application

The applicant, Geoffrey Darby (residing at 901 Chestnut Place), contacted the City to request the removal of a Manna Gum Eucalyptus (*Eucalyptus viminalis*) located on the Alta Vista side of his home due to previous root damage, unbalanced canopy, limited scaffolding root structure on the street side and perceived elevated risk of a whole tree failure.

Figure 1
Tree Location Exhibit
901 Chestnut Place

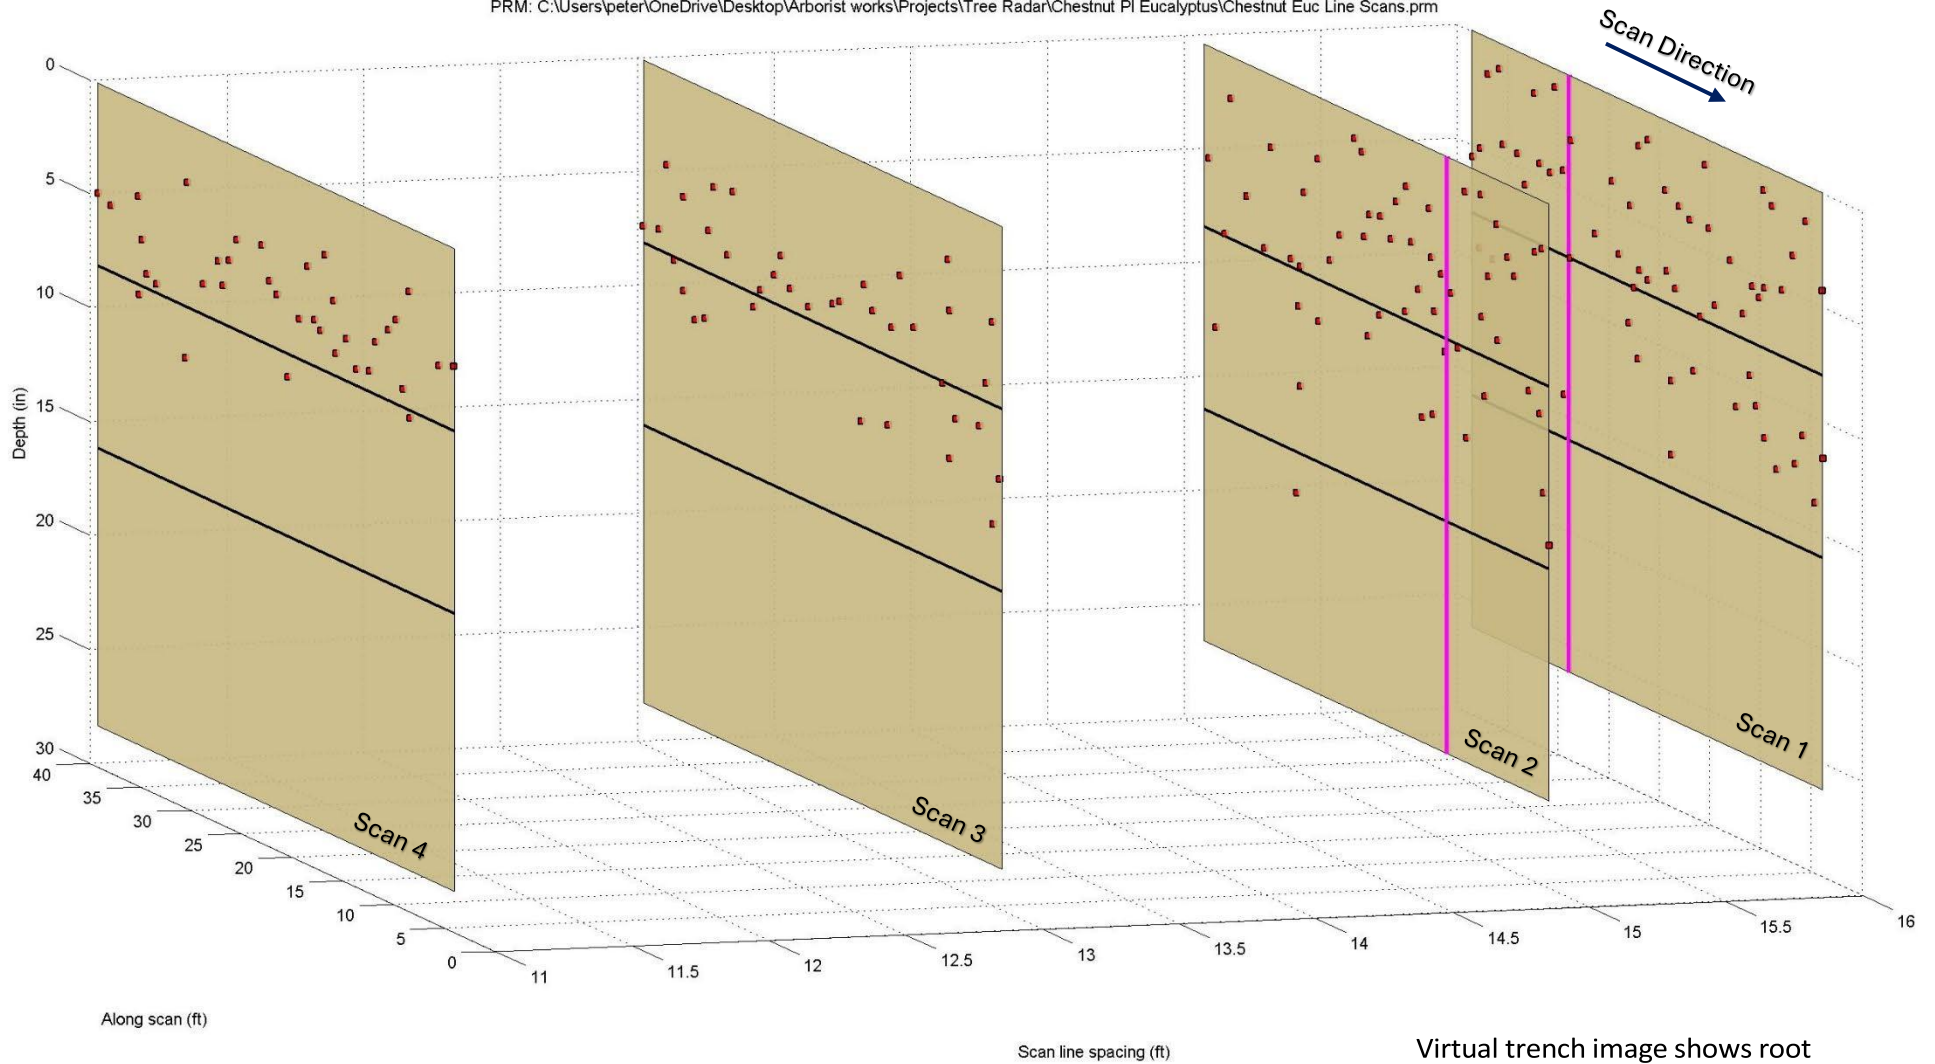
Virtual trench image shows root detections within a vertical plane for each scan line.

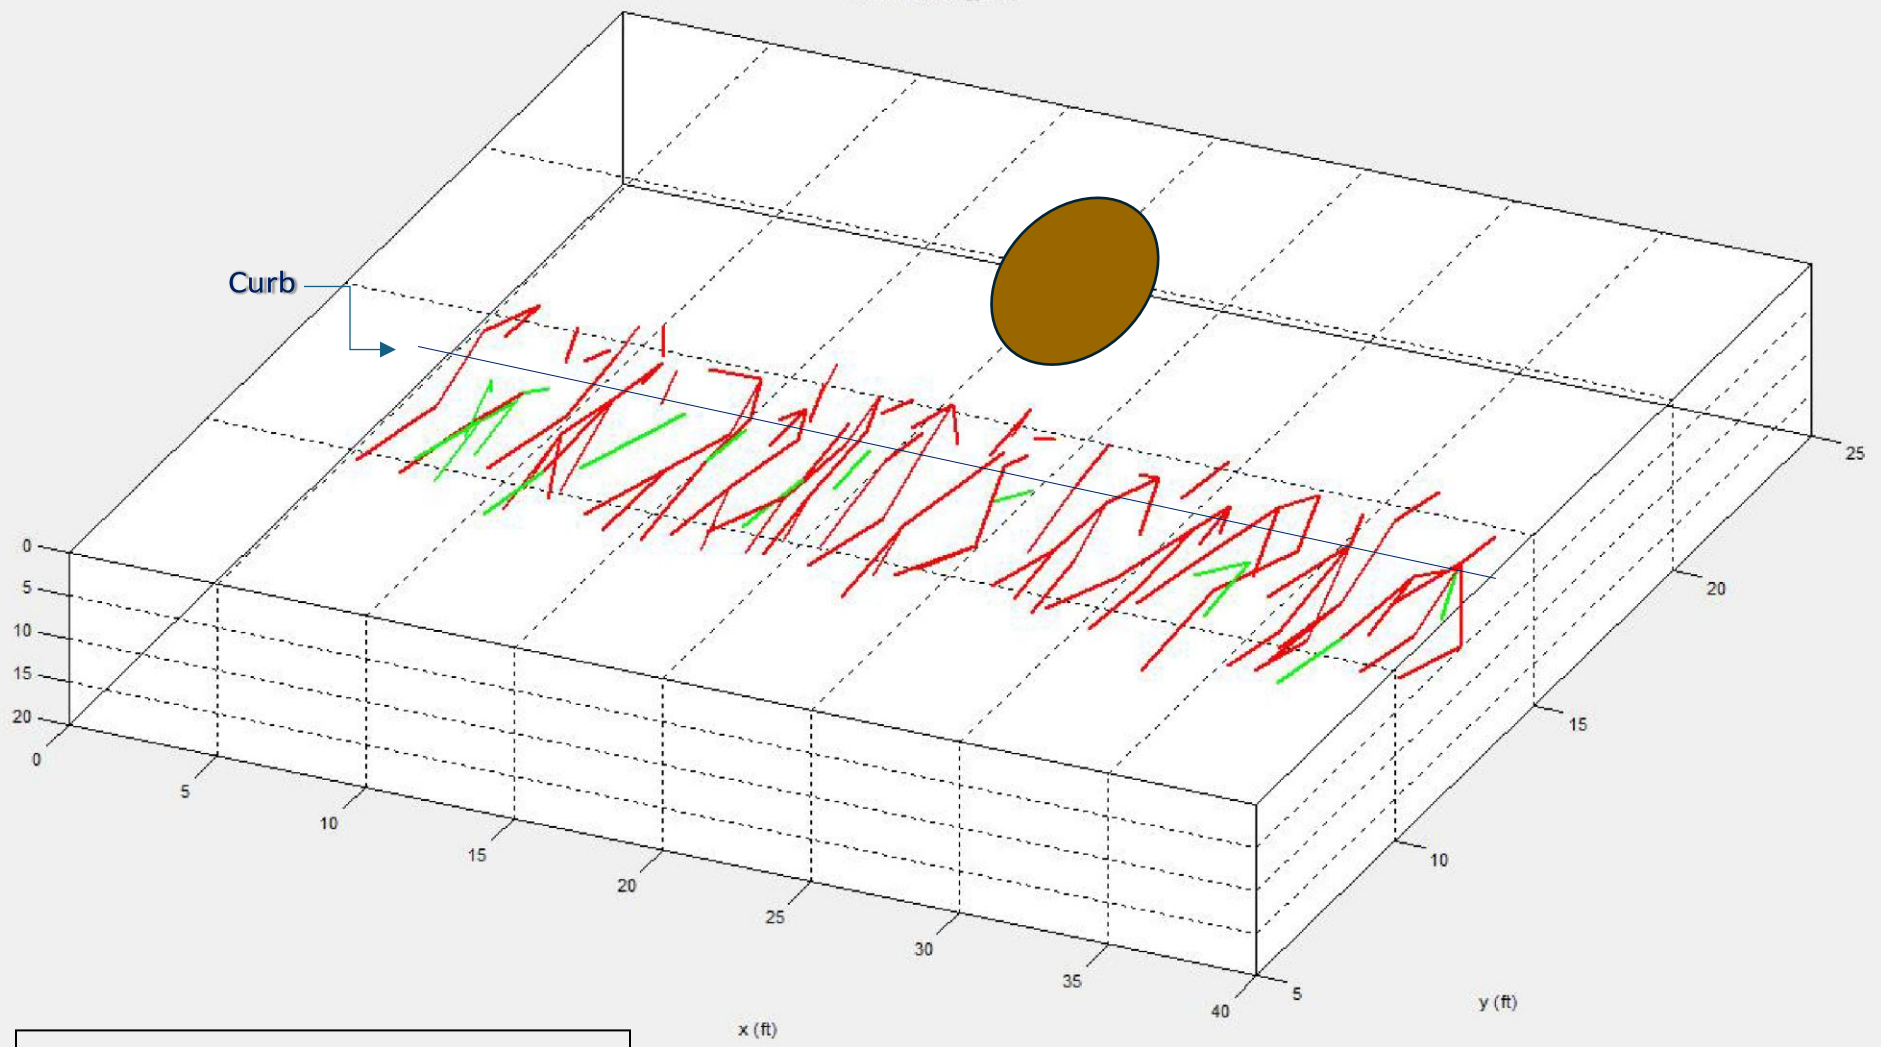
Root Morphology Map

Image shows possible root morphology based on estimated root depth. Red is 0-8" deep, Green is 8-16" deep. Blue is below 16'

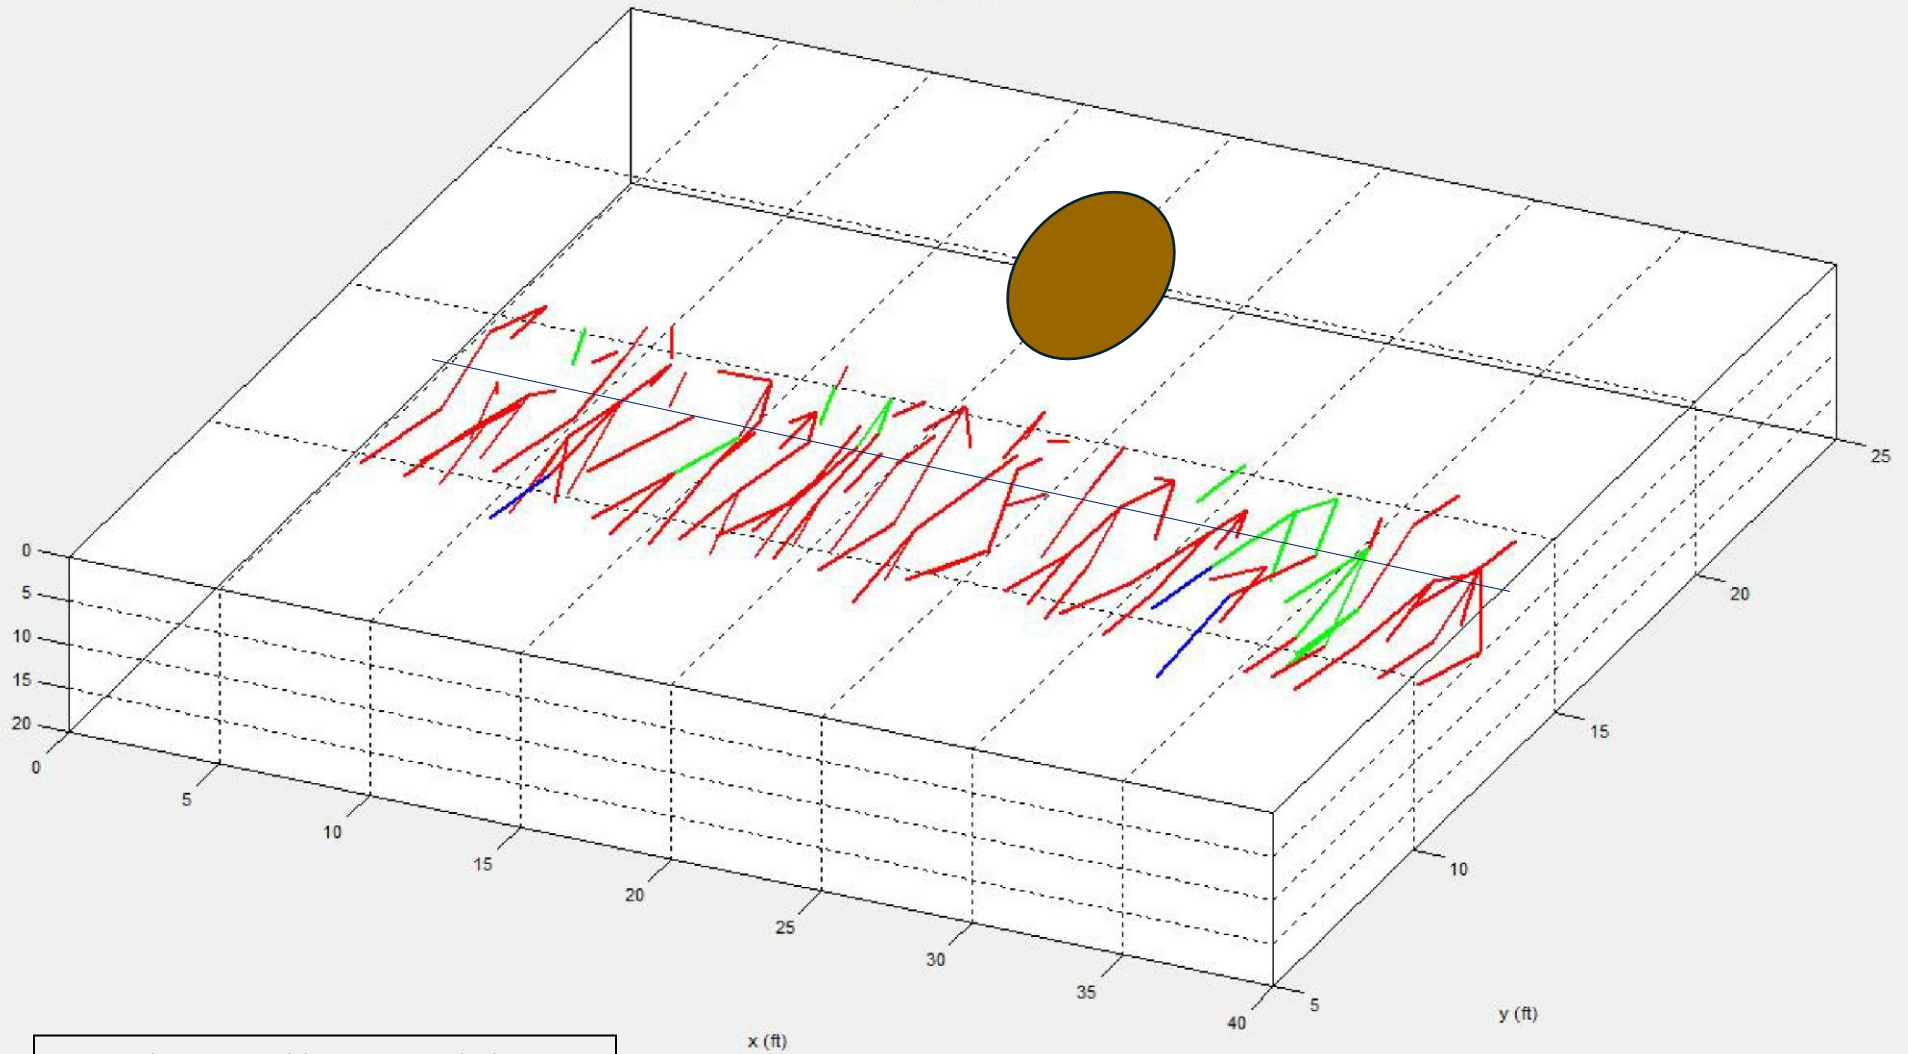
Root Morphology Map

Image shows possible root morphology based on estimated root size. Red is small; green is medium sized, blue is large

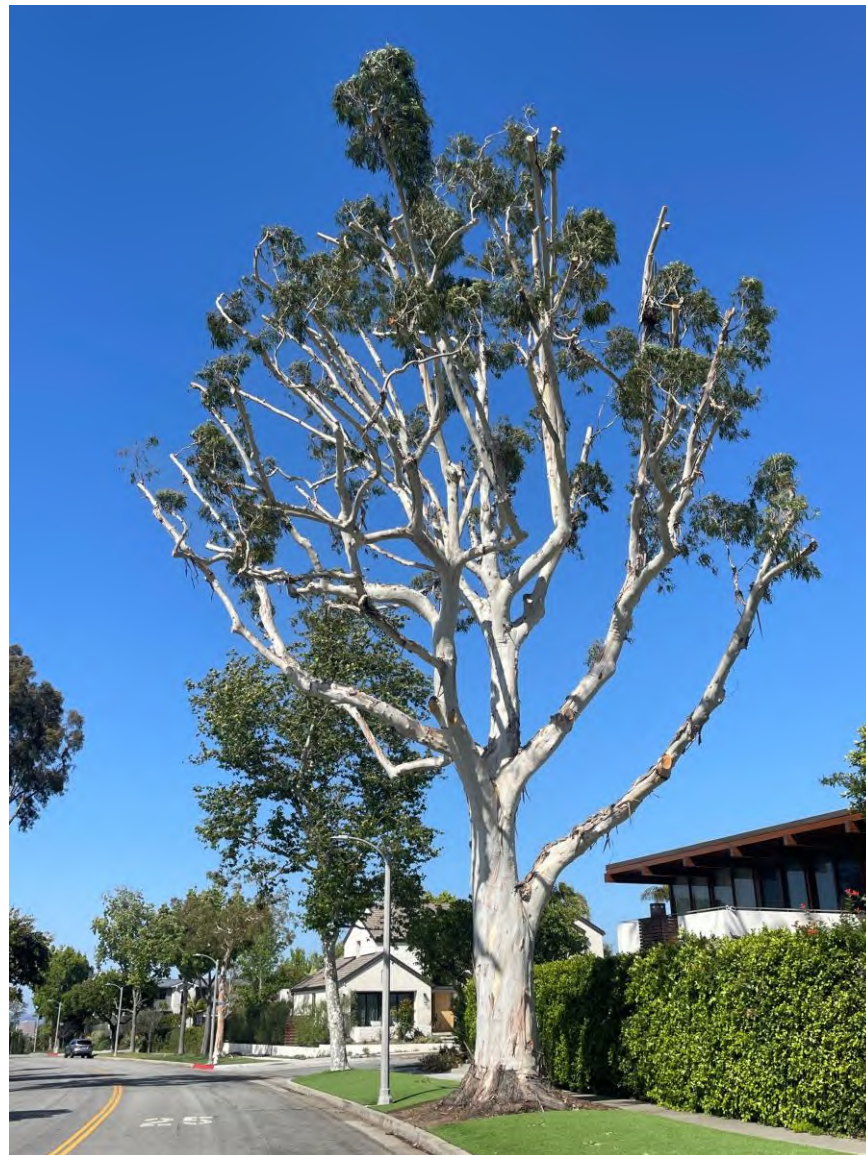
Site Observations: Dudek's site visit has confirmed the location and setting description are generally correct. The Dudek arborist observed a visual difference in color in the gutter directly adjacent to the tree indicating that the concrete had been repaired since the original infrastructure was installed. However, displacement or color difference was not observed in the curb as was described in the Arborist Report.

View of Tree ID 972864 facing northeast

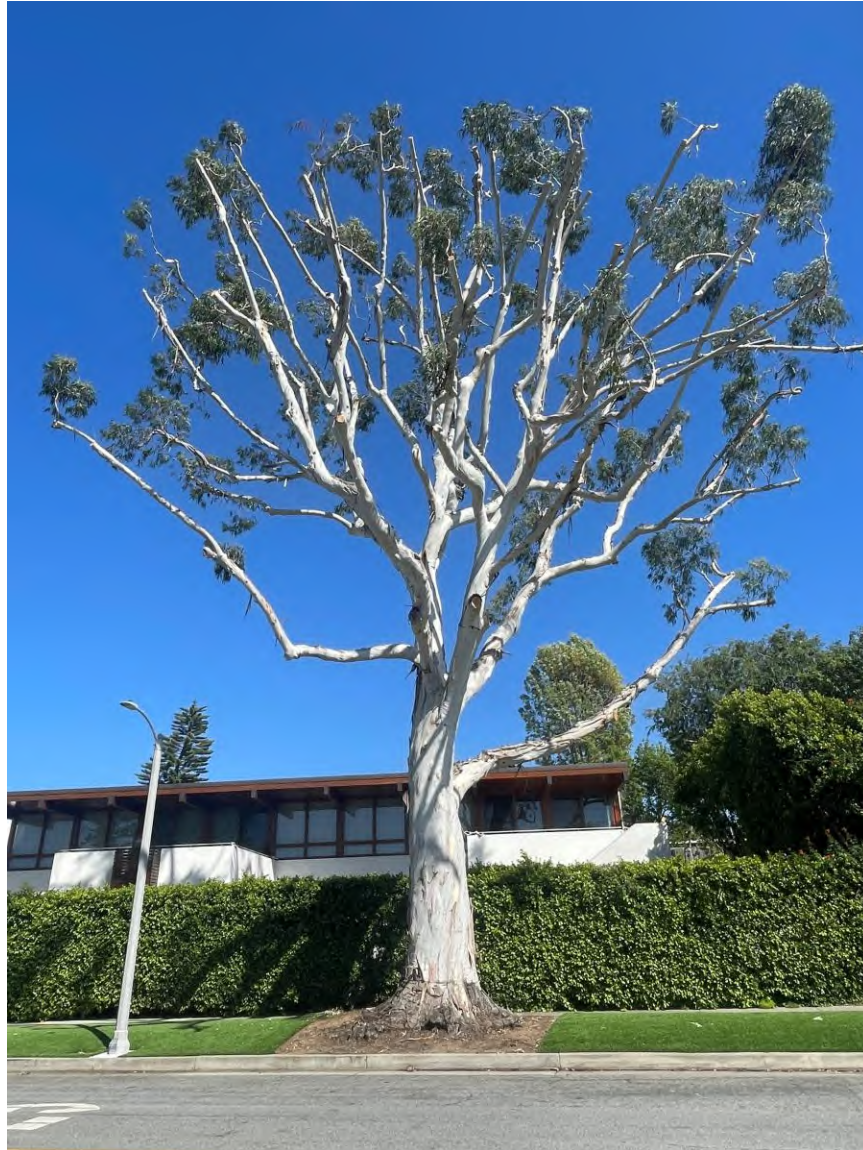
View of Tree ID 972864 facing east

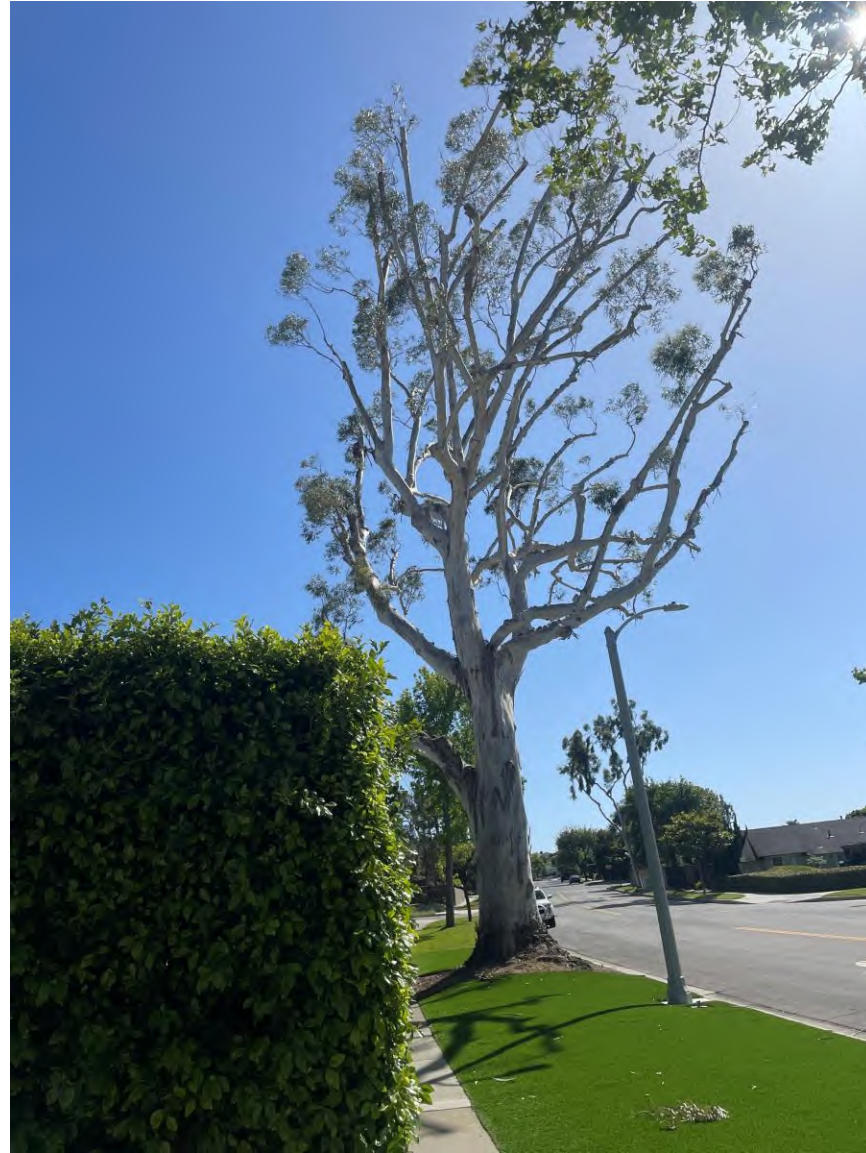
View of Tree ID 972864 facing southwest

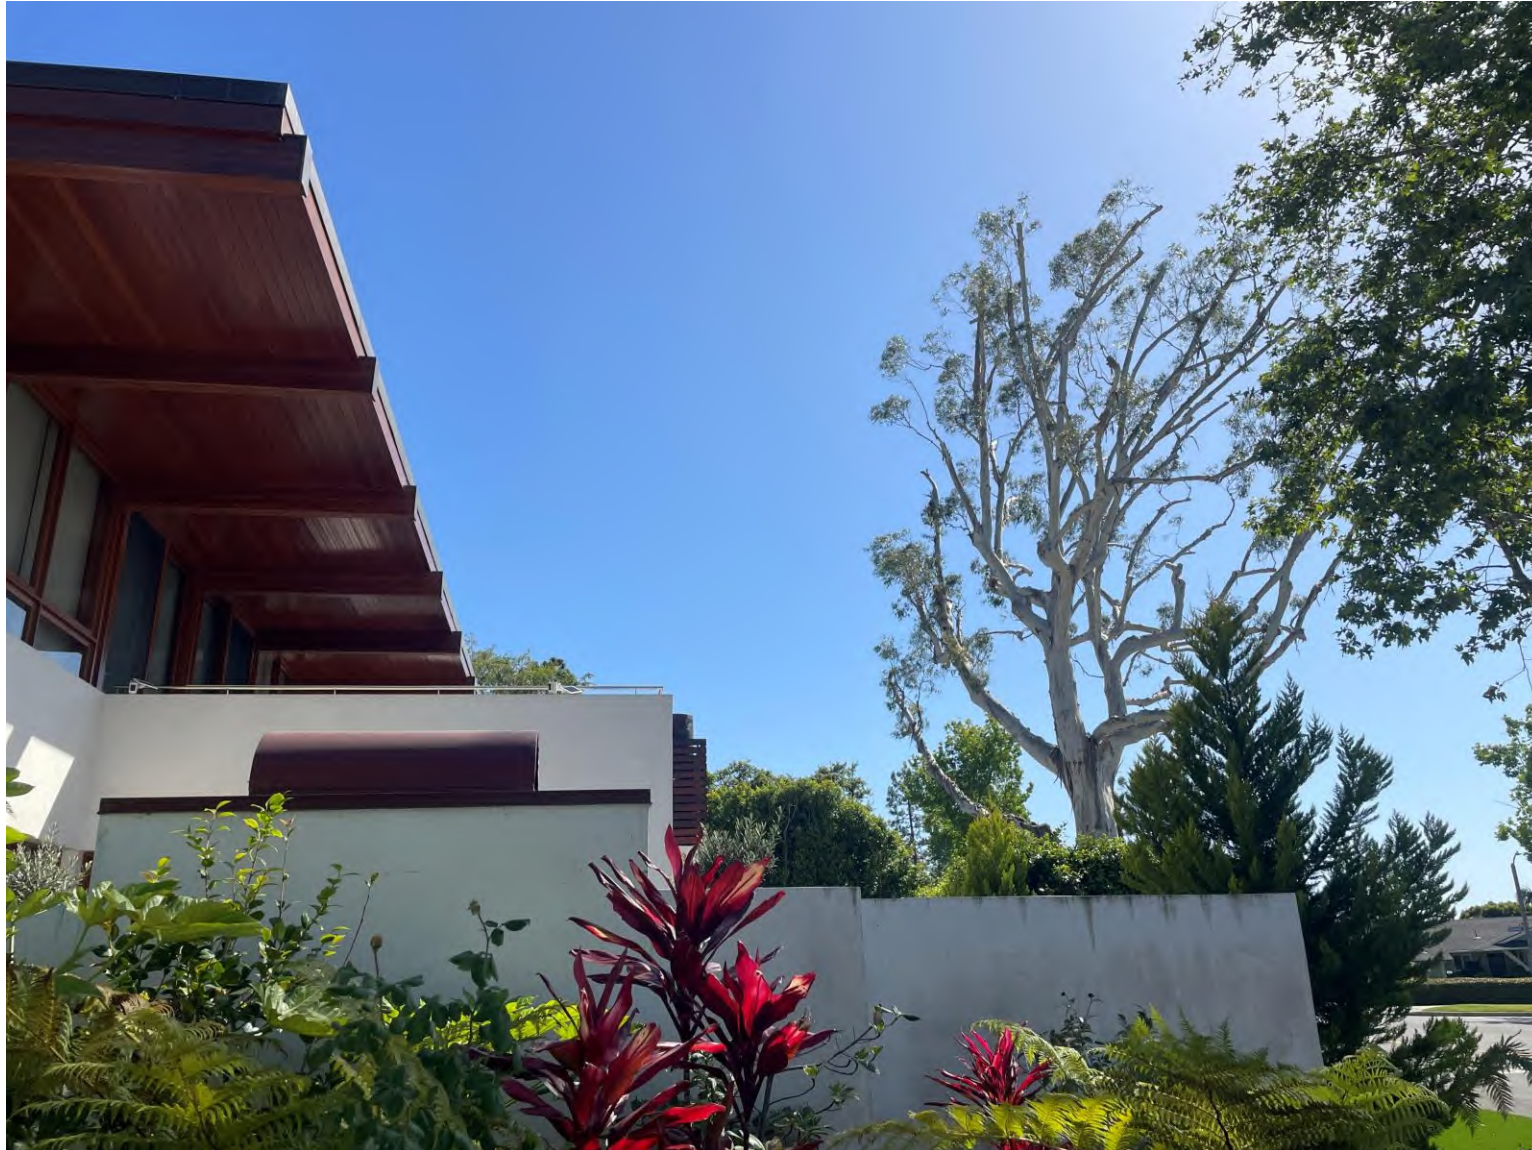
View of Tree ID 972864 in proximity to 901 Chestnut Place
