# Parks, Beaches, and Recreation Commission

September 3, 2019

## Marine Avenue Special Tree Removal Request

Public Works Department  
Municipal Operation Division

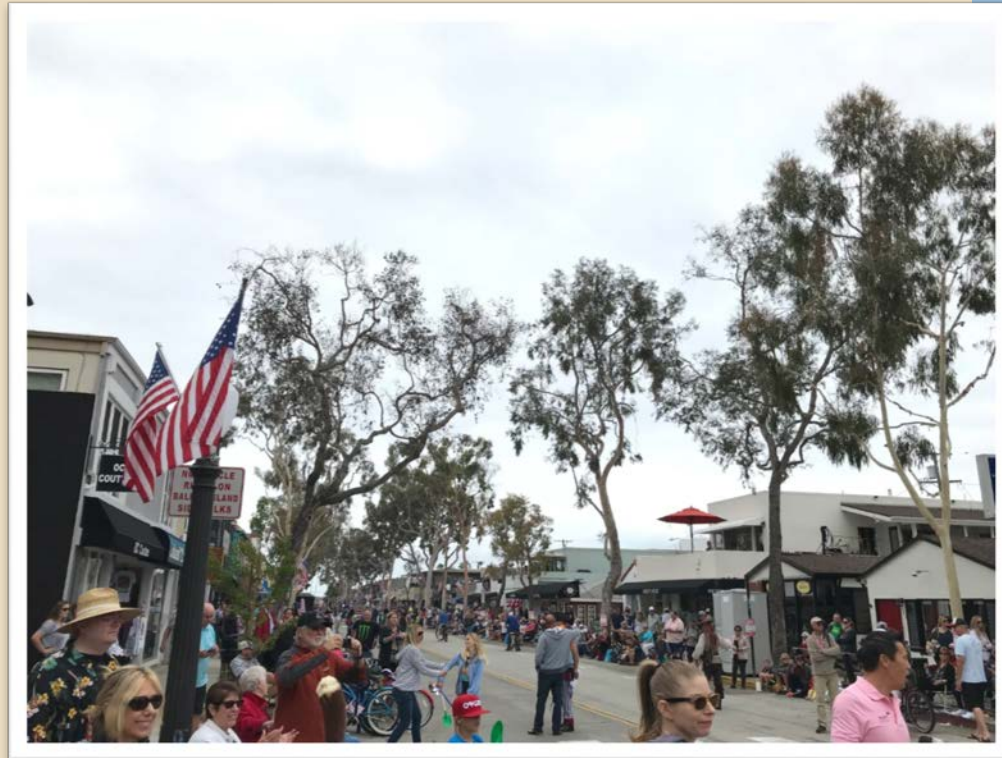
# Site Conditions

- Very Crowded Pedestrian Sidewalks and Street Parking underneath Trees on Marine Ave (*busy business, tourist area*)
- Small Tree Wells, surrounded by concrete in various states (*restricts air / water / nutrients to roots*)
- No Supplemental Irrigation
- Shallow Available Root Growth Area due to High Salt Water Table
- Years of Tree Root Crowns covered by Decomposed Granite, then more recently Artificial Turf (installed by BIIA).
- Canopies in Close Proximity to Buildings / Roofs and Signage

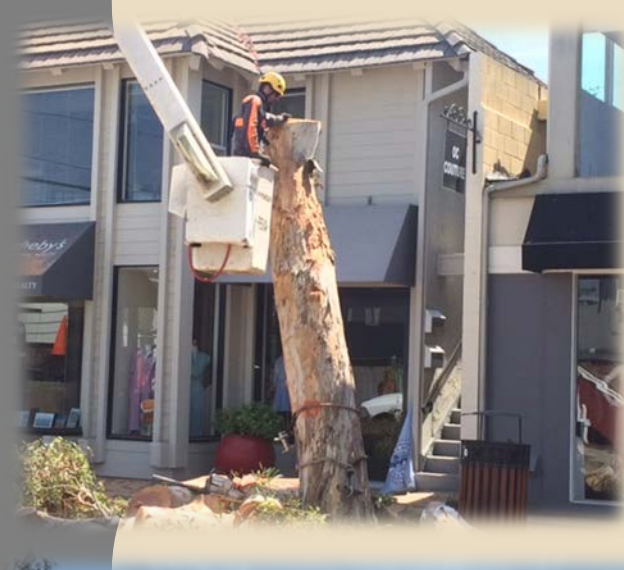
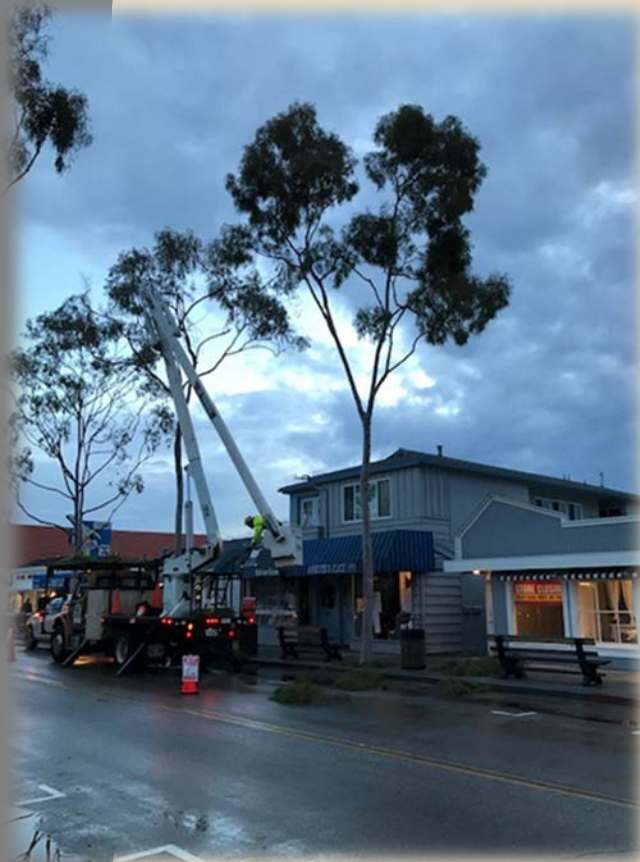
# Maintenance History

- For the past 25 years, the City has Pruned all Marine Ave Trees Annually
  - This occurs over multiple days in the early morning, so as to minimize disruption to businesses - last service on 3/11/19- 3/12/19)
- Over the past 25 years, the City has Removed and Replaced approximately 30% (20-25) of the Eucalyptus Trees
  - In May 2017, based on Risk Assessments, PB&R approved the removal of two Special Eucalyptus Trees (at 318 and 326 Marine)
- The City Responds annually to Large Limb Breakages, typically during Storm Events and Santa Ana Winds
- Prior Replacements were composed of Lemon-Scented Gums & Water Gums Eucalyptus Trees, and more recently African Tulip & Gingko trees
- Considering the location, older trees are reaching the end of their typical lifespan (50-60 years)

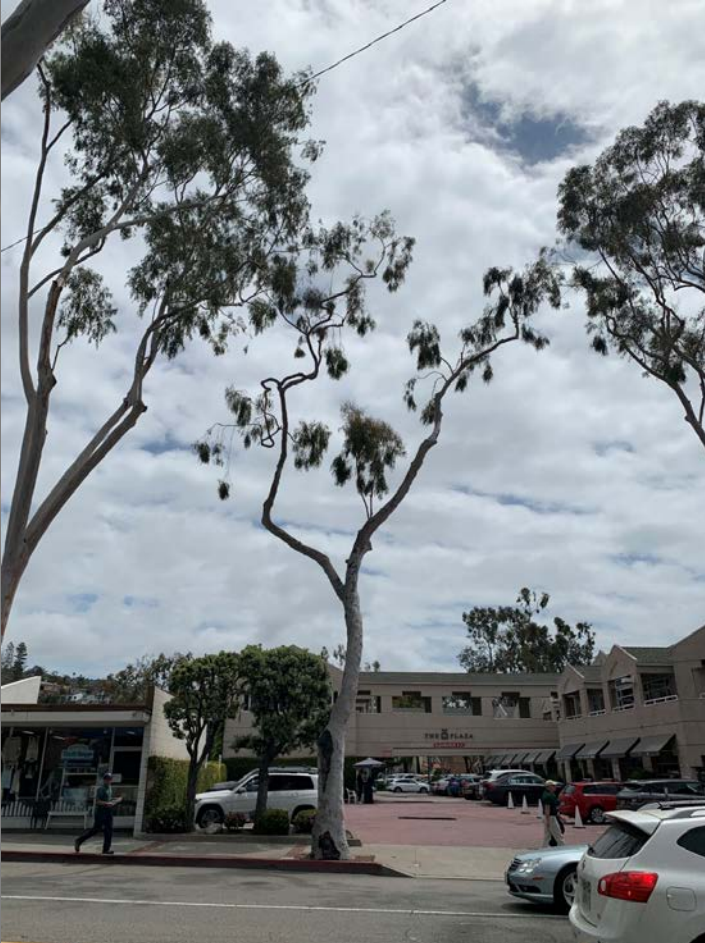
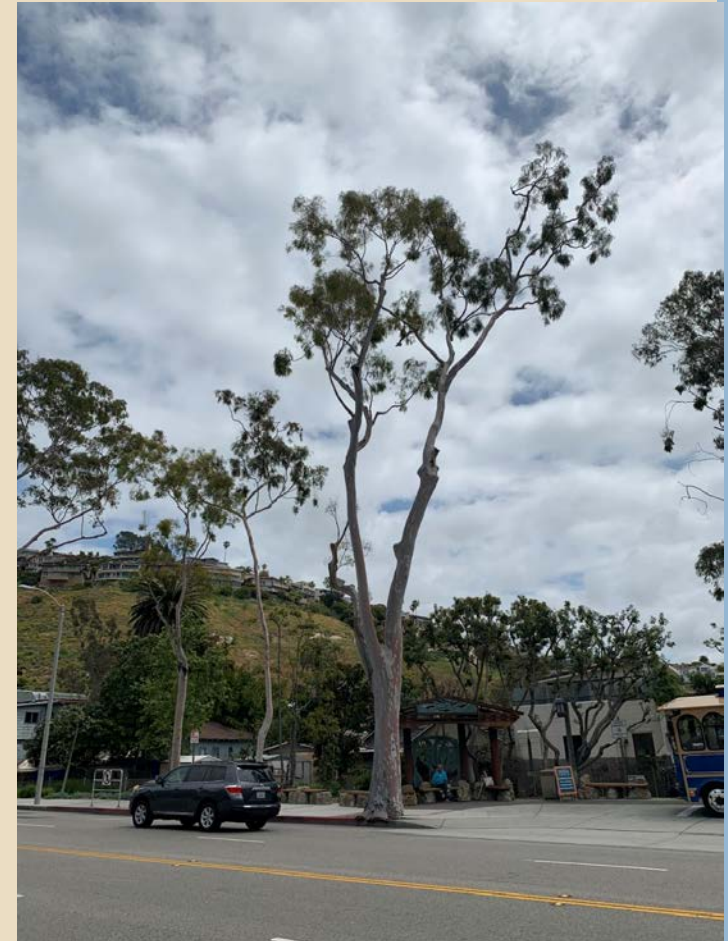
Laguna Beach  
Broadway  
Street

High  
Pedestrian,  
Parking and  
Vehicle Traffic

Similar  
Conservative  
Pruning

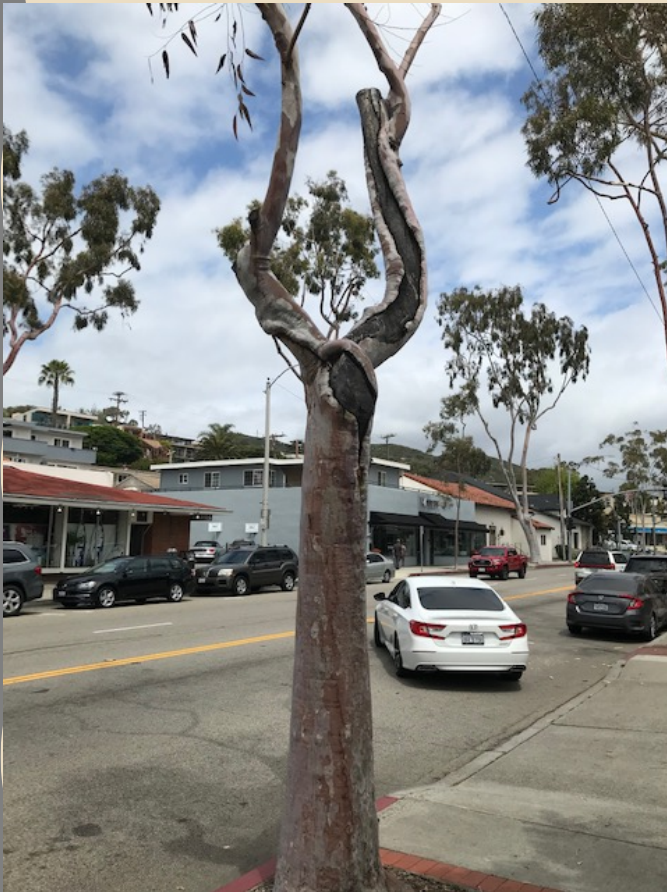
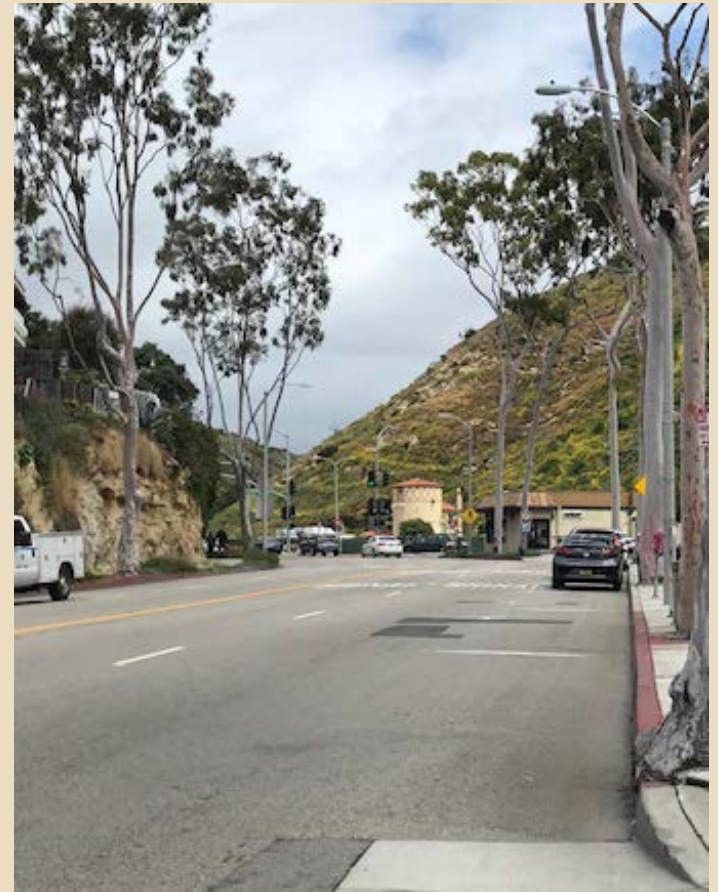
Laguna Beach  
Broadway  
Street

High  
Pedestrian,  
Parking and  
Vehicle Traffic

Similar  
Conservative  
Pruning

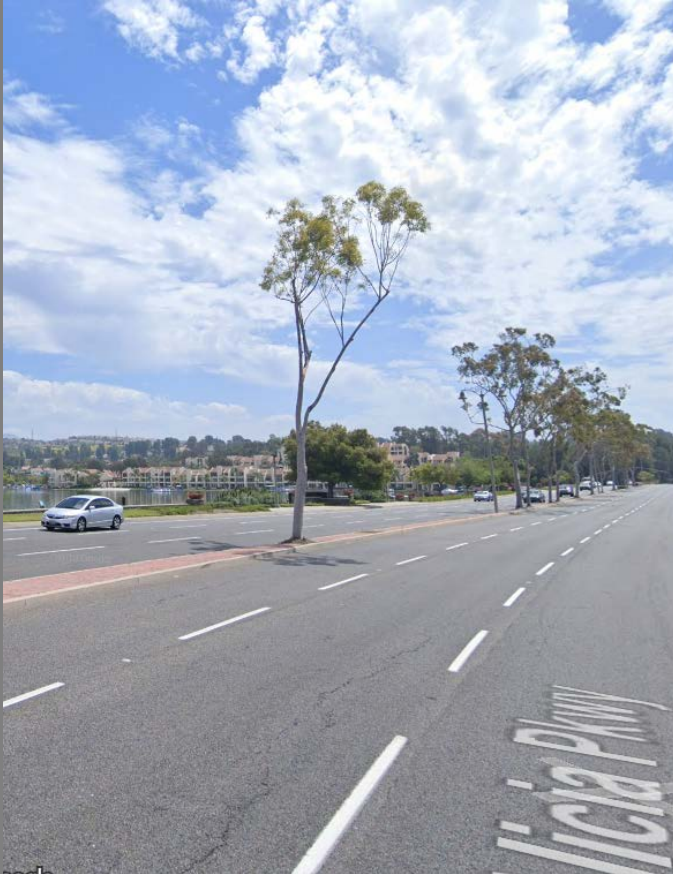
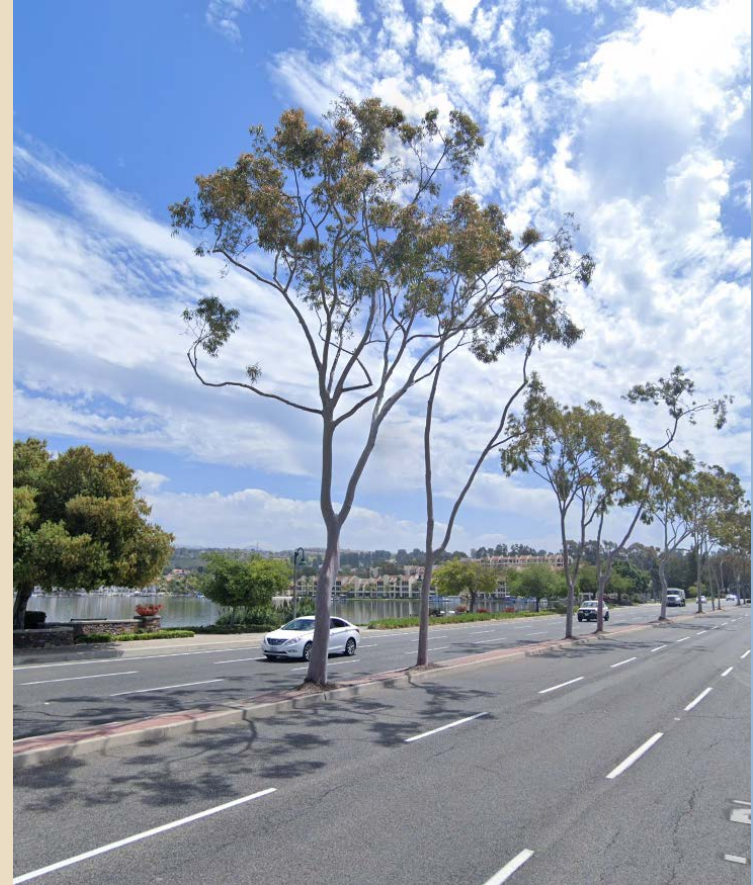
Mission Viejo  
Alicia Parkway

Narrow  
Median High  
Volume Travel  
Lane

Similar  
Conservative  
Pruning

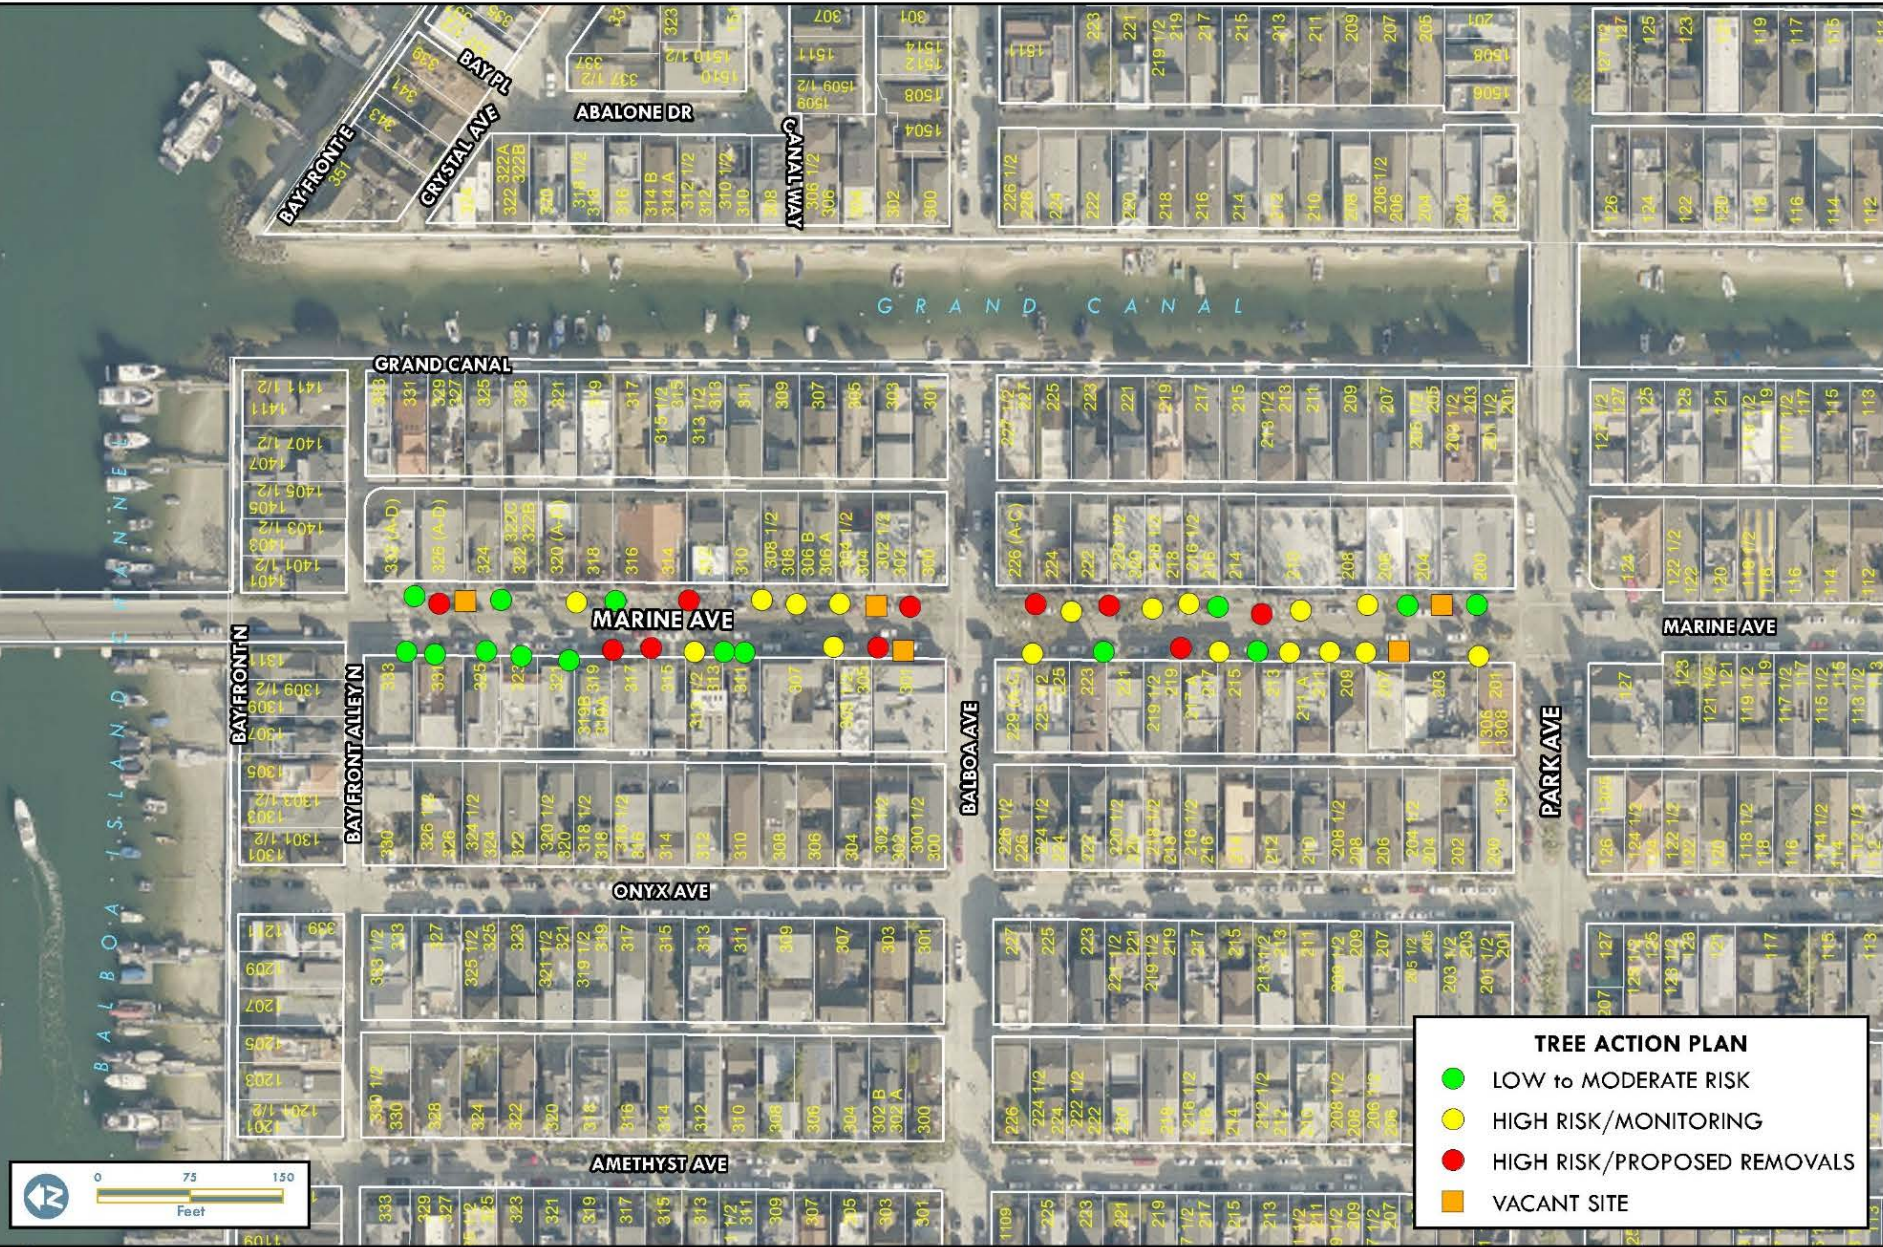
**TREE ACTION PLAN**

- LOW to MODERATE RISK
- HIGH RISK/MONITORING
- HIGH RISK/PROPOSED REMOVALS
- VACANT SITE

- Schedule Removal of the three Highest Risk trees, soon after Labor Day
  - 210 Marine Ave
  - 217 Marine Ave
  - 224 Marine Ave
- Remove Dead Tree at 315 Marine Ave (soon after Labor Day)
- Make any Necessary Hardscape Repairs Around existing Tree Wells where trees were removed such as uplifted and/or broken sidewalk or curb
- Replant all 9 Tree Wells with 24"-36" Box Eucalyptus  
*(5 currently vacant and 4 from removals)*
- Arrange for on-going Watering on new Trees by Water Truck or Merchant Volunteer

- Schedule Removal of the other 6 High Risk Trees for Early January 2020
- Make any Necessary Hardscape Repairs Around existing Tree Wells where trees were removed such as uplifted and/or broken sidewalk or curb
- Replant with 24"-36" Box Eucalyptus and Arrange for on-going Watering on new Trees by Water Truck or Merchant Volunteer
- Continue with Annual Inspection and Pruning of All Marine Ave Trees
  - Including Crown Restoration, as a mitigation measure, where applicable
- Schedule Re-Assessment of remaining High-Risk Eucalyptus Trees in 2021 by an Urban Forester, including Level III testing where practical
- Based on Reassessment, remove and replace up to 17 trees in following one – two years
